Subject: Lawrence Water PER Submittal

Preliminary Engineering Report
for **Water System Improvements**

LAWRENCE MUNICIPAL UTILITIES
LAWRENCE, INDIANA

November 2016
Revised January 9, 2017

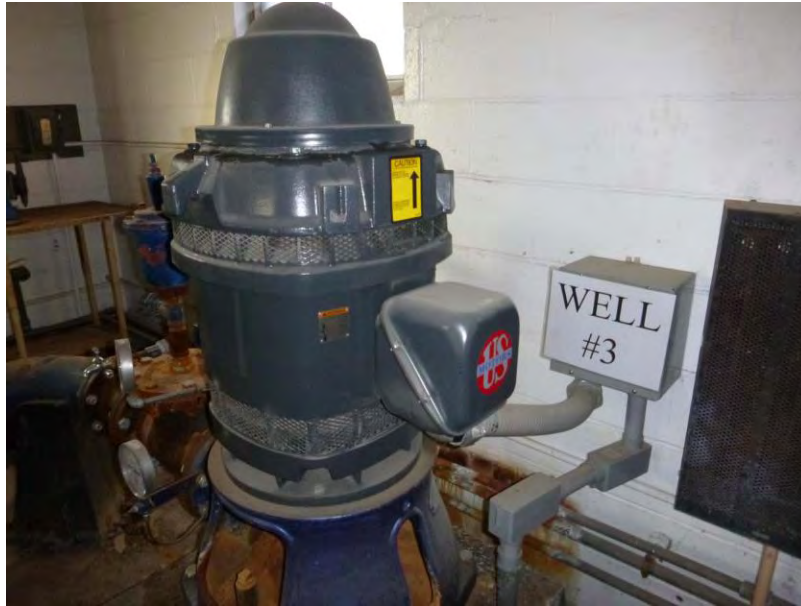
Well 3

The well was constructed in 1954. It is a rock well, reportedly 291 feet deep, 12-inches in diameter with a 50 HP across the line motor. The well has a rated capacity of 580 gpm and a current pumping capacity of 750 gpm. The well is enclosed in a masonry well house which also contains Well #4 and formerly contained the chlorine gas feed equipment for the water treatment plant. A flow totalizer and pressure switch are located on the pump discharge. The existing well house electrical, roof, doors, and windows are in need of repair.

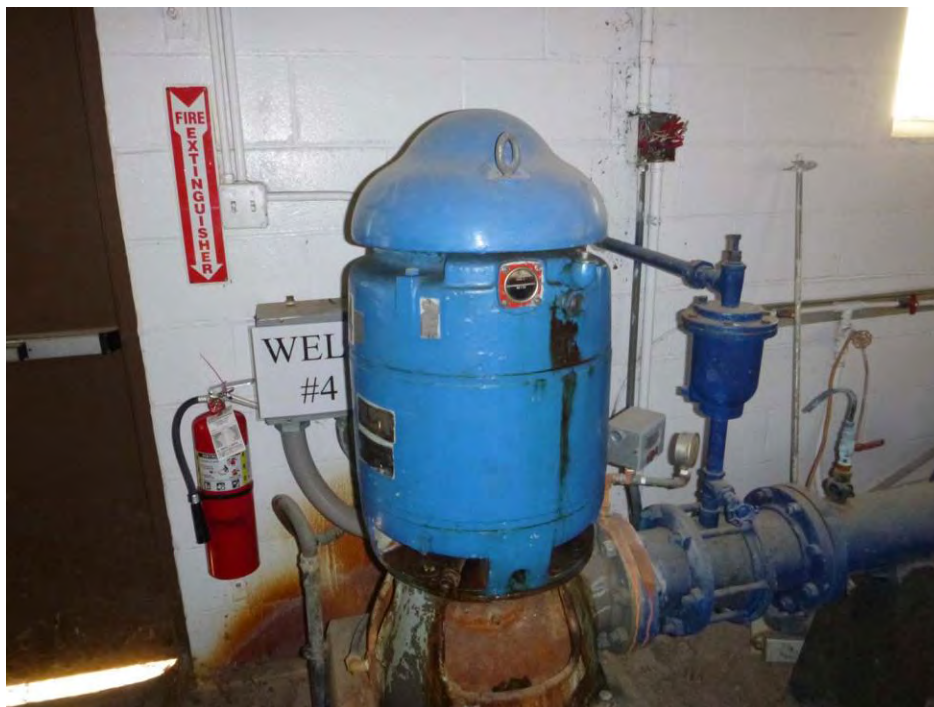
Well 4

The well was constructed in 1954. It is a rock well, reportedly 289 feet deep, 8-inches in diameter with a 30 HP across the line motor. The well has a rated capacity of 250 gpm but is currently not in operation. The well is enclosed in a masonry well house which also contains Well #3 as noted above. A flow totalizer and pressure switch are located on the pump discharge.

Well 4’s physical condition and age contribute greatly to the probability of failure for both the pump and motor. The financial impact of replacing the well pump or motor contribute to the moderate consequence of failure rating.

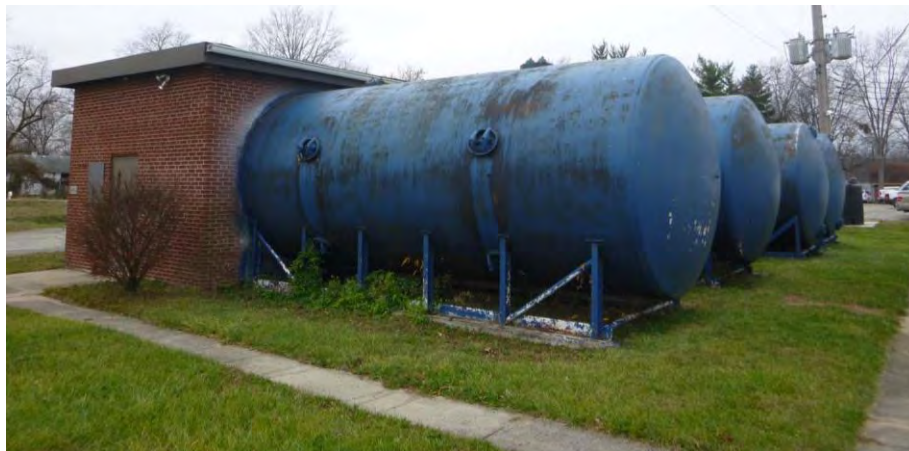
Horizontal Pressure Filters

Recently, the pressure filters have been operating as biological filters to consume the ammonia present in the raw water. In March 2016, Peerless Midwest completed an evaluation of the pressure filter and

filter media conditions. The filters are experiencing corrosion resulting in structural deficiencies including failure of the bracket system holding the interior PVC headers, the poor condition of the access hatches and associated appurtenances resulting in difficult access, and corrosion of nuts and bolts. The filter media in the pressure filters consists of anthracite over a gravel support bed. Typically, filter media has an expected useful life of 15 years before its filtration capacity begins to diminish and must be replaced. The existing media in the filters was last replaced more than 15 years ago. However, the anthracite filter media in the filters are in fair condition but is not performing as intended.

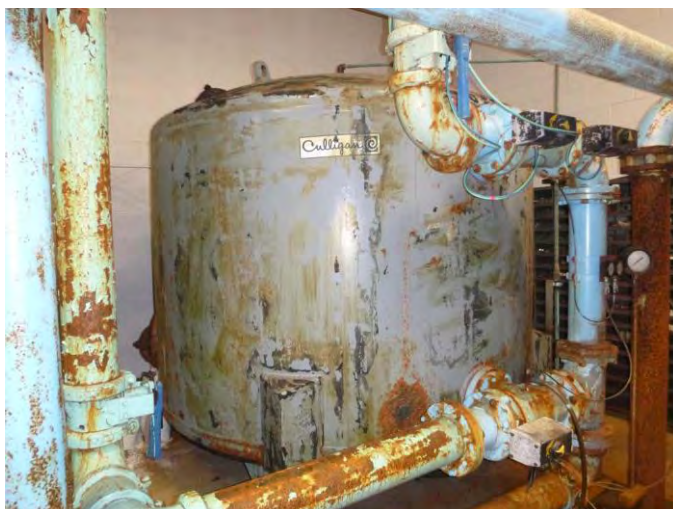
Filter 6

The filter media in the pressure filters reportedly consists of anthracite over a gravel support bed. Typically, filter media has an expected useful life of 15 years before its filtration capacity begins to diminish and must be replaced. The condition of the existing media, interior coating, and interior steel is unknown and in need of evaluation.

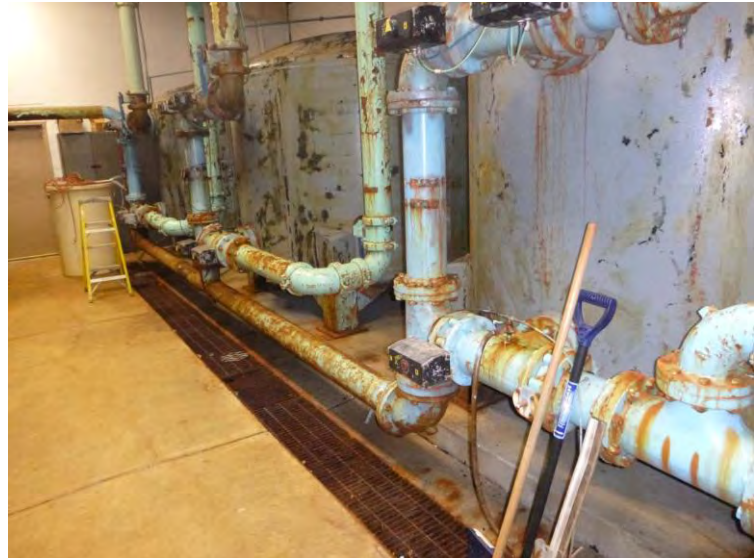
Corroded Process Piping

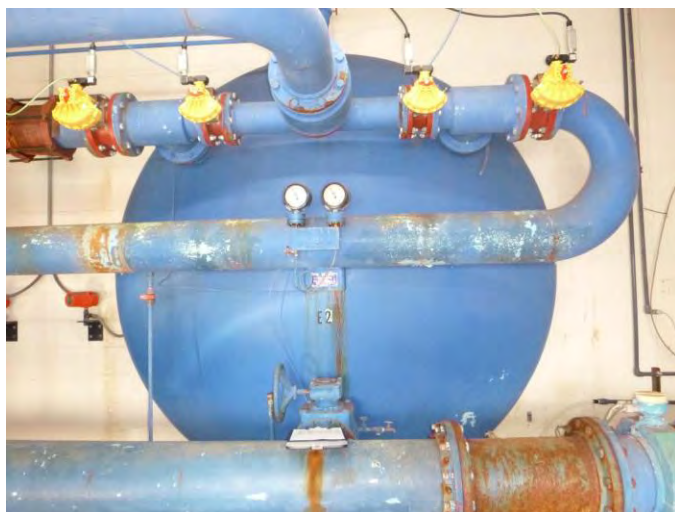
Filter E2

Also according to the *Recommended Standards for Water Works*, the filters shall be capable of providing the maximum demand of the system with any filter out of service. The firm rated capacity of the filters is 1,944 gpm with one filter out of service. The condition of the existing media, interior coating, and interior steel was evaluated in 2011 by Peerless Midwest. The filter media was installed in 1990 and is well past its useful life of 7-10 years. The edges of the filter media are sub-rounded to rounded and are significantly smaller than their original size. In addition, the particles are soft and turn to dust when subjected to “finger” pressure.

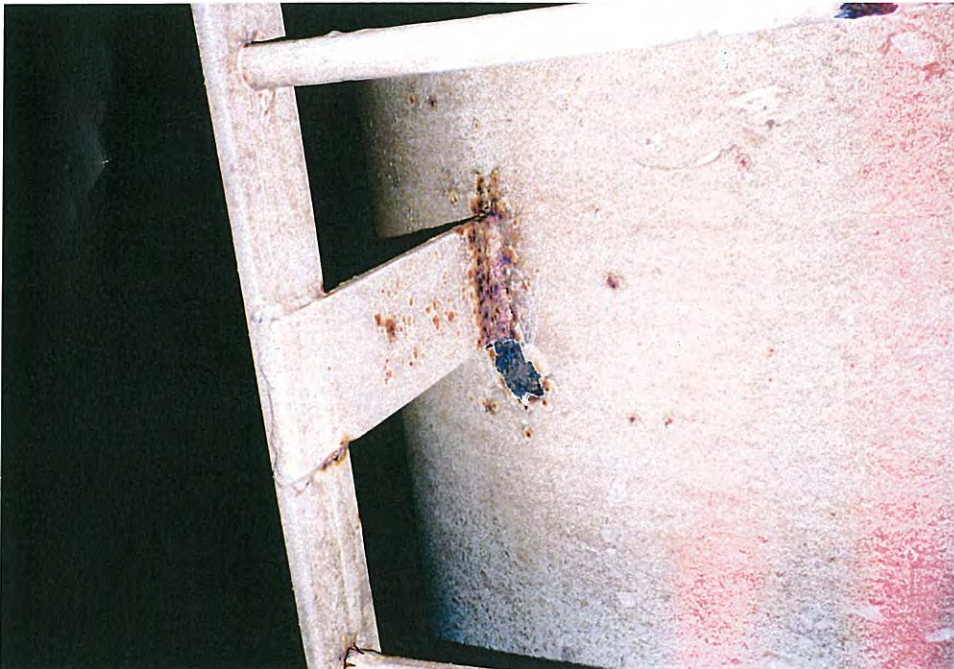
3 MG Ground Storage Reservoir

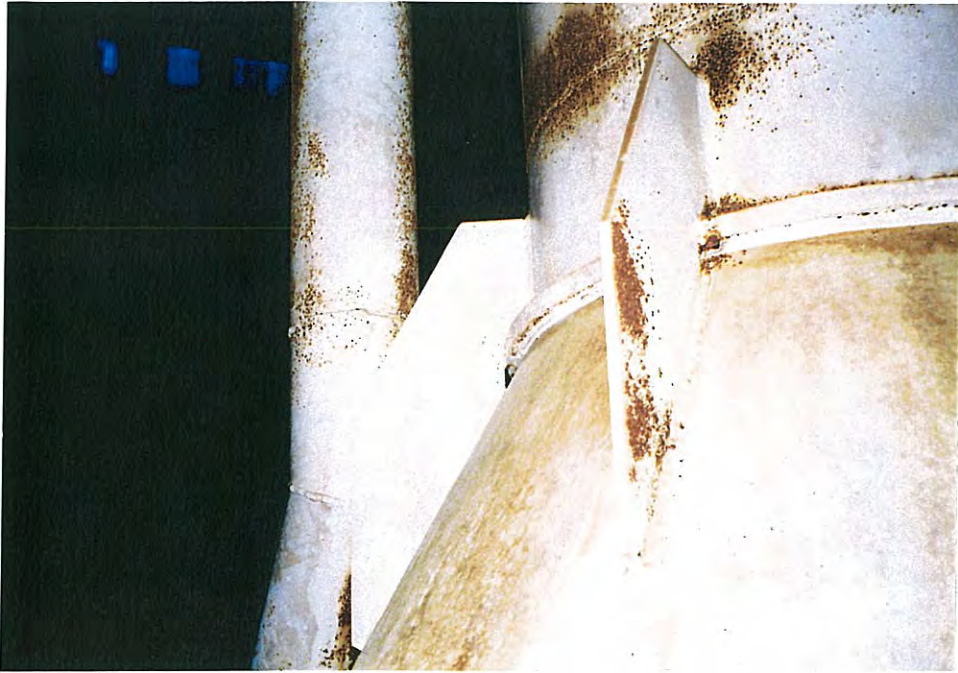
3 MG Ground Storage Reservoir Roof

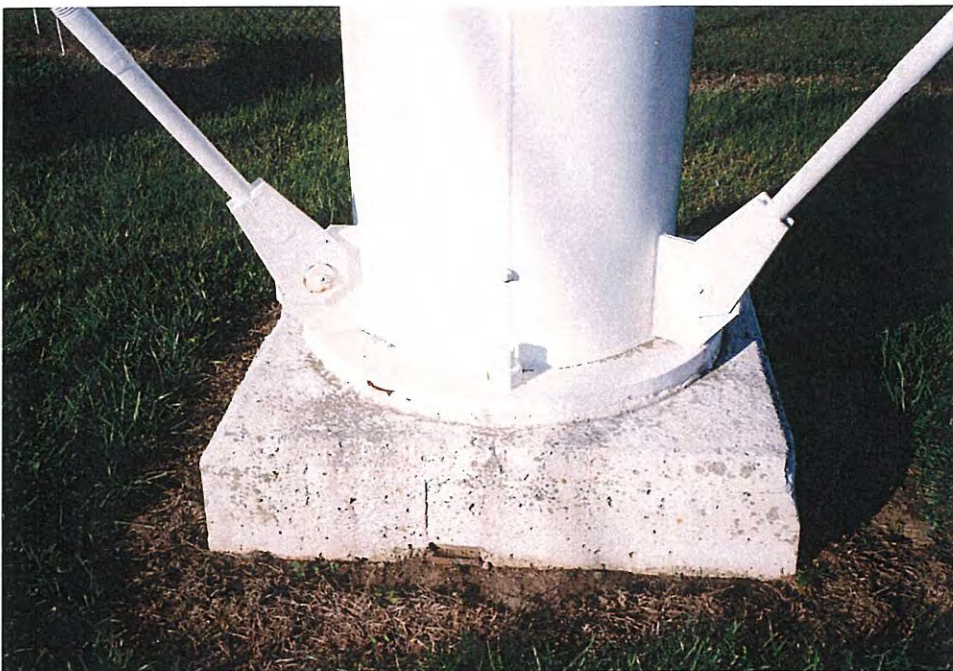
9. Column foundation, base plate, and anchor bolt. Note rust near wing plate.

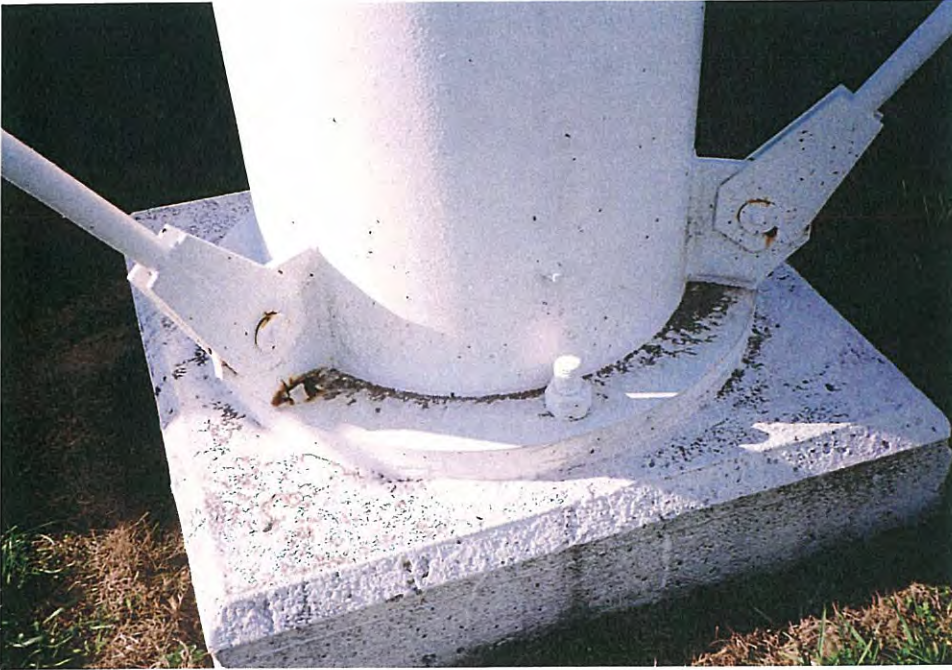
10. Column foundation, base plate, and anchor bolt. Note rust near wing plate.

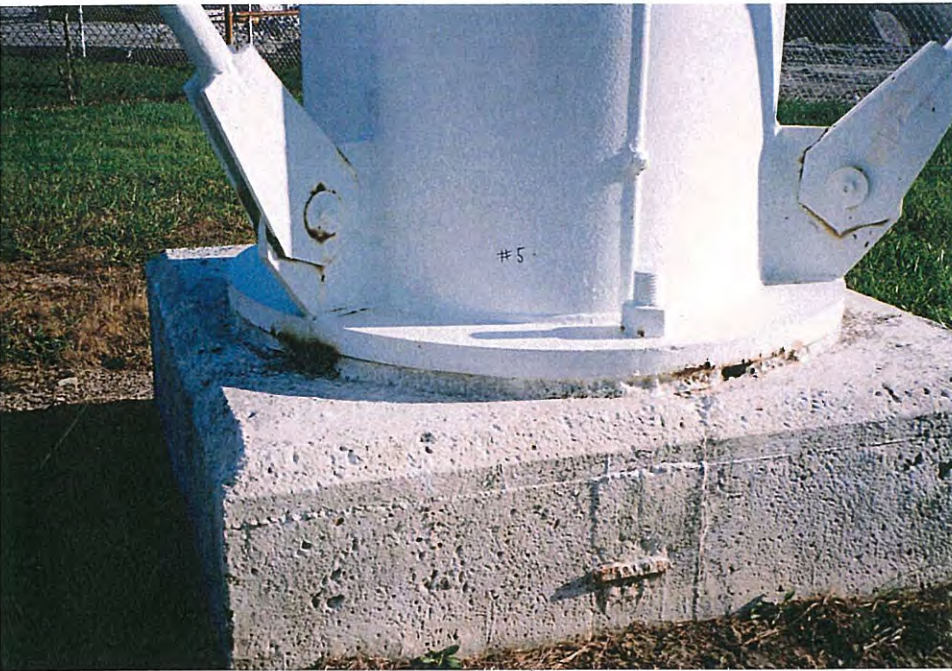
11. Riser base plate and anchor bolt. Note corrosion and gap at bolt hole.

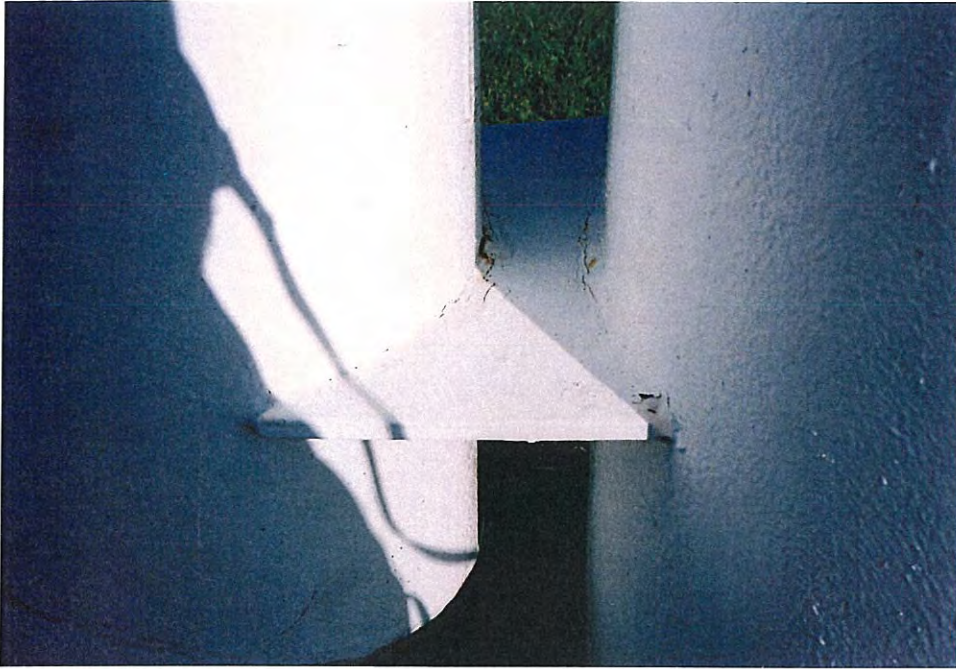
17. Cracked coating on lower overflow pipe bracket.

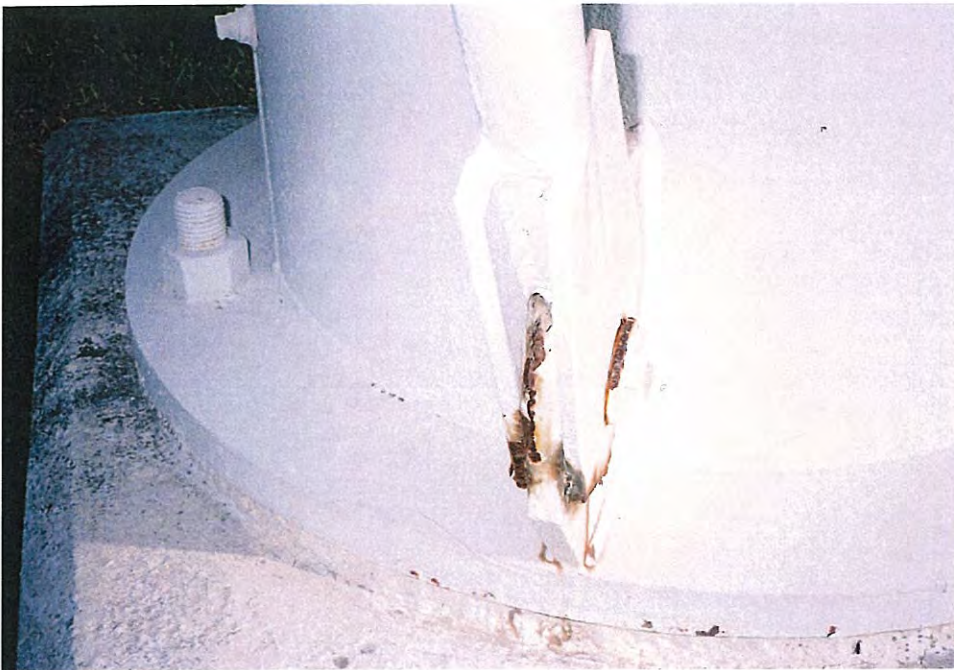
22. Corrosion at diagonal bracing clevis and wing plate at bottom of column.

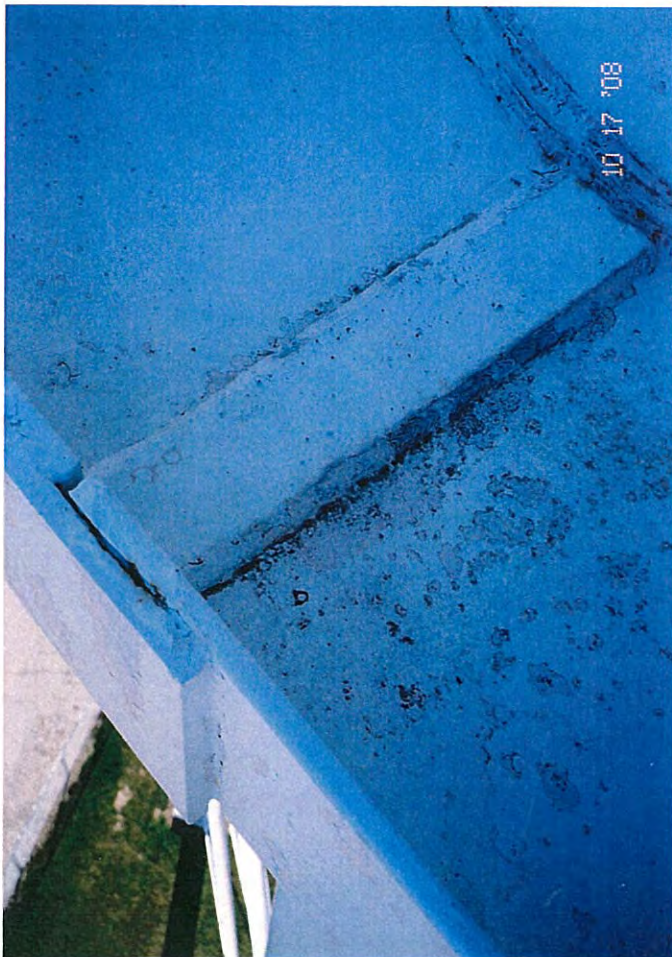
38. Cracked weld at top of toe bar splice.

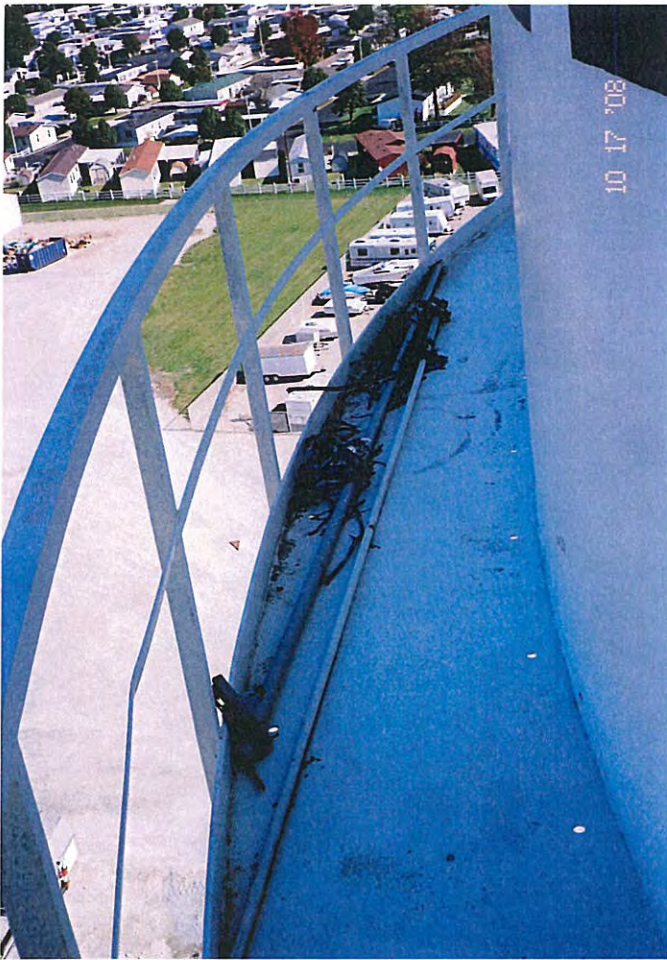
39. Pipes and debris lying on balcony.

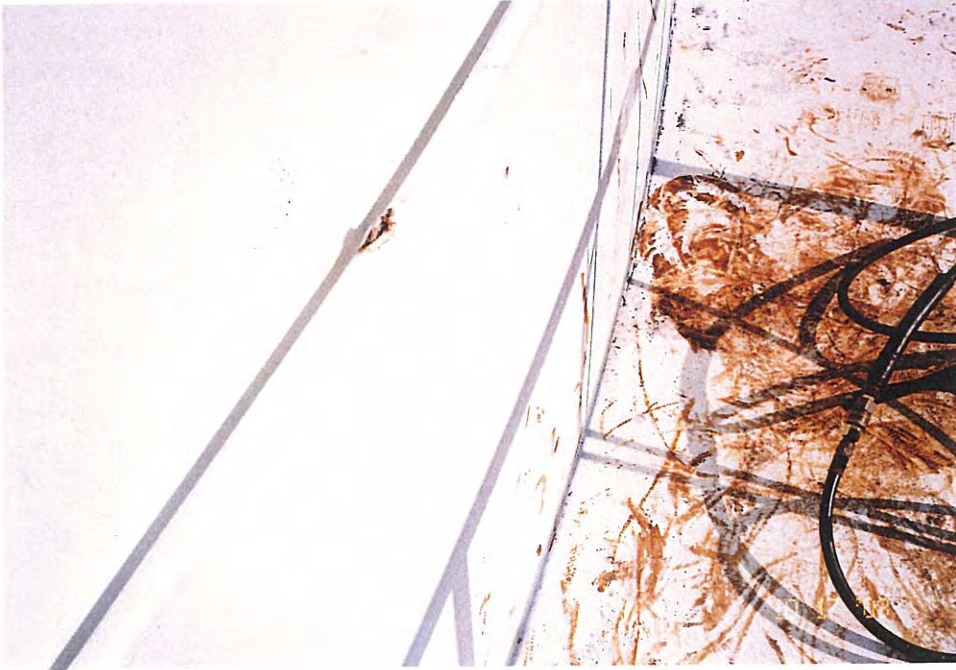
41. Cracked conduit on shell.

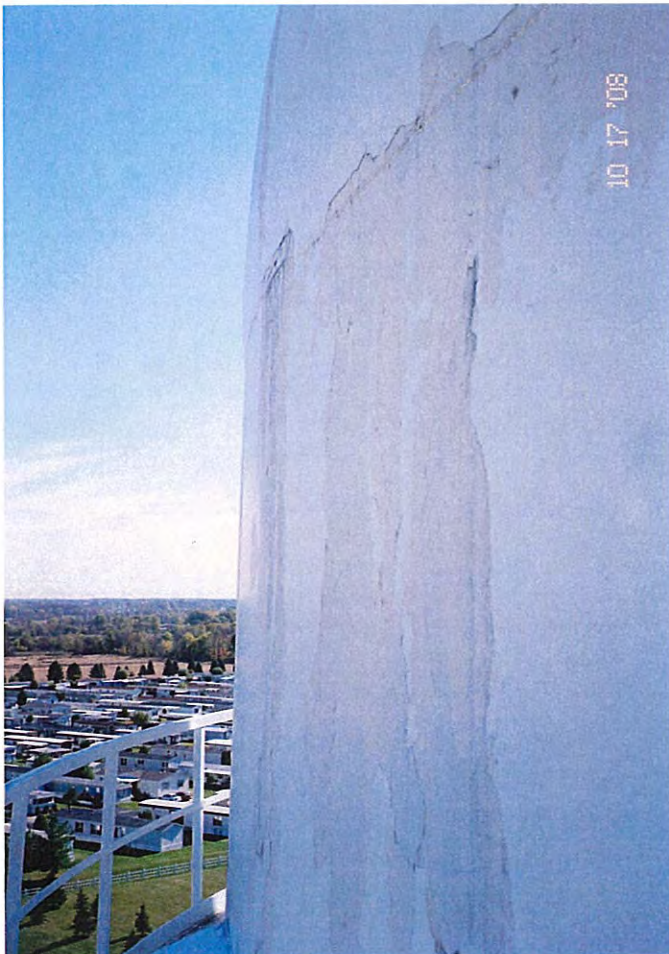
42. Peeled topcoat on exterior shell.

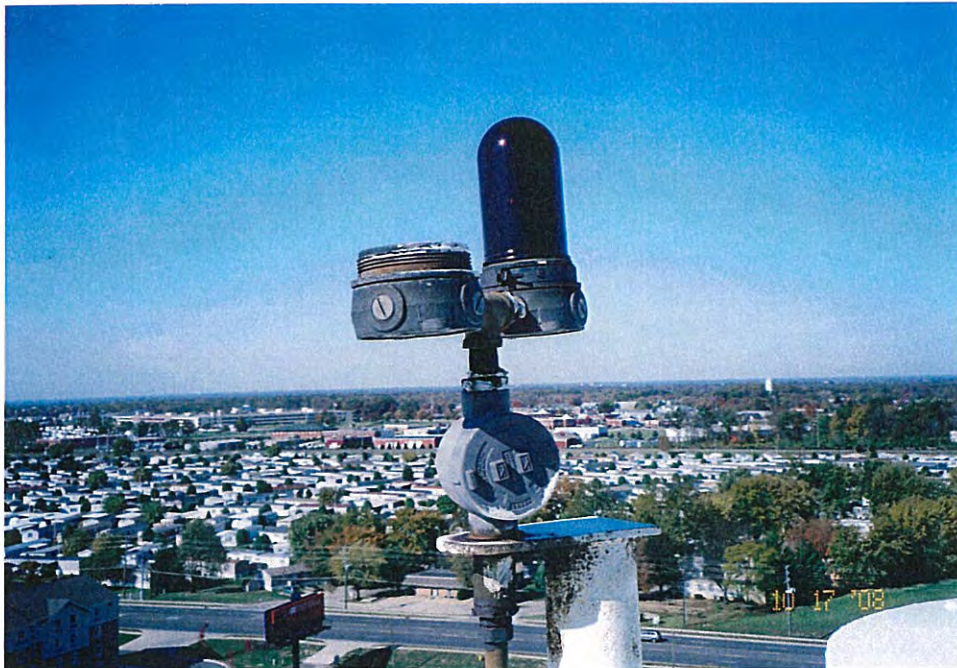
50. Obstruction light on roof. Note bulb and globe missing.

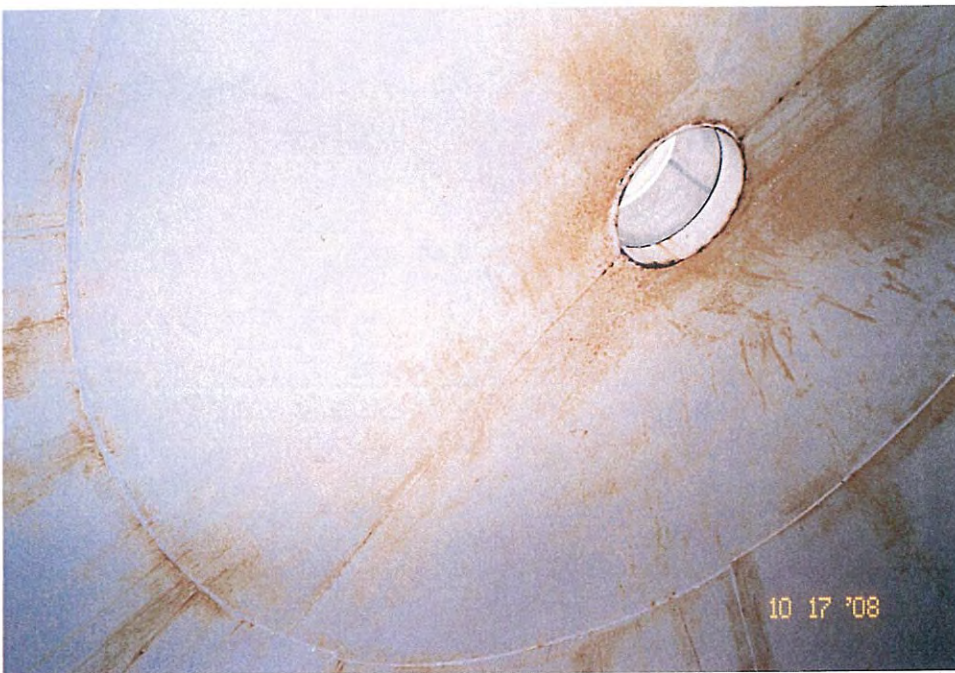
54. Surface rust on interior roof.

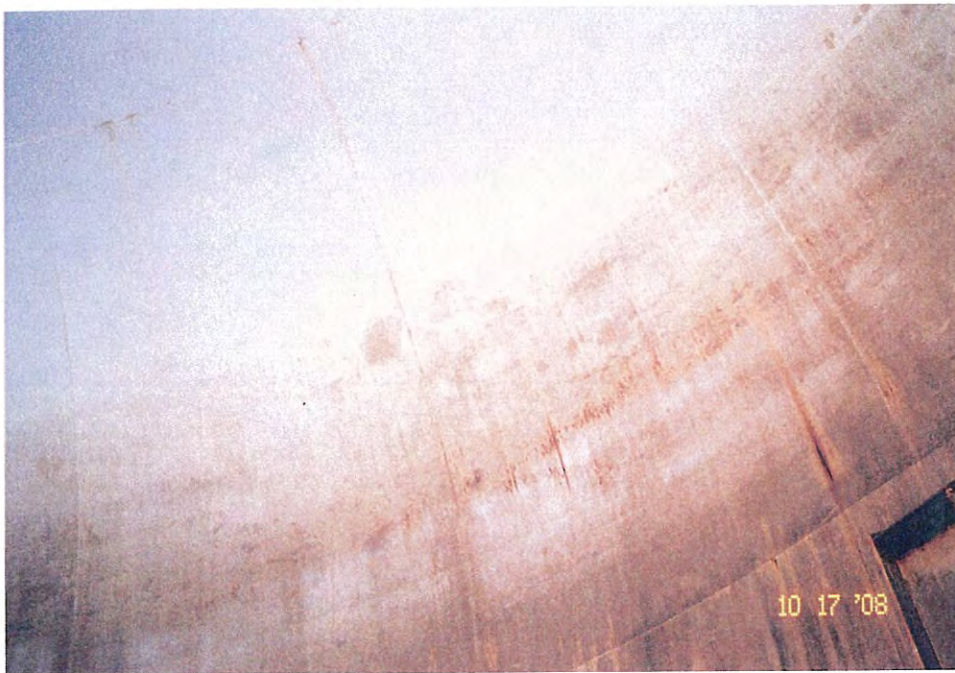
60. Interior roof knuckle.
Note spot rust.

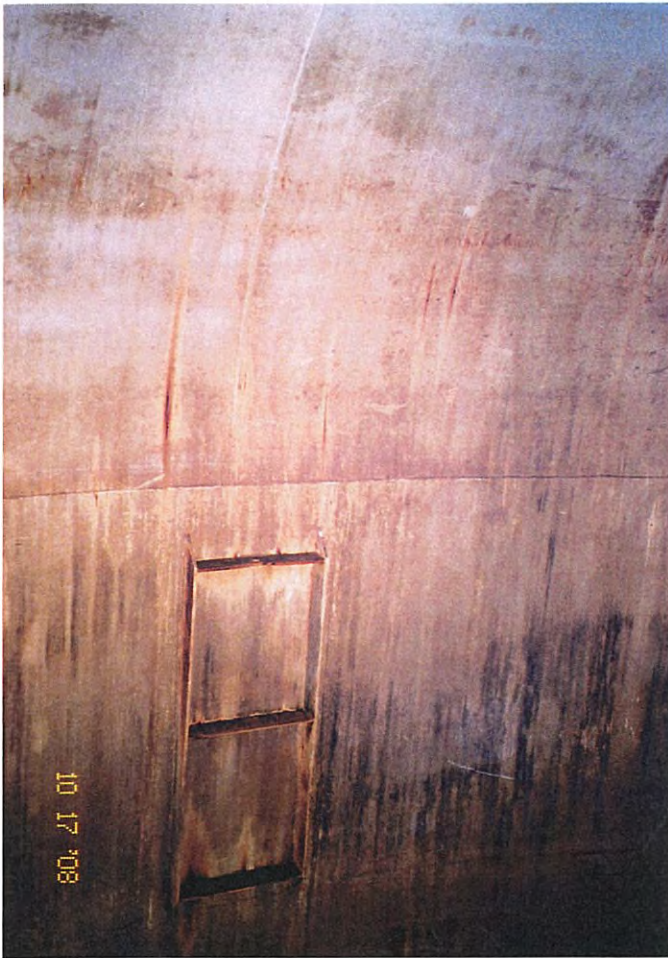
- 61. Spot rust on interior roof knuckle, shell, and column post head stiffeners.

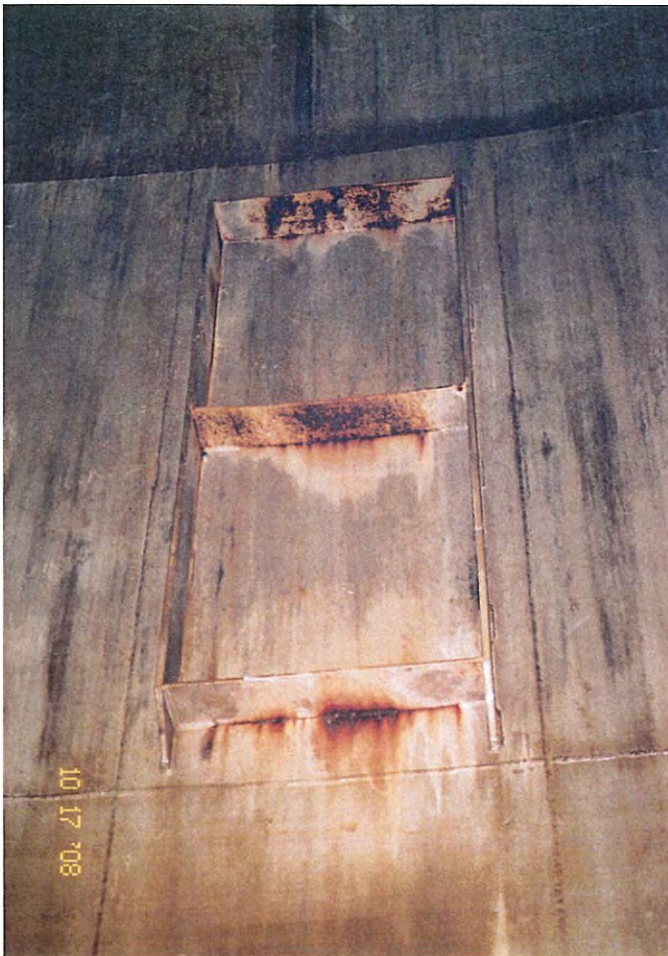
- 62. Corrosion on column post head stiffeners on interior shell.
