Subject: Lawrence Water PER Submittal

Preliminary Engineering Report
for **Water System Improvements**

LAWRENCE MUNICIPAL UTILITIES
LAWRENCE, INDIANA

November 2016
Revised January 9, 2017

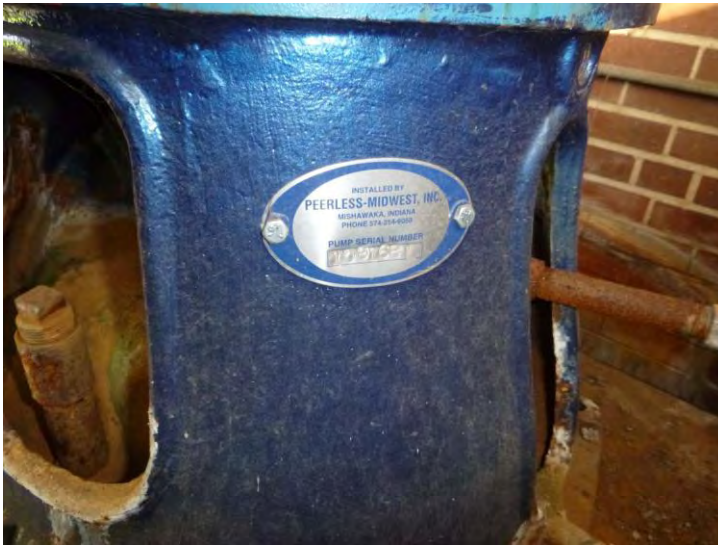
Well 1 Pump Head

The well was constructed in 1959. It is a rock well, reportedly 242 feet deep, 16-inches in diameter with a 125 HP premium efficient inverter duty motor. The well has a rated capacity of 1,200 gpm and a current pumping capacity of 1,250 gpm. The well is enclosed in a masonry well house. A 2002 variable frequency drive (VFD) located in the well house is used to set the discharge rate of the well. Flow testing in 2012 indicated that the specific capacity of the well was 216. A flow totalizer and pressure switch are located on the pump discharge. The existing well house roof, door, and windows are in need of repair.

The transformer and controller have a BRE ratings above 10 because of their poor physical condition, O&M protocols, operational condition, and financial impact.

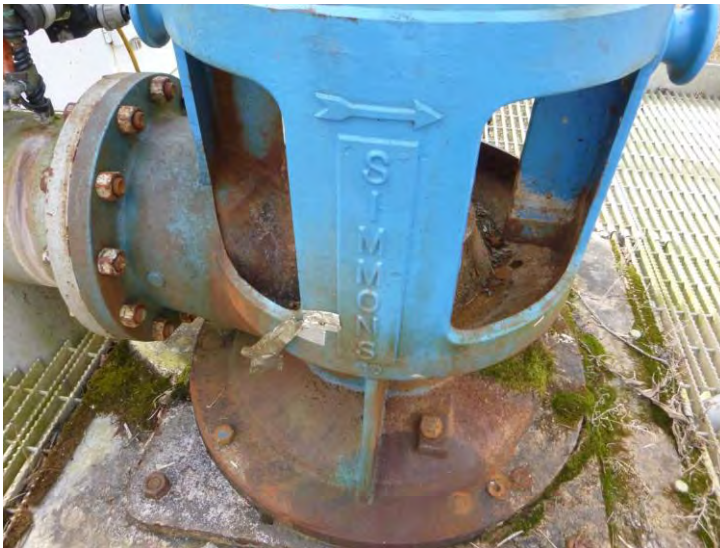
Well 8 Pump Head

capacity of 1,250 gpm and a current pumping capacity of 1,250 gpm. The well is located on an elevated platform exposed to the elements. Flow testing in 2010 indicated the well had a specific capacity of 52.26.

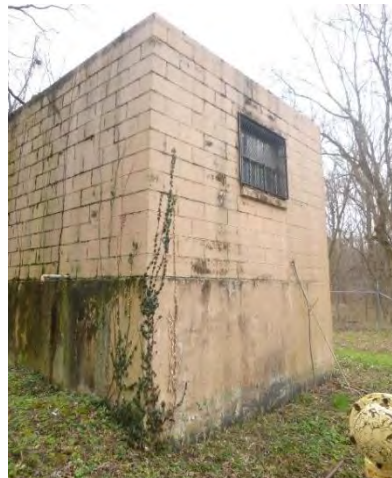
Well 9

The well was constructed in 1968 and last rehabilitated in 2008. It is a gravel pack well, reportedly 111.5 feet deep, 18-inches in diameter with a 60 HP motor. The well has a rated capacity of 500 gpm and a current pumping capacity of 1,000 gpm. The well is located in a well house. Flow testing in 2010 indicated the well had a specific capacity of 32 which is substantially off from its peak production potential according to Peerless Midwest. The well house is in fair condition and in need of minor repairs.

The safety switches and transformer have elevated probability of failure and consequence of failure ratings as a result of the physical condition, age, operational condition, and safety concerns.

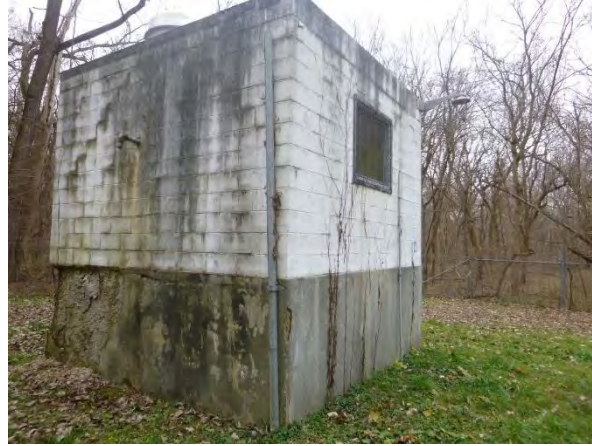
Well 10

The well was constructed in 1975 and was rehabilitated in 2010. It is a gravel pack well, reportedly 86 feet deep, 18-inches in diameter with a 100 HP premium efficient inverter duty motor. The well has a rated capacity of 1,000 gpm and a current pumping capacity of 750 gpm. The pump was replaced in 2010 with a six stage pump rated at 650 gpm at 372 feet of TDH. The well is located in a well house. Flow testing in 2010 indicated the well had a specific capacity of 28.05. The well house is in poor condition and requires rehabilitation.

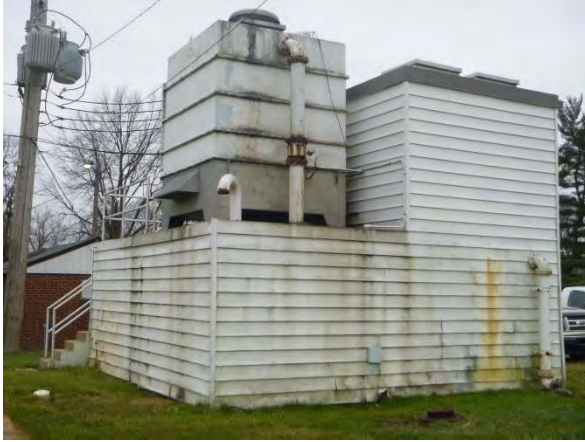
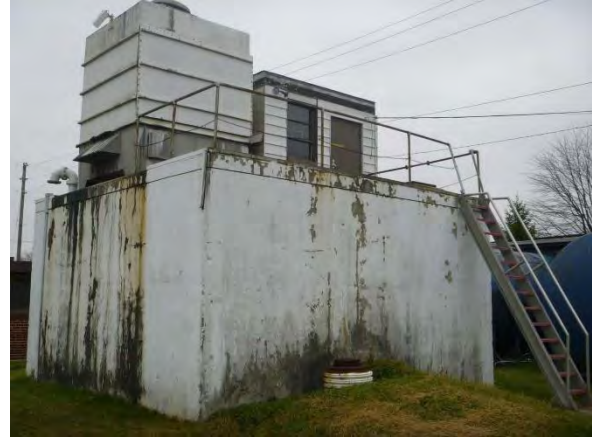
West Detention Tank

Two detention tanks are located on the site. The east tank was constructed with the original plant construction of 1958 and the west tank was added with the plant expansion in 1971. These tanks follow the aeration process. The detention tanks were originally designed to operate independent of each other, but in 2002 the Utility installed an interconnect pipe to allow the detention tanks to be hydraulically connected. Each detention tank is partially below ground. Each detention tank has a reported volume of 15,000 gallons, however, the west tank is approximately 4 feet lower than the east tank, and so only about 75% of the east tank volume can be utilized, resulting in a total detention volume of 26,000 gallons. This volume provides 15 minutes of detention time at 1,700 gpm plant production, which is the maximum operating rate currently used according to Utility pumping data. According to the *Recommended Standards for Water Works*, a minimum of 30 minutes of detention time is required to ensure that oxidation reactions are as complete as possible. This reduced detention time does not appear to have an impact on the oxidation of iron and manganese in the raw water, as indicated by the filter influent water quality for these parameters. The amount of ferric iron (aqueous) is 0 mg/L at the filter influent indicating the iron has been oxidized. The detention tanks are taken out of service, cleaned, and inspected annually. Currently, the east detention tank is not utilized due to inoperable high service pumps located above the tank.

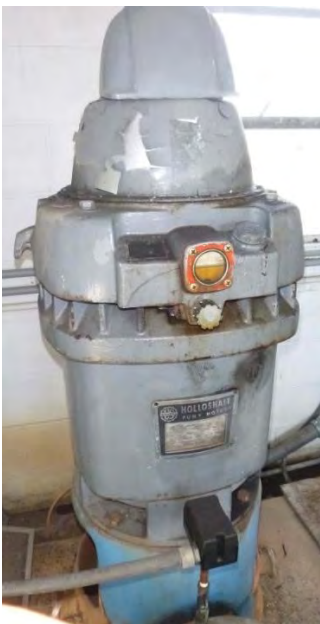
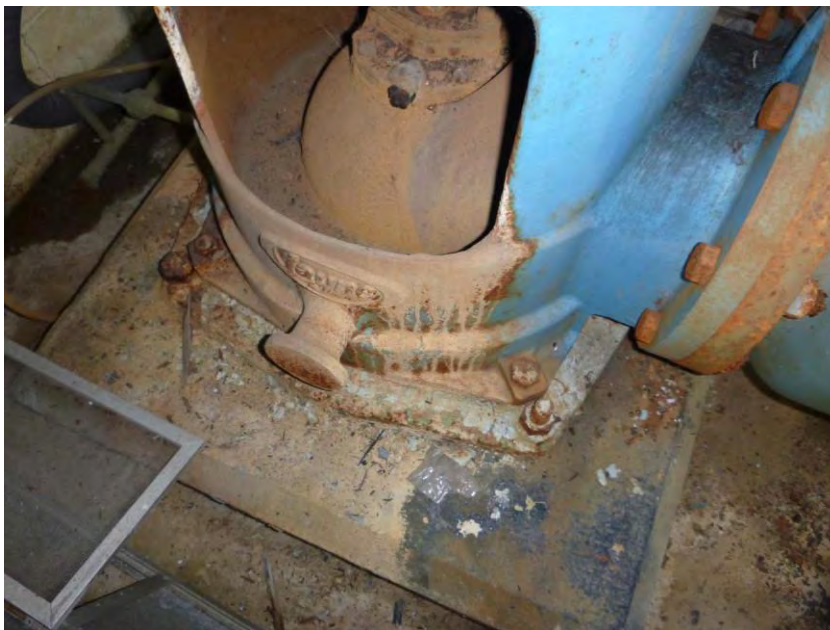
High Service Pump 2

High service pump No. 1 and No. 2 are located on top of the east detention tank and were installed as part of the 1971 plant expansion. Both high service pumps are no longer in operation.

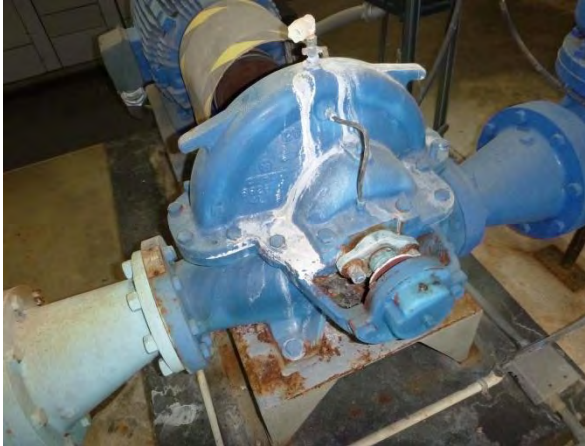
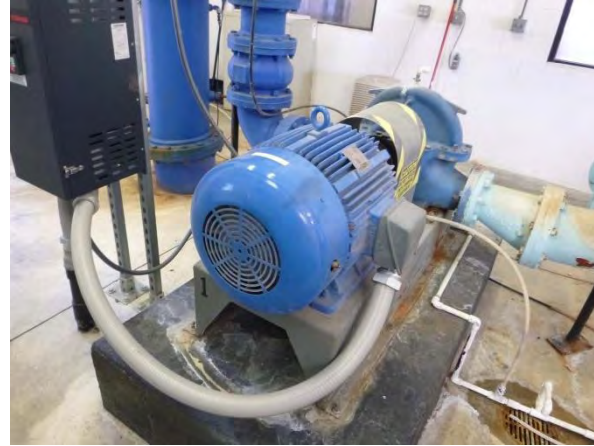
High Service Pump 1

High service pump 1 is located in the pumping building and produces 800 gpm. The pump is a horizontal centrifugal pump with a 50 HP motor and VFD. The pump is in fair condition and the motor is in good condition.

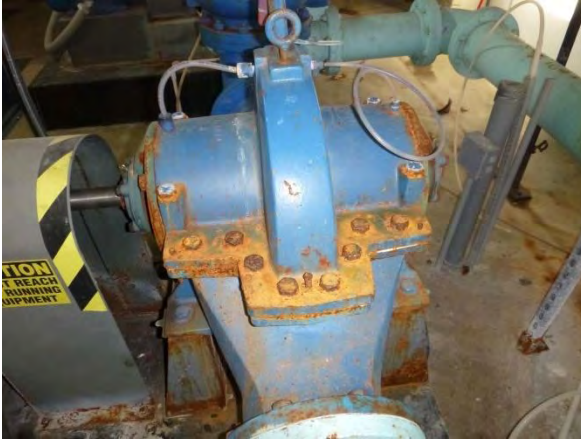
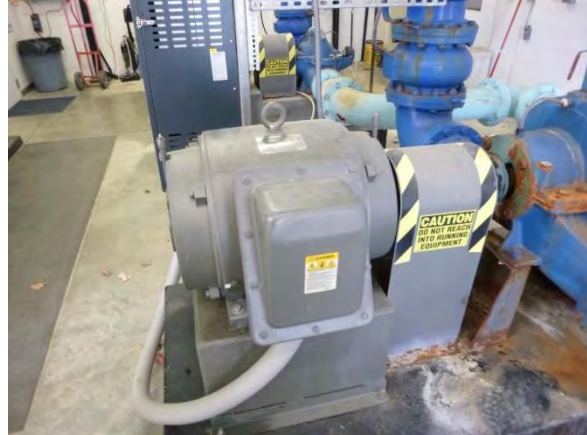
High Service Pump 2

High service pump 2 is located in the pumping building and produces 1,200 gpm. The pump is a horizontal centrifugal pump with a 75 HP motor and VFD. The pump and motor are in fair condition.

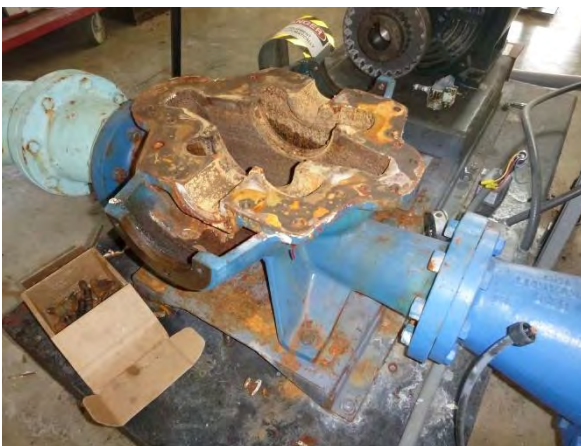
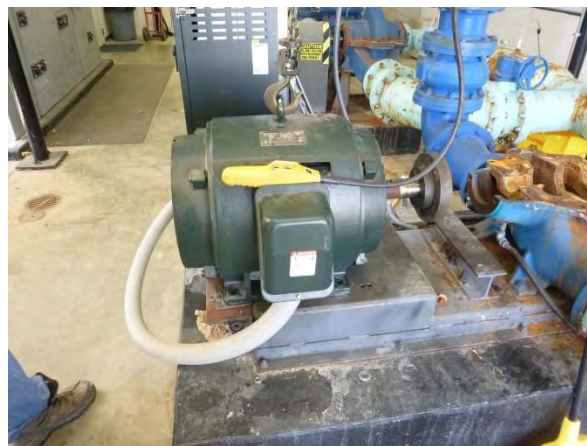
High Service Pump 3

High service pump 3 is in the pumping building and produces 1,000 gpm. The pump is a horizontal centrifugal pump with a 75 HP motor and VFD. The pump was not in operation at the time of this report, but the motor is in good condition.

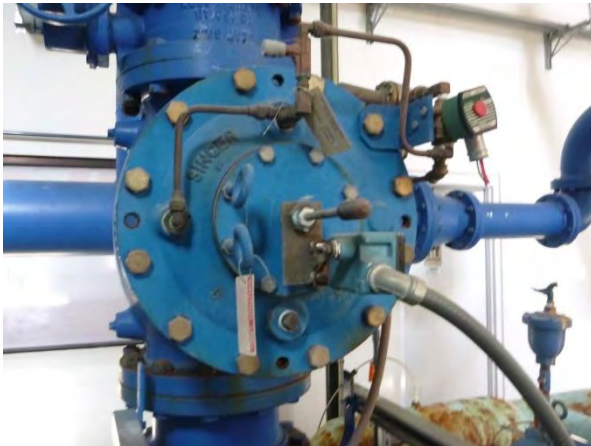
Process Piping in Pumping Building

The process piping located in the pumping building is all in good condition. There are no signs of corrosion and it appears that portions of the process piping were recently coated. However, the process piping shows signs of significant corrosion in the filter building. The existing coating system is flaking off the pipe exposing the metallic pipe to the corrosive chemical vapors present in the filter building.

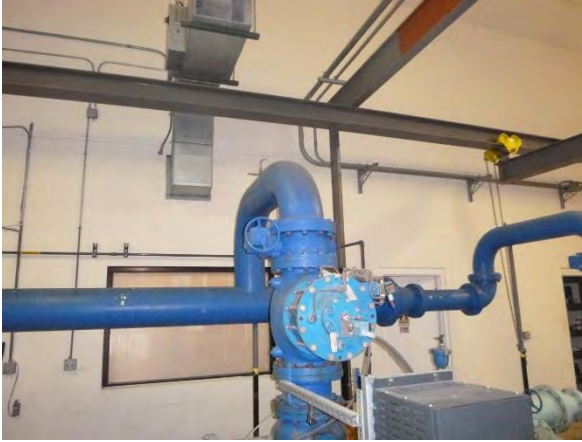
Butterfly and Check Valve in Pumping Building

The valves located in the pumping building are butterfly, singer, or silent check valves. There is one gate valve that is no longer used in the process. The butterfly valves all have manual actuators. They are all in good condition and there are no operating issues with the valves. In the filter building, the valves are all butterfly valves with either manual or pneumatic actuators. Many of the valves are missing actuators and are showing signs of corrosion. There are several valves in poor operating condition.

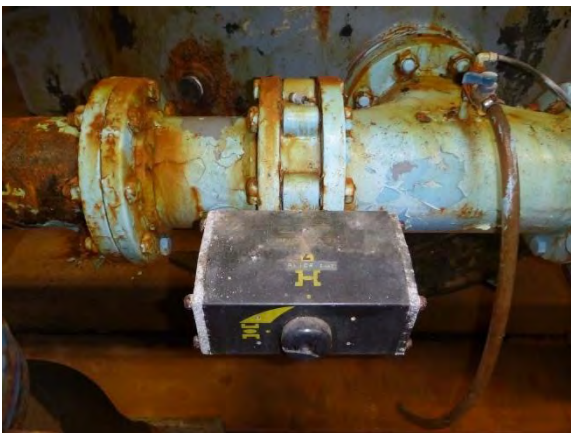
Electric Actuator in Filter Building

The valve actuators in the pumping building are all manual and in good condition. The actuators for the butterfly valves in the filter building are pneumatic and in poor condition or missing altogether.

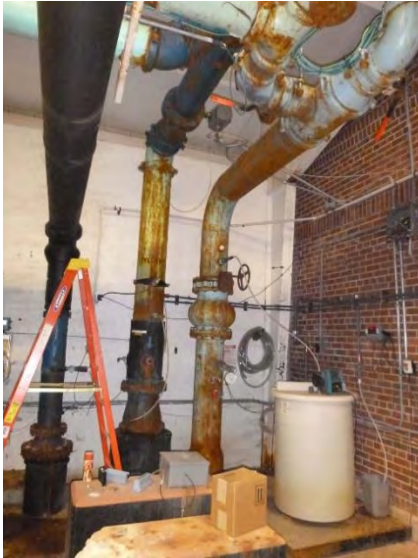
Process Piping & Chlorine Feed

The Fort Harrison plant feeds phosphates and chlorine in the filter building. However, the chlorine and phosphate feeds and storage tanks are located in the filter room. As a result, the process piping, actuator components, valves, etc. are corroding due to the chemical vapors present in the building.

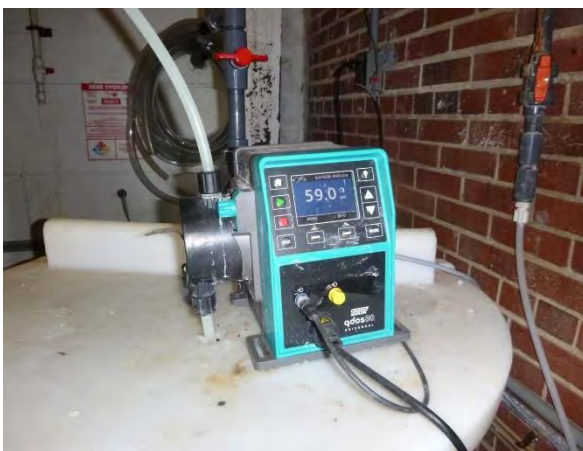
Pre-Filtration Chlorine Feed

Lawrence feeds bulk sodium hypochlorite at the Fort Harrison WTP as their method of disinfection. There are two chlorine feed points in the WTP located prior to and after the filters. The sodium hypochlorite is stored outside of the filter building in a polyethylene storage tank. Lawrence uses breakpoint chlorination for disinfection. According to the MROs for 2016, the amount of chlorine fed per day varies from an average of 15 pounds per day (ppd) to 50 ppd. The pre-chlorination chemical feed pump is set to feed 51 gpd with a maximum capacity of 190 gpd. The post-chlorination chemical feed pump is set to feed 6 gpd with a maximum capacity of 190 gpd. The sodium hypochlorite is stored in a day tank inside the filter building. The pre-filtration sodium hypochlorite feed is injected by a metering pump. The chemical feed is not contained and there is not a secondary containment in place for the day tank inside the building. In addition, chemical vapors are corroding metallic surfaces due to the lack of chemical isolation. The post-filtration chlorine feed pump is in good condition.

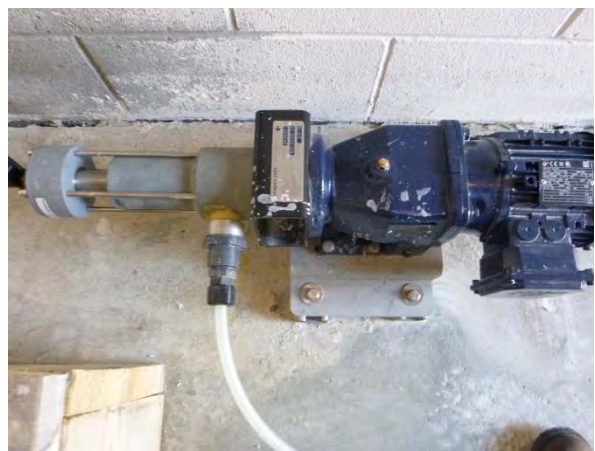
Post-Filtration Chlorine Feed

The chlorine analyzers have a high consequence of failure since an over dosing or under dosing chlorine.

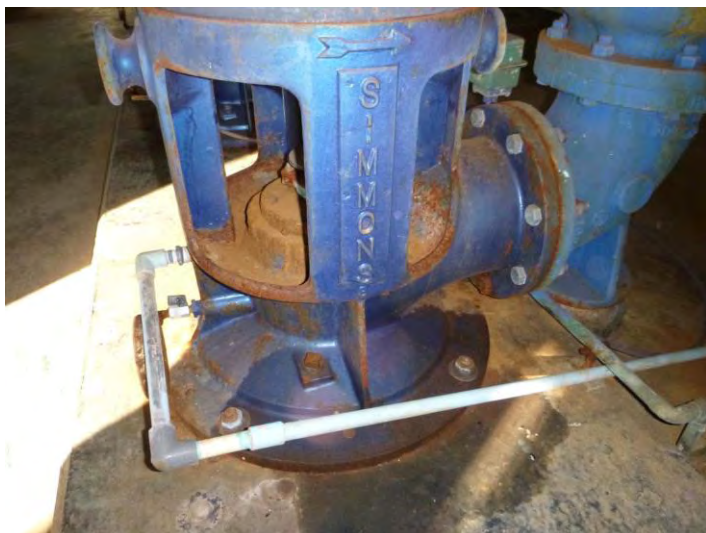
High Service Pump Head 1

High service pump 1 has a current operating capacity of 1,000 gpm. The pump is a vertical turbine pump with a 50 HP motor and VFD. The pump and motor were installed in 2012 and are in good condition.

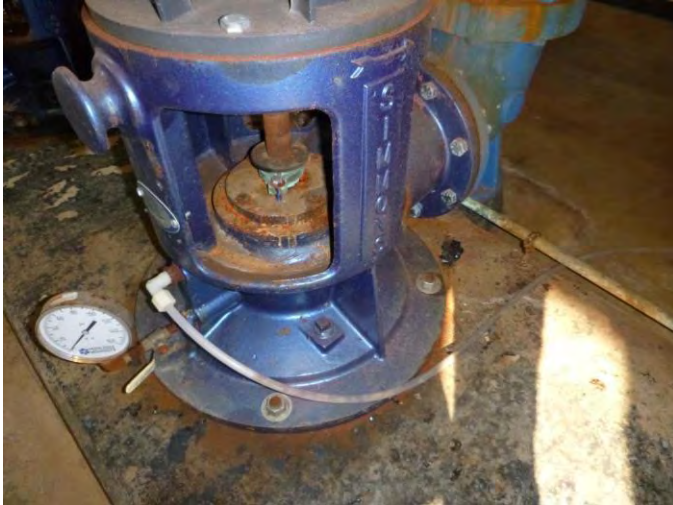
High Service Pump 2

High service pump 2 has a current operating capacity of 1,000 gpm. The pump is a vertical turbine pump with a 50 HP motor and VFD. The pump and motor were installed in 2012 and are in good condition.

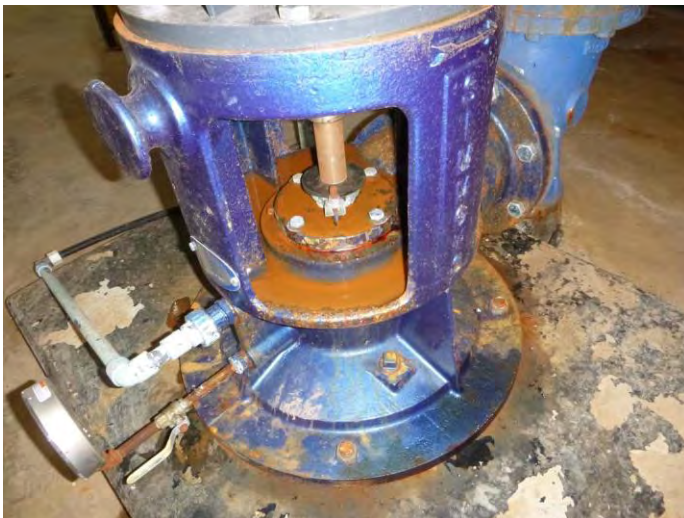
High Service Pump 3

High service pump 3 has a current operating capacity of 1,000 gpm. The pump is a vertical turbine pump with a 50 HP motor and VFD. The pump and motor were installed in 2012 and are in good condition.

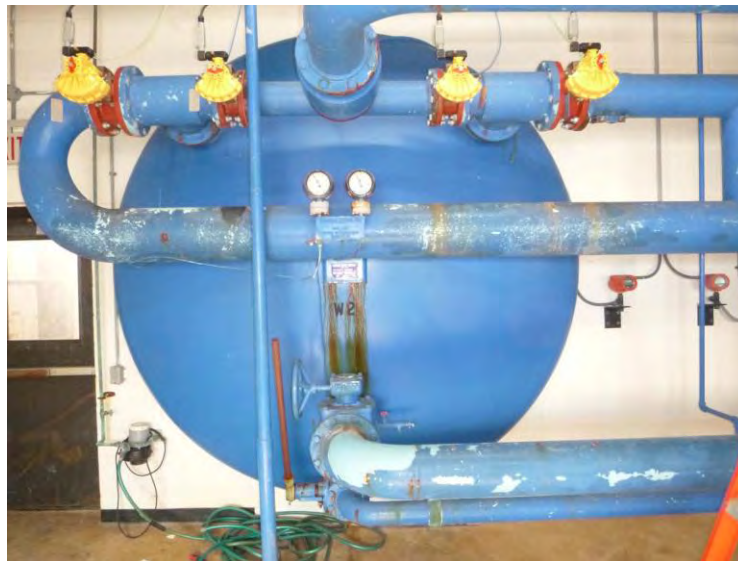
Filter W2, Process Piping, Valves, and Actuators

The process piping is showing signs of corrosion due to chemical off gassing present in the filter room.

The process valves are all butterfly or gate valves. All of the filter face piping valves were replaced in 2015 with new butterfly valves. The valves are all in good condition but some are showing signs of corrosion due to the chemical odors present in the environment.

The actuators for the filter face valves were all replaced with new pneumatic vane style actuators in 2015. The remaining actuators are manual.

Lawrence feeds chlorine, fluoride, and phosphates. However, the phosphate feed pump and storage tank are located in the filter room. As a result, the process piping, actuator components, valves, etc. are corroding due to the chemical vapors present in the building.

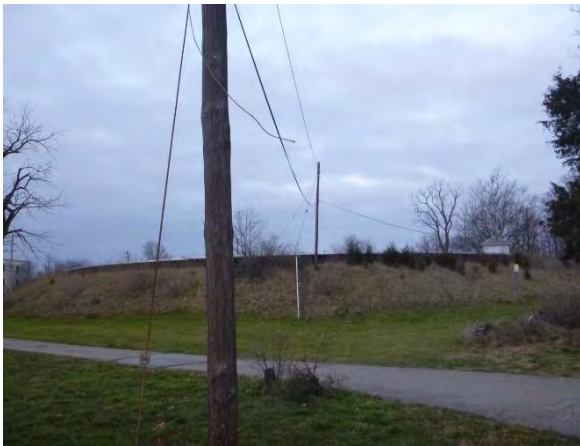
3 MG Ground Storage Reservoir

The 3 MG ground storage reservoir located at the Fort Harrison WTP site was installed circa 1913, last cleaned in 2004 and needs inspection. The roof of the tank requires a structural evaluation by a certified structural engineer. Due to the apparent age of the tank and lack of periodic maintenance, it is probable that the tank will require some rehabilitation.

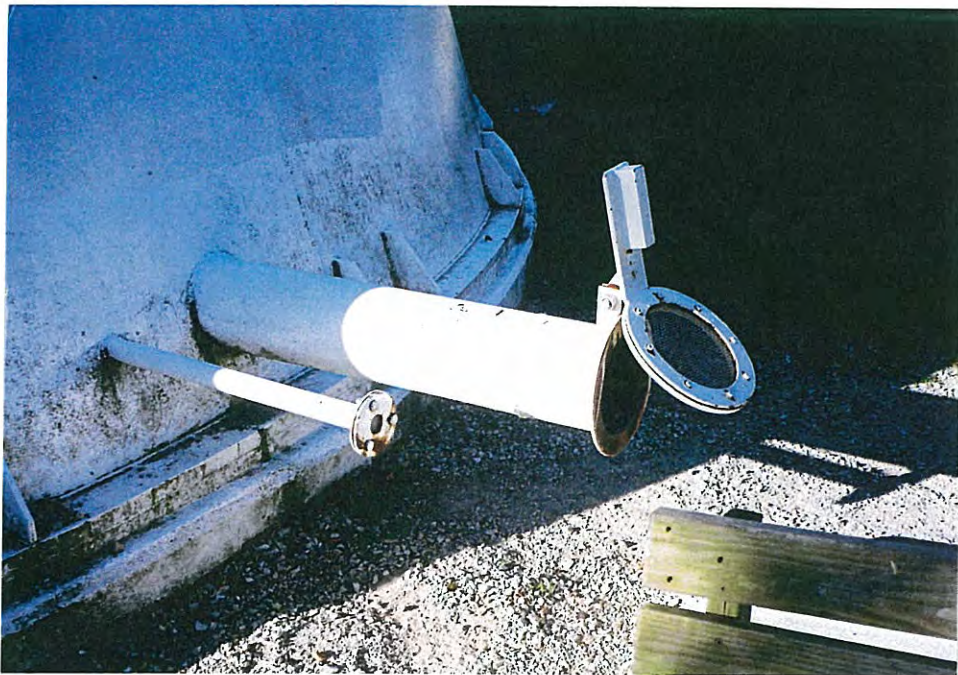
11. Overflow pipe and condensate pipe discharges above splash pad.

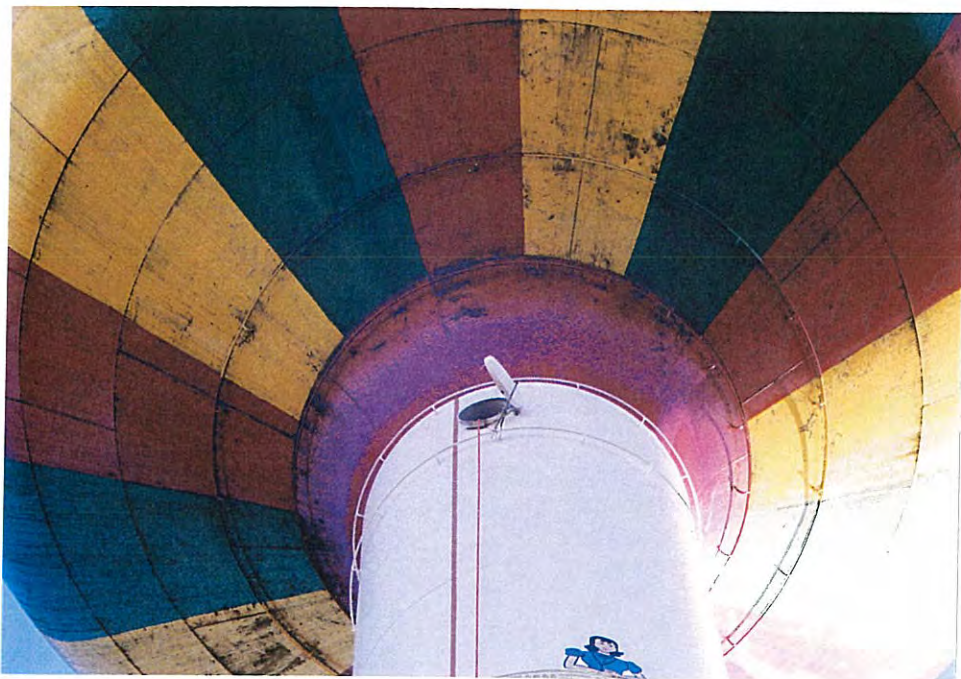
26. Graphics on pedestal.

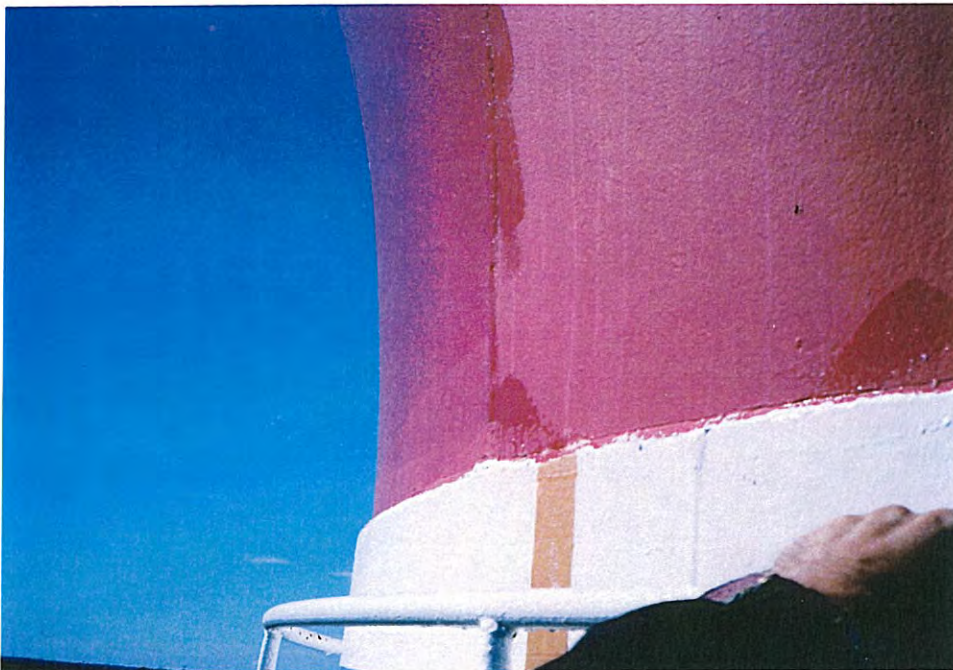
29. Painter's ring and mildew on pedestal seam.

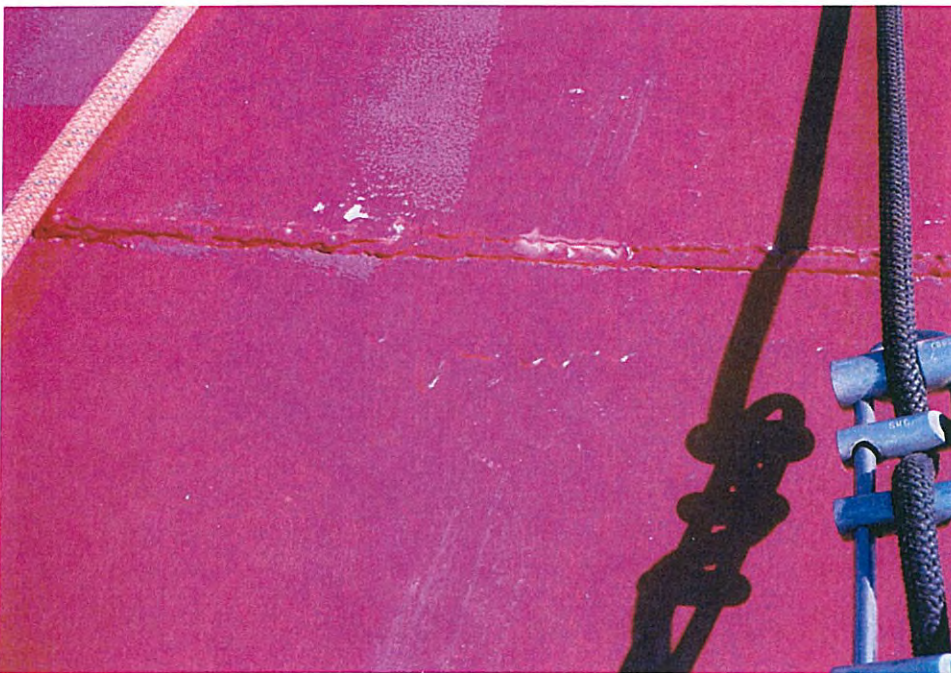
37. Roof knuckle.

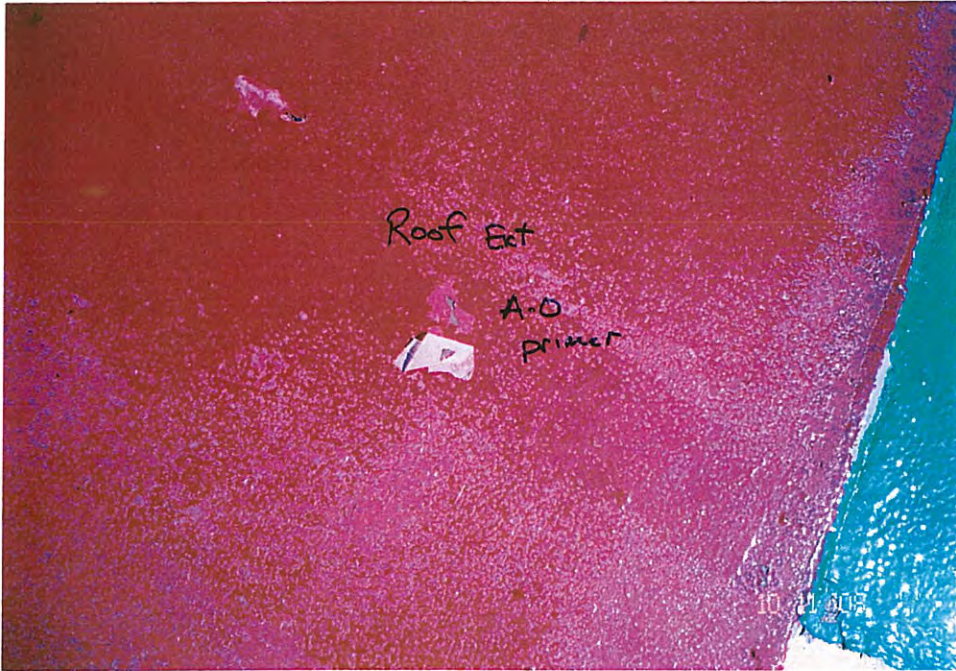
40. Roof exterior.

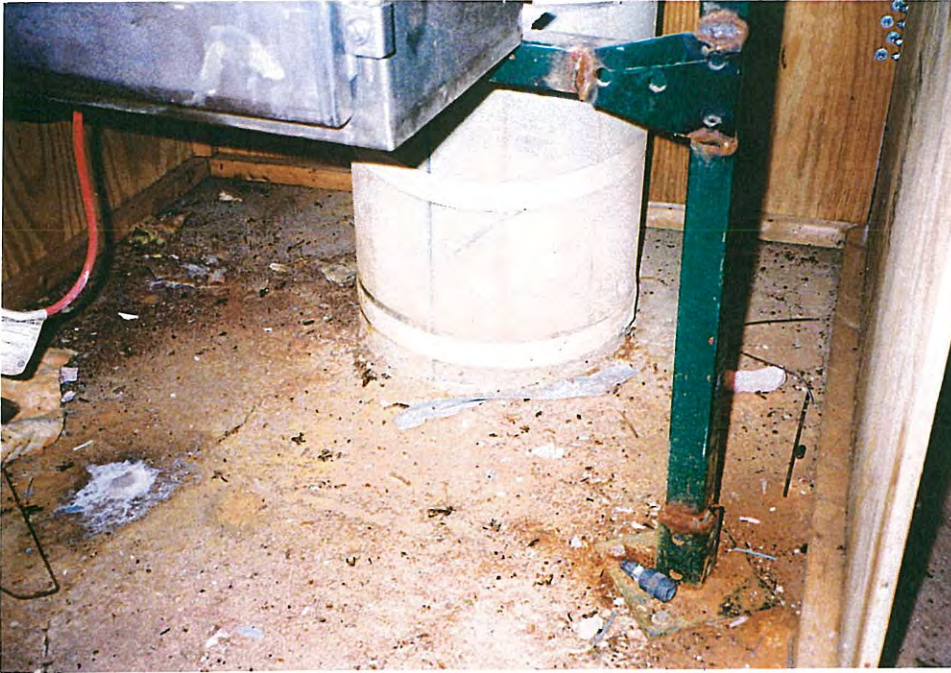
51. Dirt on base cone enclosure floor around inlet/outlet pipe penetration through concrete floor/

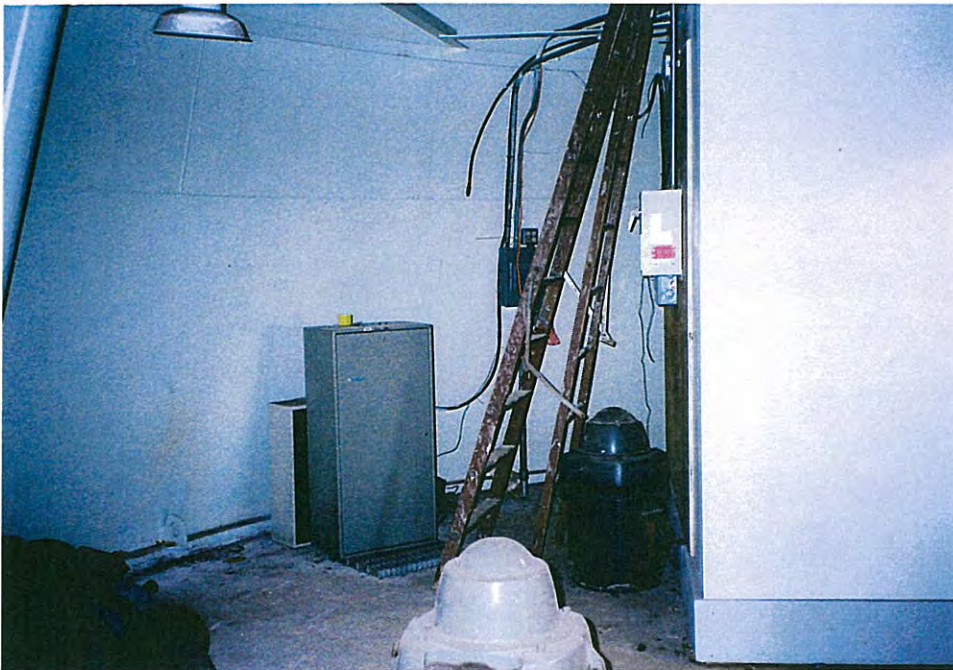
52. Electrical cabinets and unused pumps in base cone.

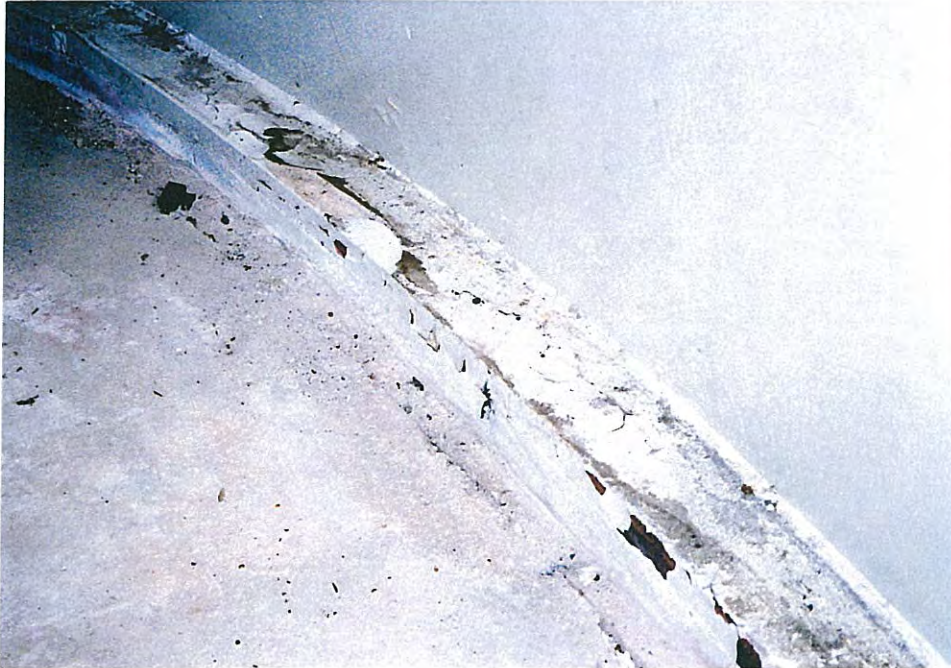
53. Peeled coating on interior dry base plate projection.

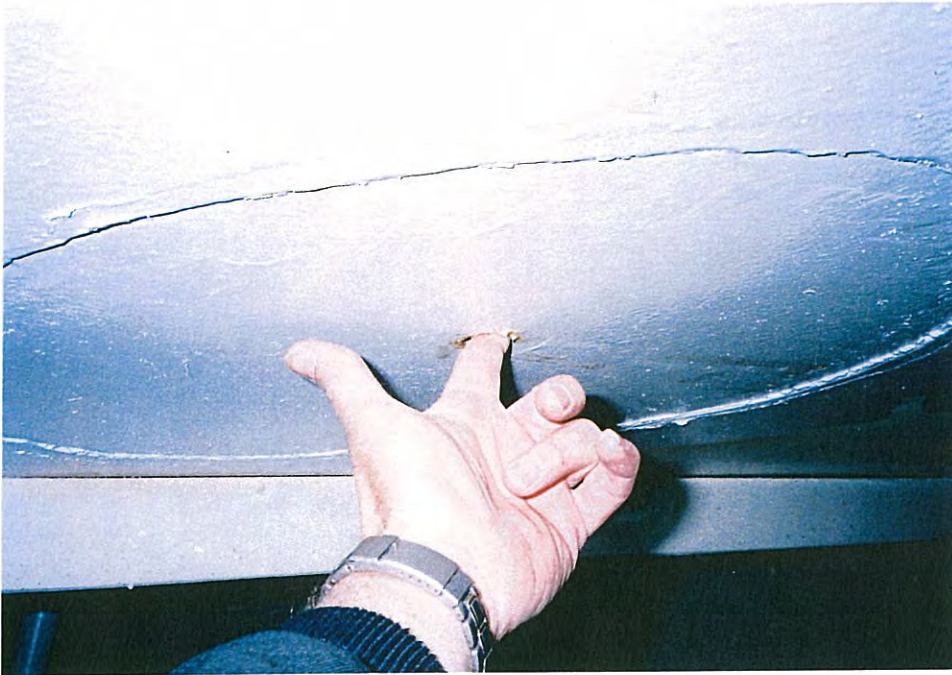
61. Hole in condensate platform.

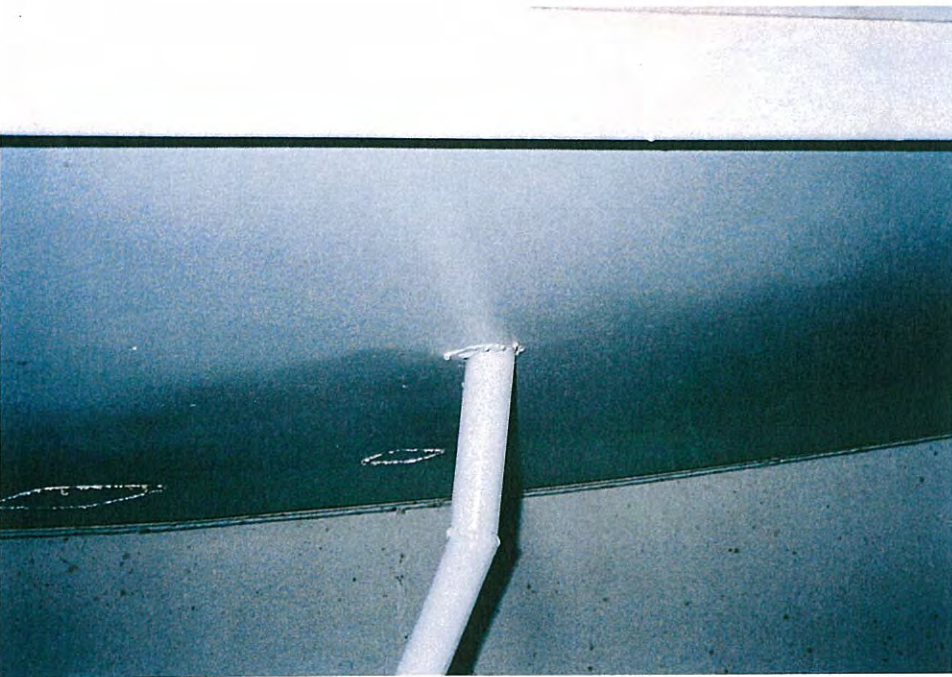
62. Condensate platform drain pipe.

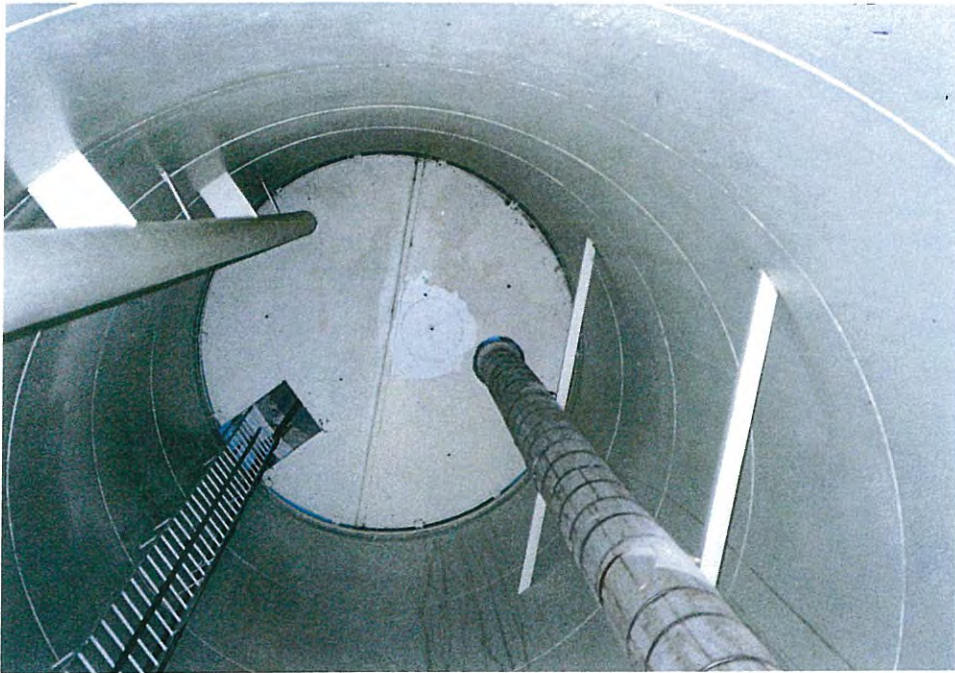
67. Pedestal, overflow pipe, inlet/outlet pipe, pedestal ladder, safe-climbing device, and underside of top platform.

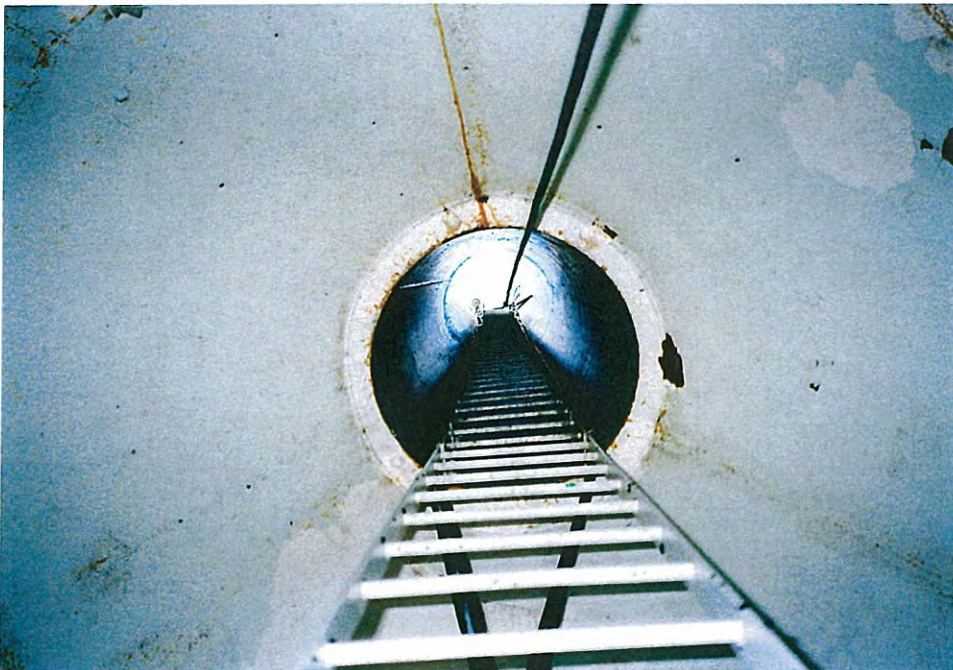
76. Dry bowl, access tube, and ladder.

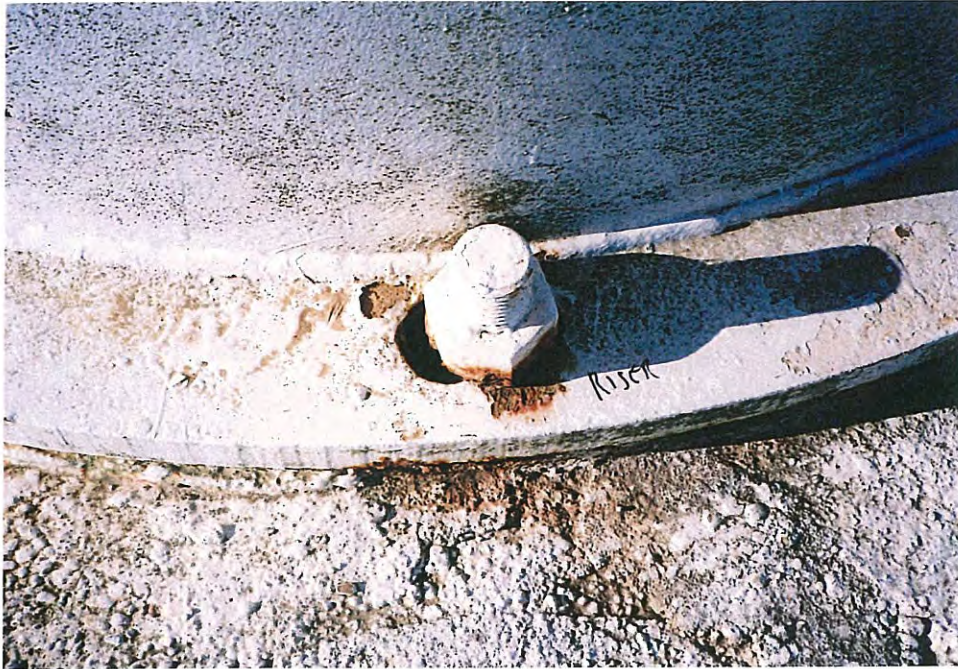
11. Riser base plate and anchor bolt. Note corrosion and gap at bolt hole.

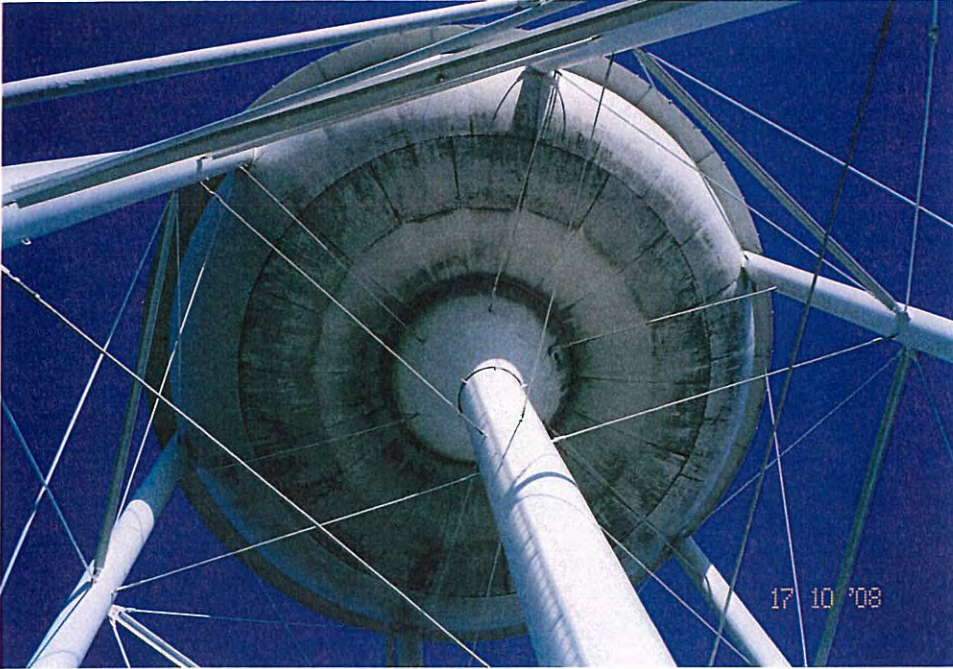
29. Bowl, riser, and riser rods. Note mildew on bowl.

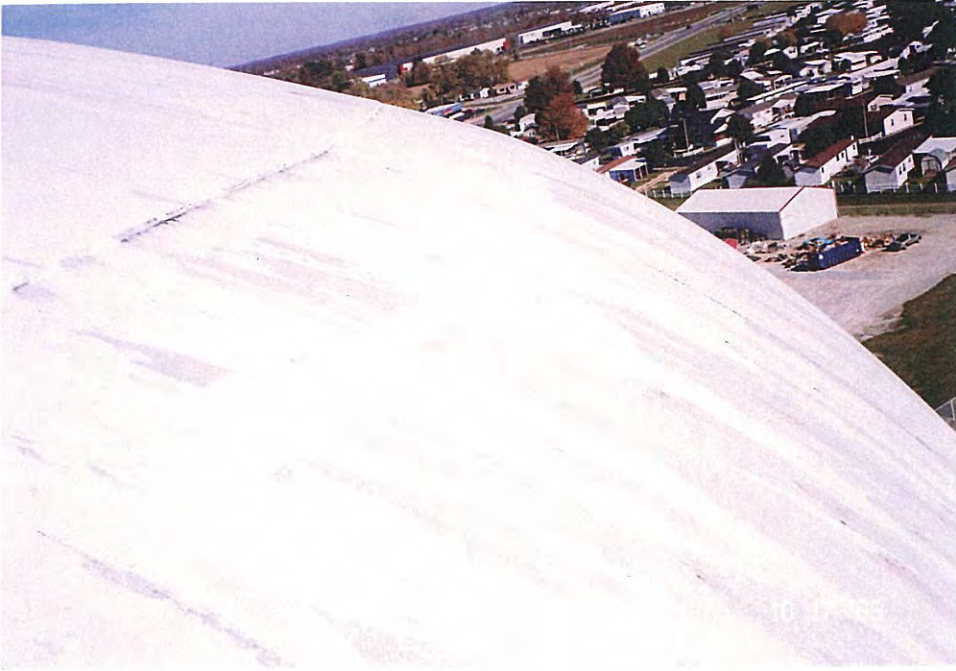
47. Weathered topcoat on roof knuckle.

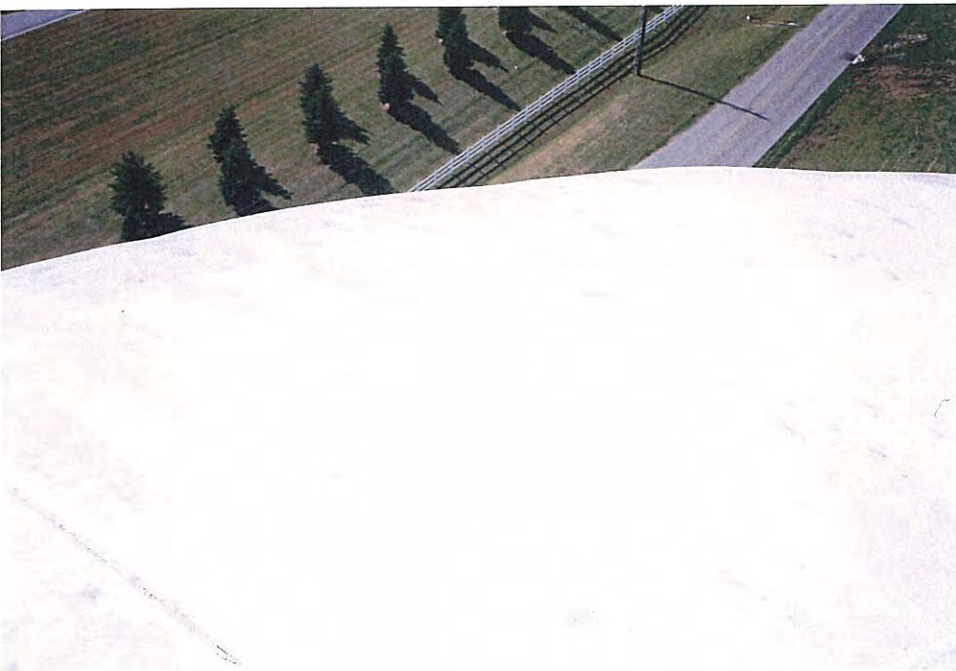
48. Weathered topcoat on roof.

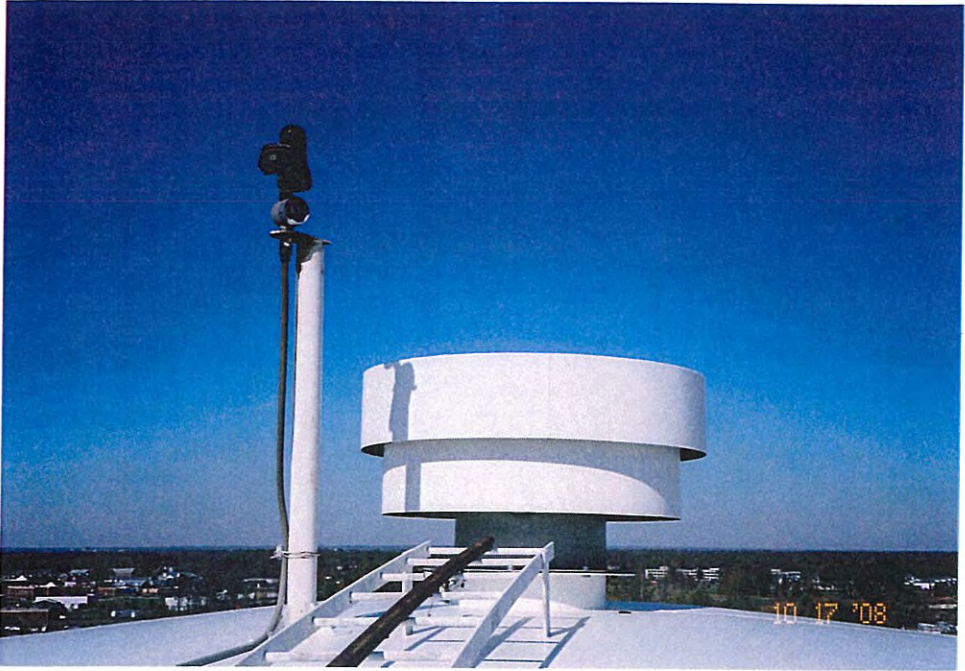
51. Obstruction light and roof vent.

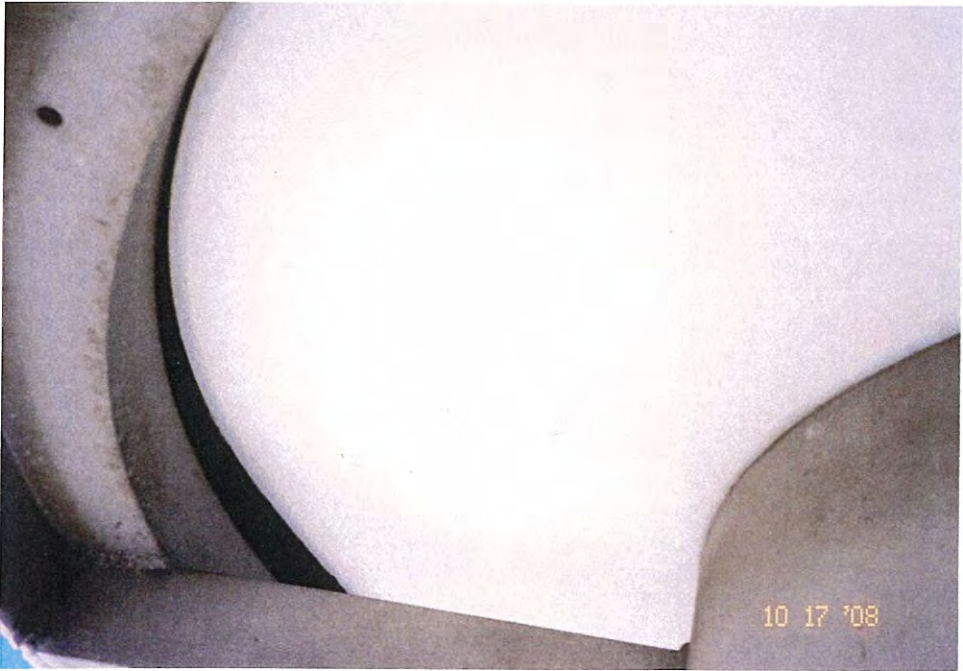
52. Gap at roof vent pallet.

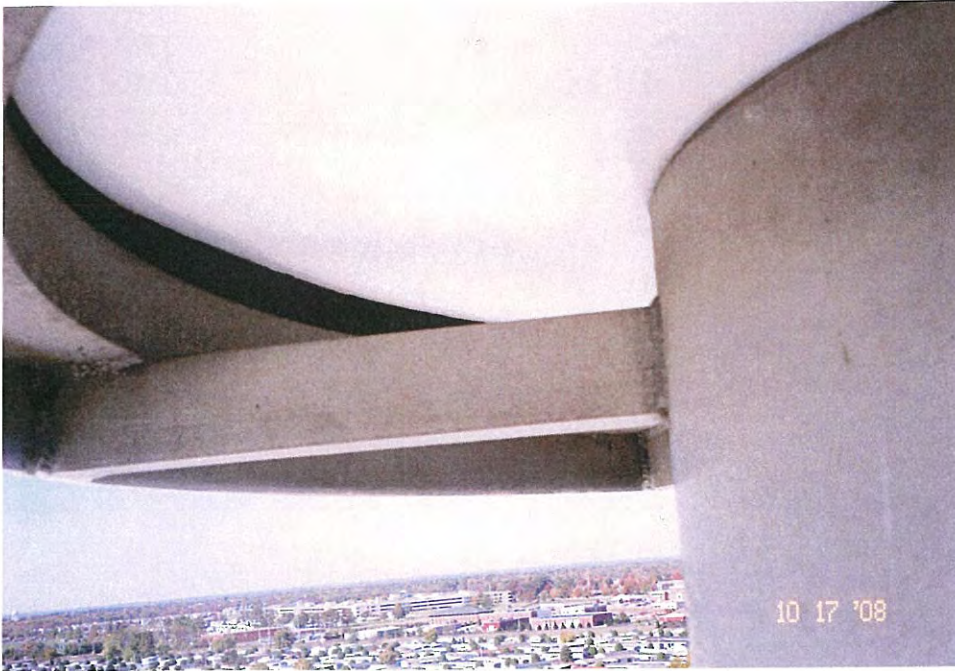
53. Gap at roof vent pallet.

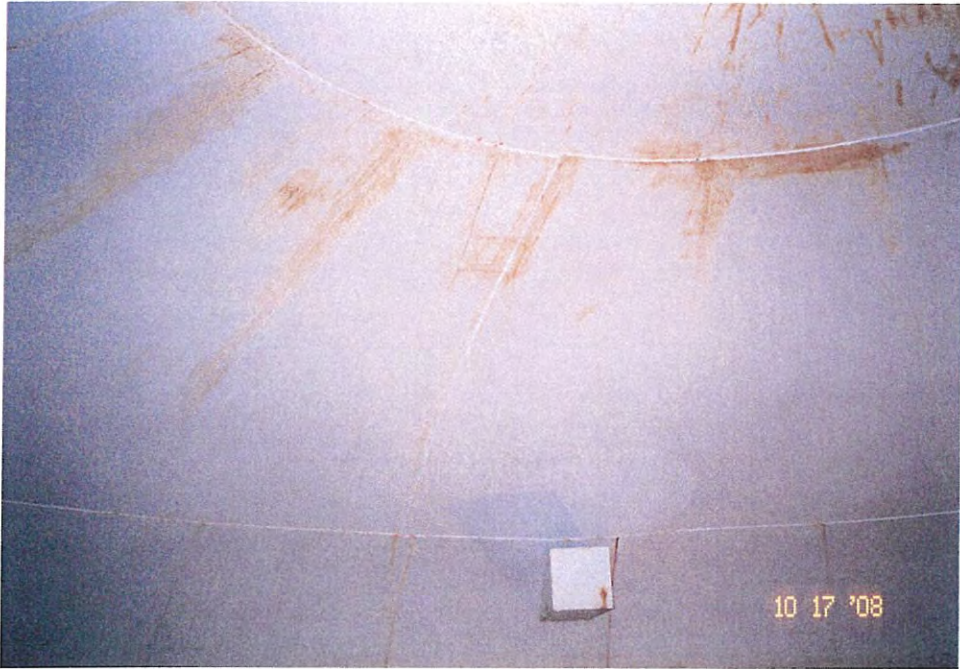
57. Interior roof and overflow weir box.
