Subject: Lawrence Water PER Submittal

Preliminary Engineering Report
for **Water System Improvements**

LAWRENCE MUNICIPAL UTILITIES
LAWRENCE, INDIANA

November 2016
Revised January 9, 2017

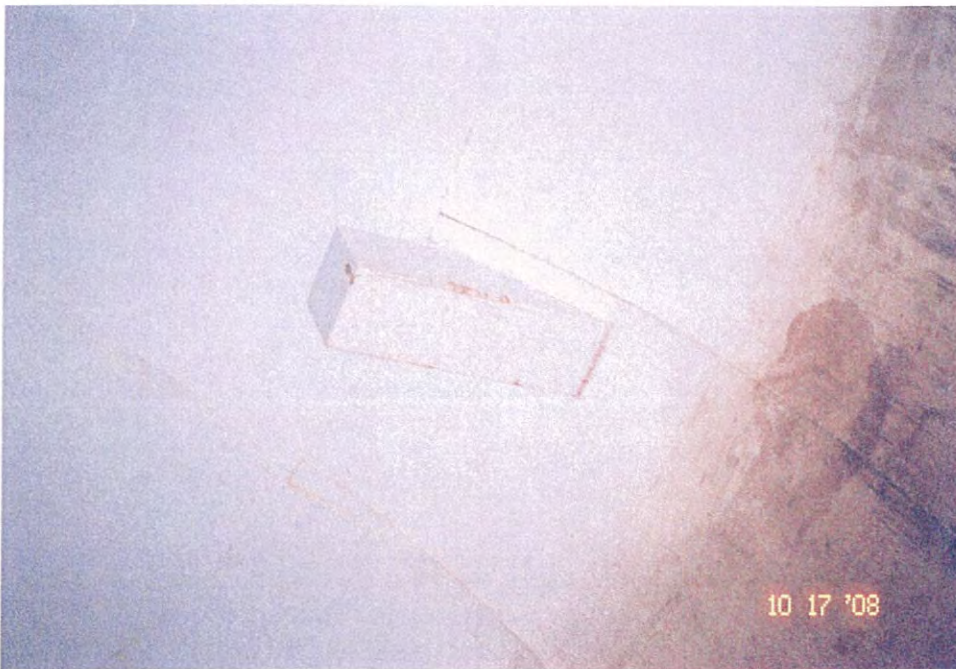
58. Overflow weir box.

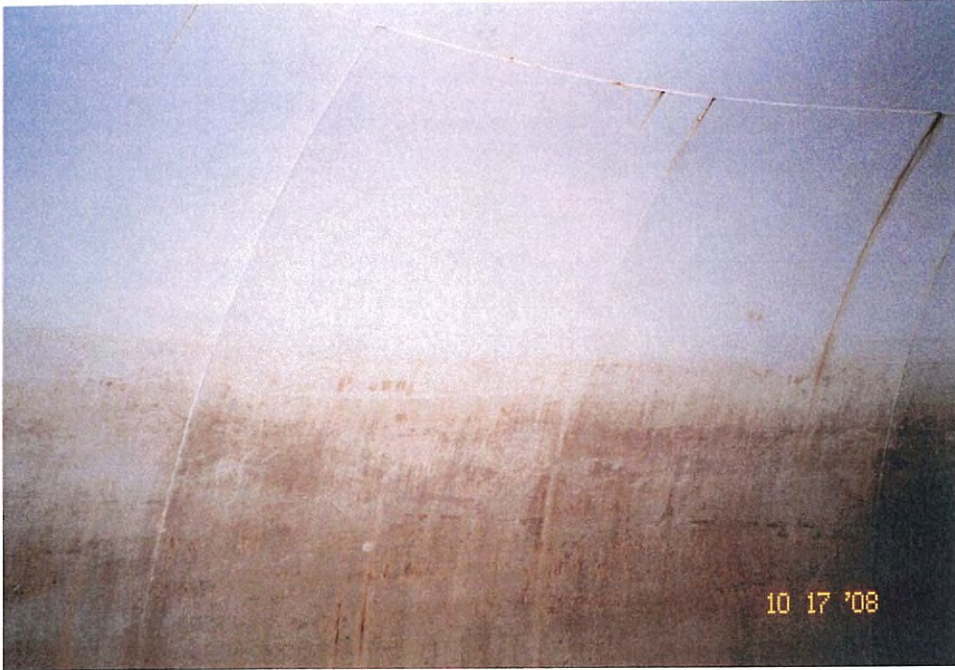
59. Interior roof knuckle.

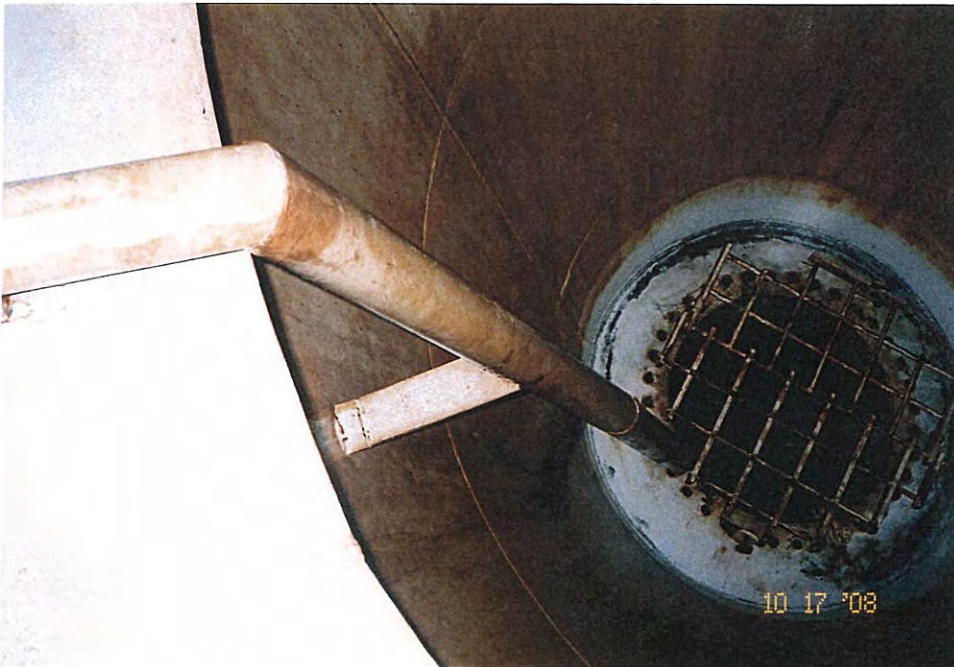
68. Siphon pipe in transition cone.

10. **Siphon Pipe:** The missing air check valve for the siphon pipe should be replaced.
