Subject: Lawrence Water PER Submittal

Preliminary Engineering Report
for **Water System Improvements**

LAWRENCE MUNICIPAL UTILITIES
LAWRENCE, INDIANA

November 2016
Revised January 9, 2017

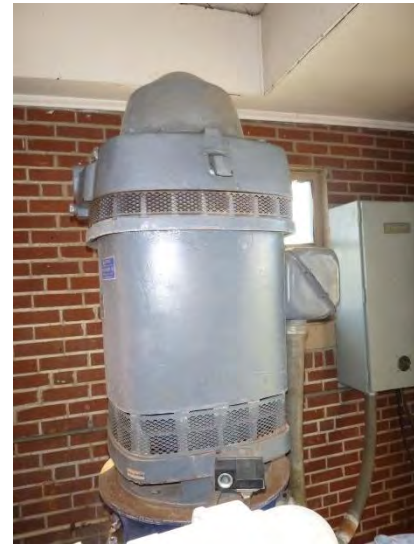
Well 1 Pump Head

The well was constructed in 1959. It is a rock well, reportedly 242 feet deep, 16-inches in diameter with a 125 HP premium efficient inverter duty motor. The well has a rated capacity of 1,200 gpm and a current pumping capacity of 1,250 gpm. The well is enclosed in a masonry well house. A 2002 variable frequency drive (VFD) located in the well house is used to set the discharge rate of the well. Flow testing in 2012 indicated that the specific capacity of the well was 216. A flow totalizer and pressure switch are located on the pump discharge. The existing well house roof, door, and windows are in need of repair.

The transformer and controller have a BRE ratings above 10 because of their poor physical condition, O&M protocols, operational condition, and financial impact.

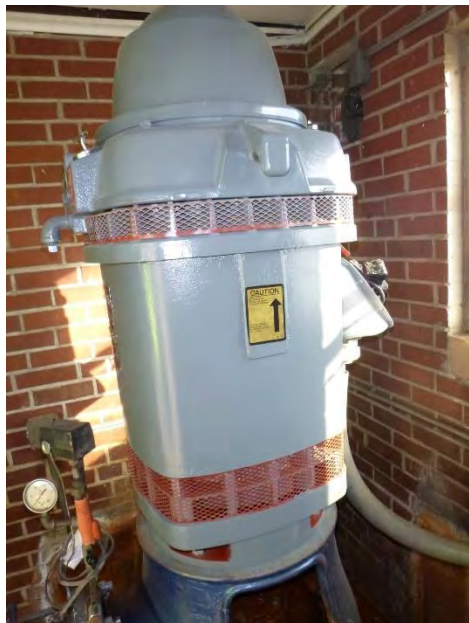
Well 2

The well was constructed in 1963. It is a rock well, reportedly 250 feet deep, 16-inches in diameter with a 100 HP premium efficient inverter duty motor. The well has a rated capacity of 1,100 gpm and a current pumping capacity of 1,000 gpm. The well is enclosed in a masonry well house. A 2011 VFD located in the well house is used to set the discharge rate of the well. Flow testing in 2012 indicated that the specific capacity of the well was 161.8. A flow totalizer and pressure switch are located on the pump discharge. The existing well house roof, door, and windows are in need of repair.

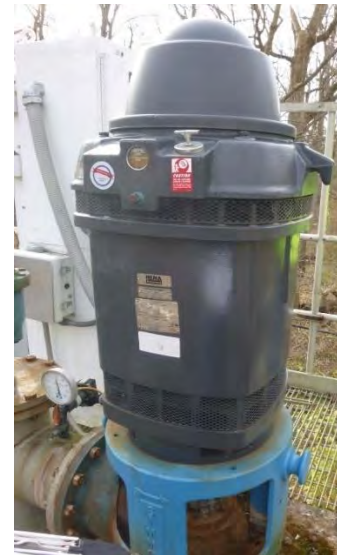
Well 8 Pump Head

capacity of 1,250 gpm and a current pumping capacity of 1,250 gpm. The well is located on an elevated platform exposed to the elements. Flow testing in 2010 indicated the well had a specific capacity of 52.26.

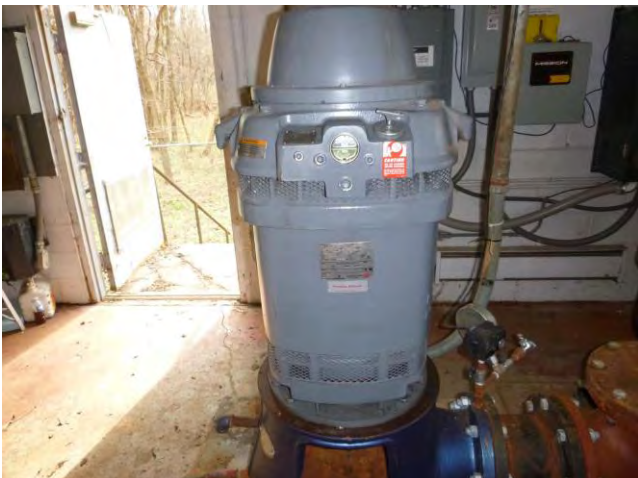
Well 9

The well was constructed in 1968 and last rehabilitated in 2008. It is a gravel pack well, reportedly 111.5 feet deep, 18-inches in diameter with a 60 HP motor. The well has a rated capacity of 500 gpm and a current pumping capacity of 1,000 gpm. The well is located in a well house. Flow testing in 2010 indicated the well had a specific capacity of 32 which is substantially off from its peak production potential according to Peerless Midwest. The well house is in fair condition and in need of minor repairs.

The safety switches and transformer have elevated probability of failure and consequence of failure ratings as a result of the physical condition, age, operational condition, and safety concerns.

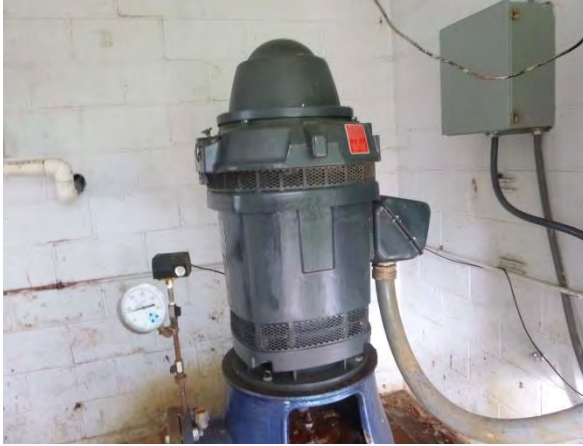
Well 10

The well was constructed in 1975 and was rehabilitated in 2010. It is a gravel pack well, reportedly 86 feet deep, 18-inches in diameter with a 100 HP premium efficient inverter duty motor. The well has a rated capacity of 1,000 gpm and a current pumping capacity of 750 gpm. The pump was replaced in 2010 with a six stage pump rated at 650 gpm at 372 feet of TDH. The well is located in a well house. Flow testing in 2010 indicated the well had a specific capacity of 28.05. The well house is in poor condition and requires rehabilitation.

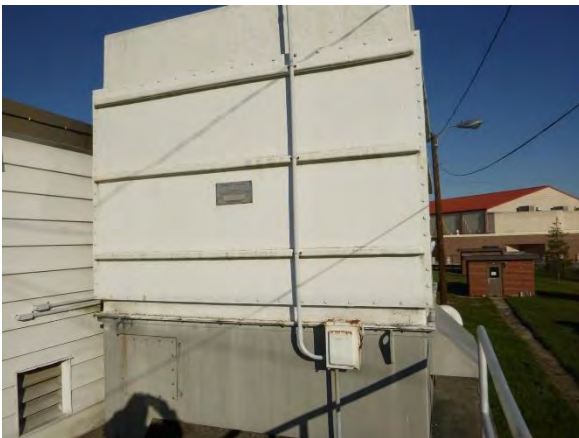
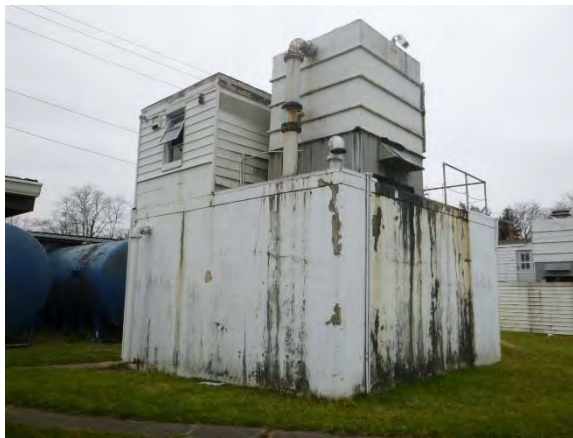
Aerator 1

One induced draft aerator is located on top of each detention tank, for a total of two aerators. Each aerator has a reported capacity of 1,200 gpm. The aerators can be bypassed allowing flow from the wells directly to the pressure filters using valves on the site. The aerators are in poor condition but the aerator located on top of the east detention tank (Aerator 2) has failed and is not currently in operation. The internal wooden slats in the east aerator failed in early 2016 and resulted in debris getting lodged in the high service pumps. The aerator slats were replaced but the high service pumps were not.

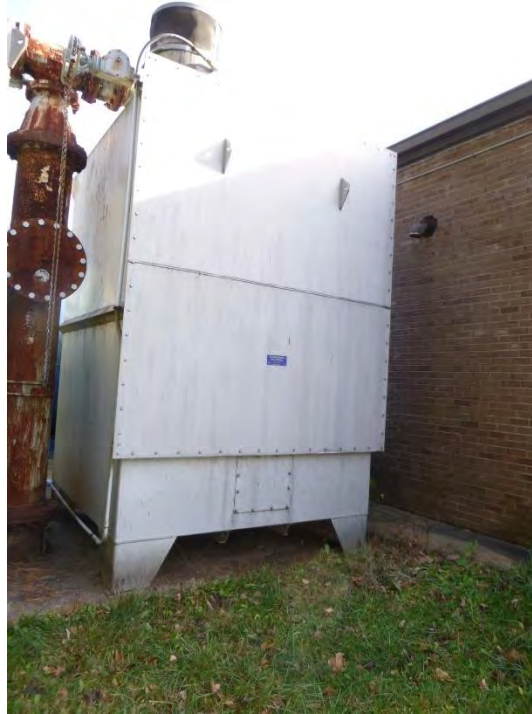
Aerator

There are two General Filter aluminum forced draft aerators rated at 1,300 gpm each that were installed in 1989.

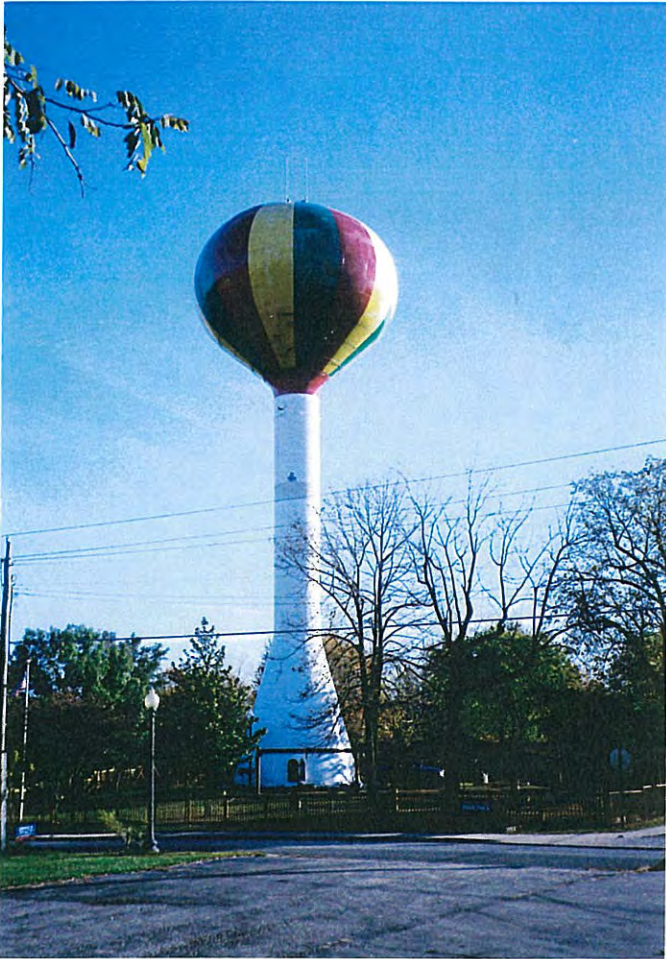
2. **Site Conditions:** The tank site was covered with grass and gravel and appeared to be graded to provide adequate drainage away from the foundation. The entire park was equipped with a short wooden picket fence which was equipped with a gate on the east side of the site. The gate was not equipped with a lock. Electrical meters were located on the site adjacent to the east side of the base cone. (See photos 1-2, 6-10)

1. Tank and site.

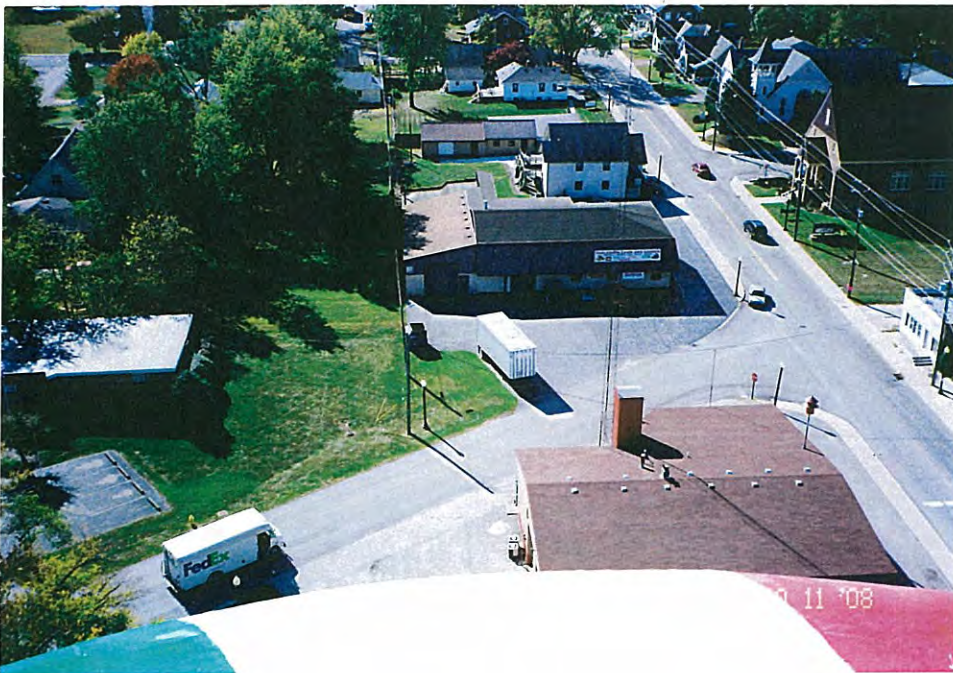
3. Surrounding area.

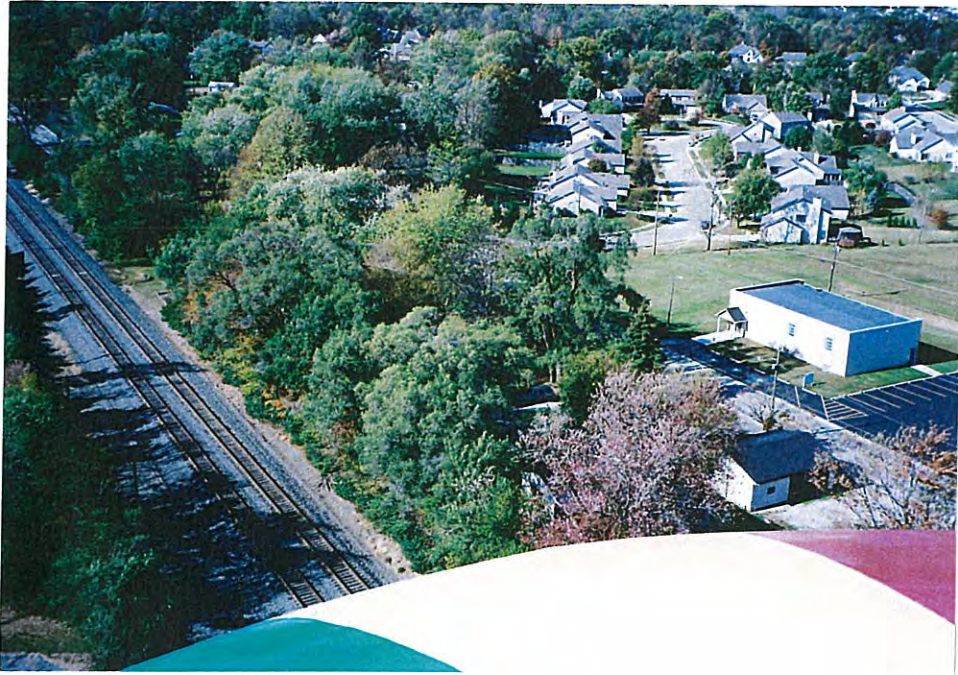
4. Surrounding area.

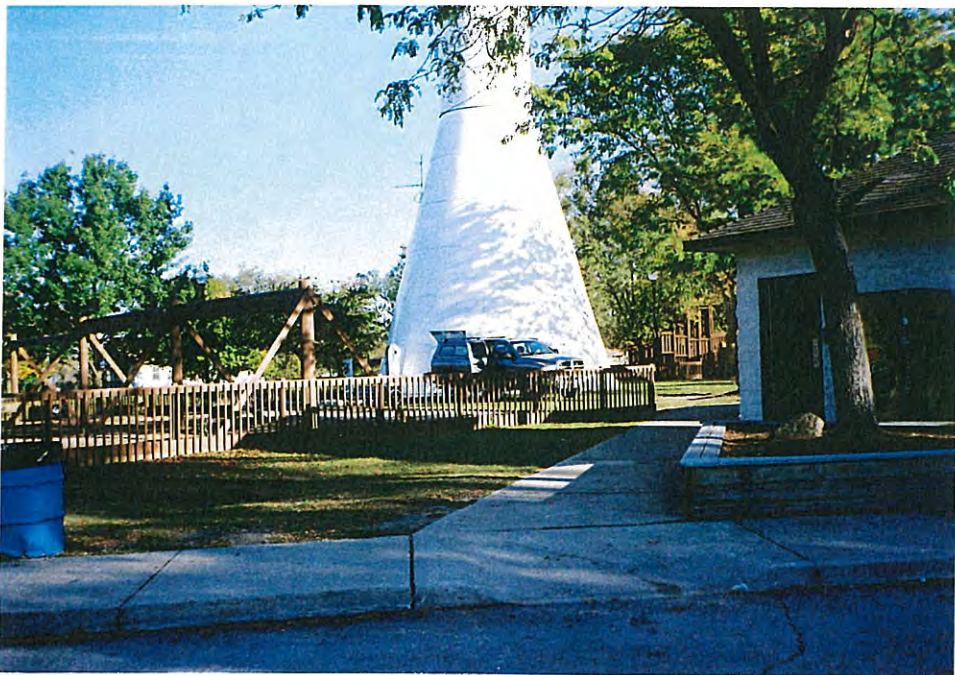
5. Surrounding area.

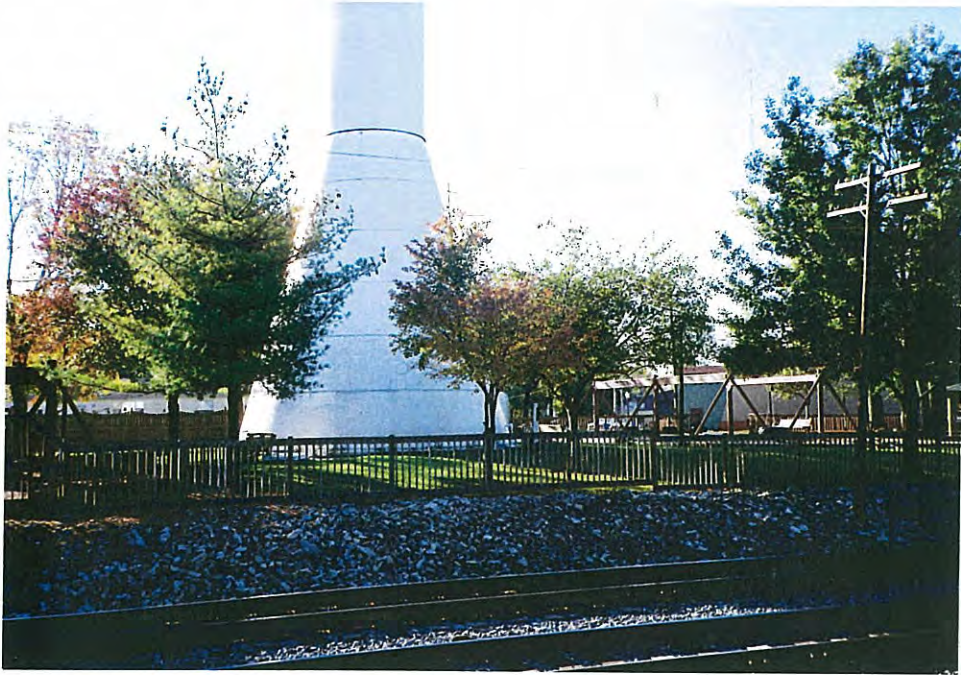
6. Site.

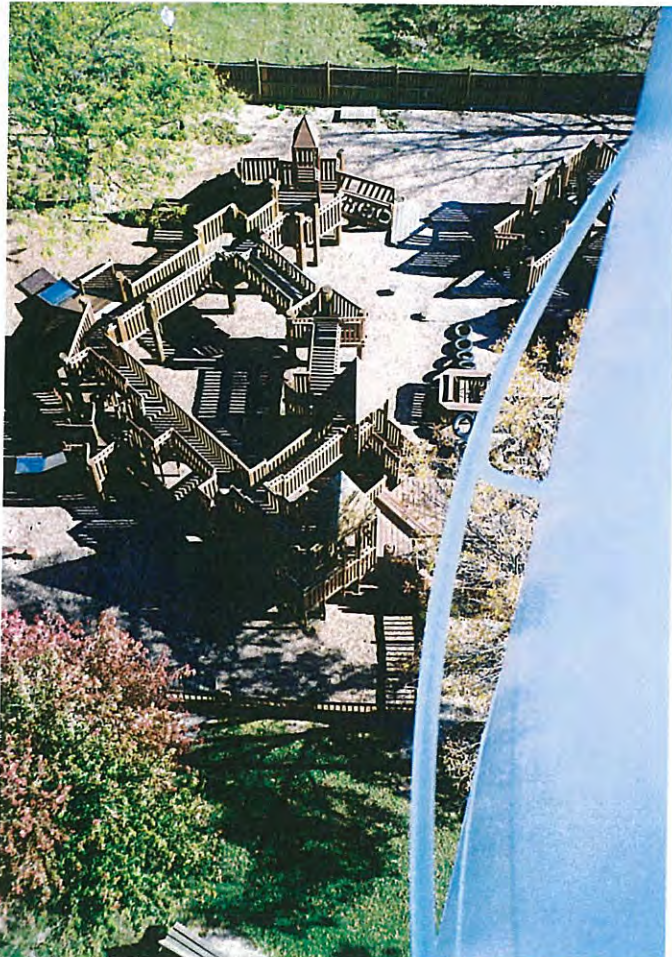
7. Site.

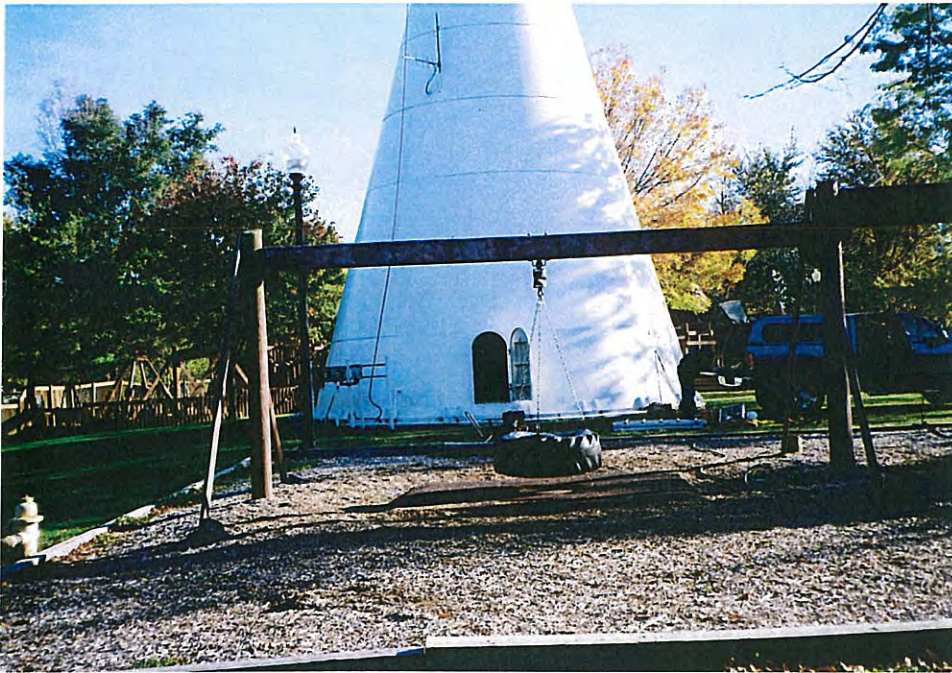
8. Playground adjacent to tank.

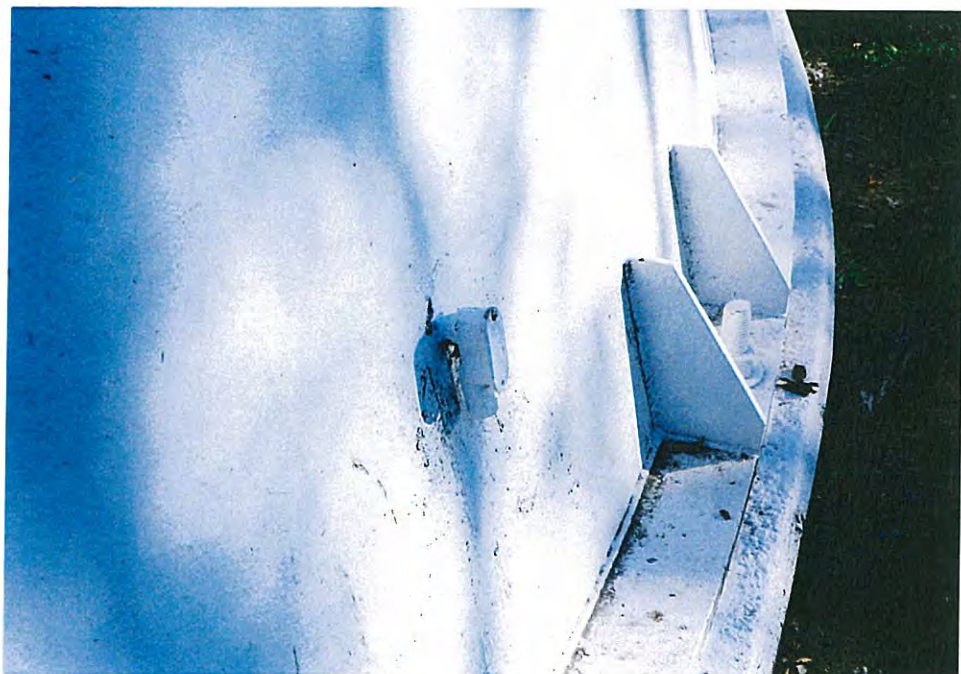
13. Tank foundation, grout, base plate, anchor bolt, and gussets. Note mildew.

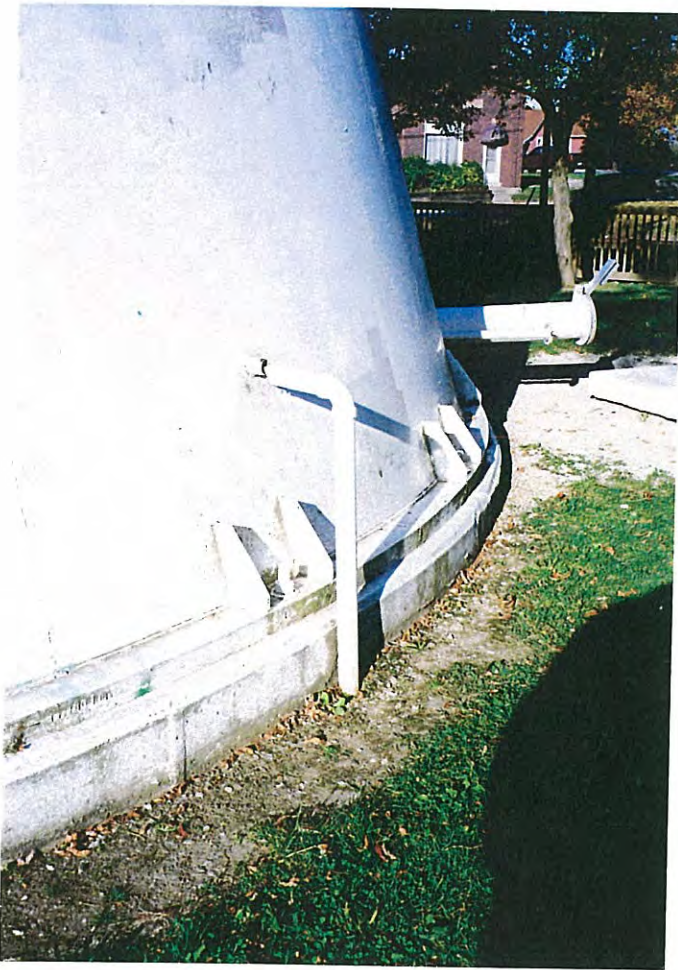
14. Junction box on base cone.

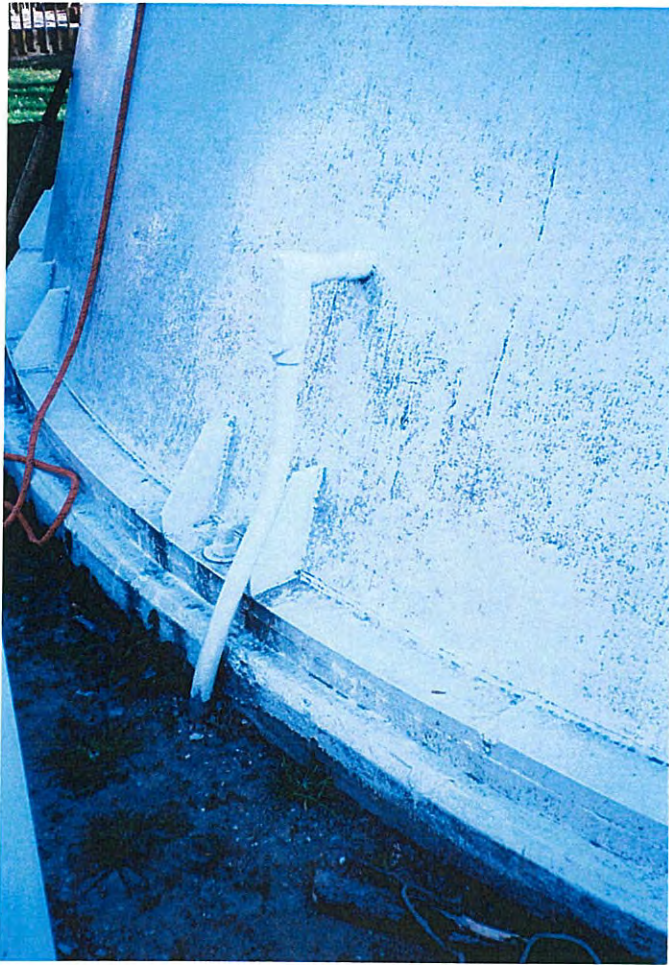
16. Broken conduit on base cone.

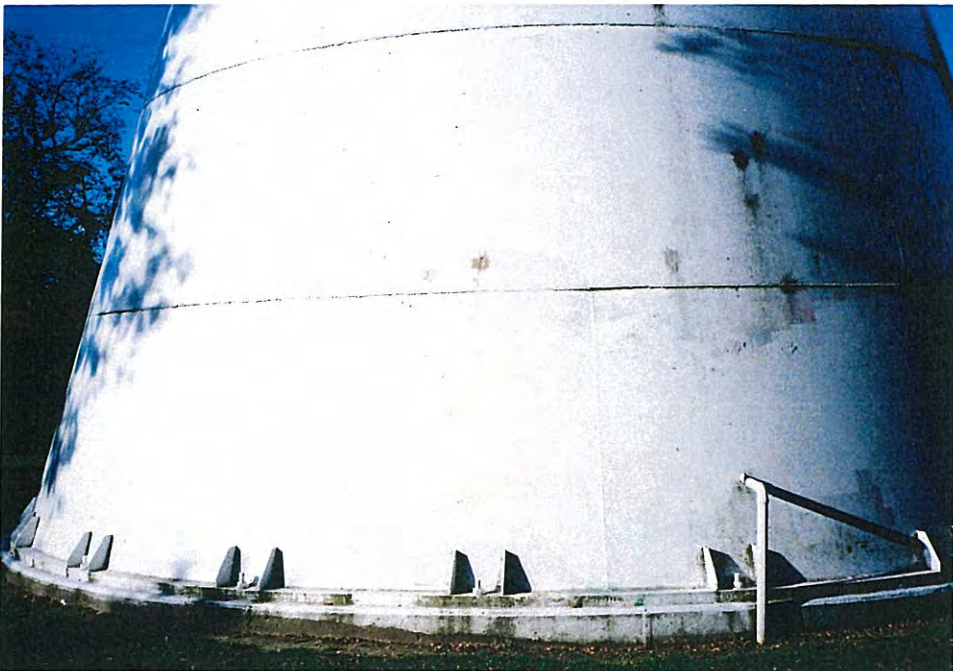
17. Conduit on base cone.

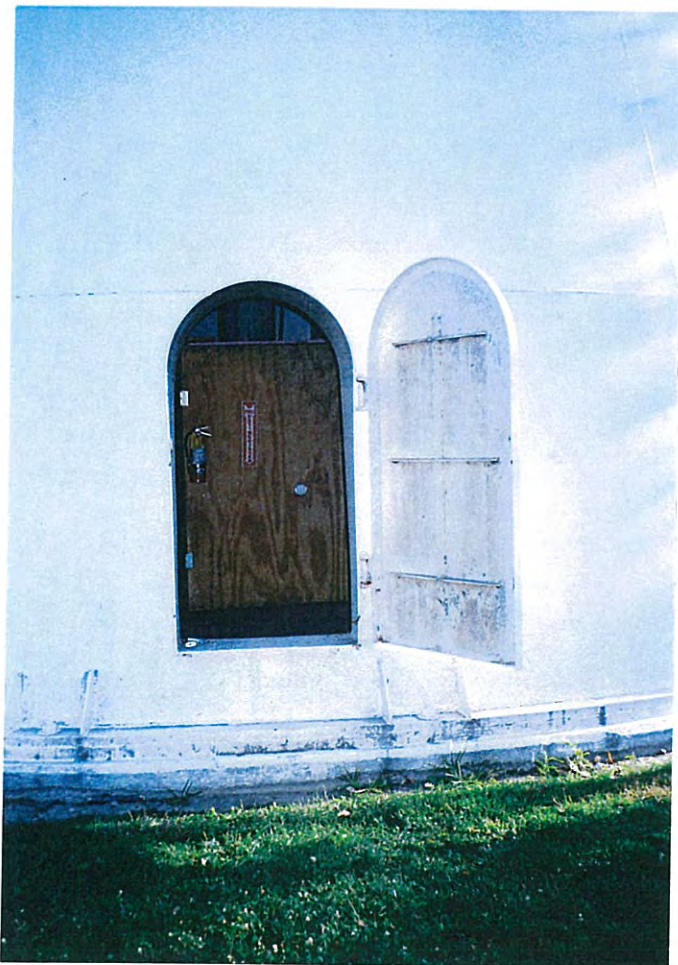
19. Coating adhesion tests and coating thickness measurements on base cone.

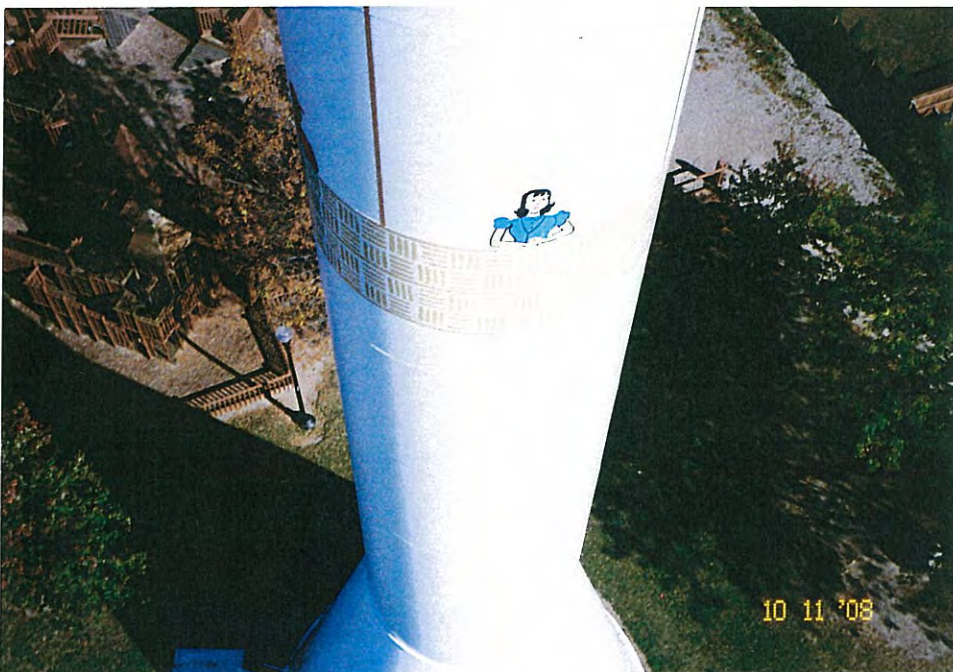
25. Pedestal and bowl.

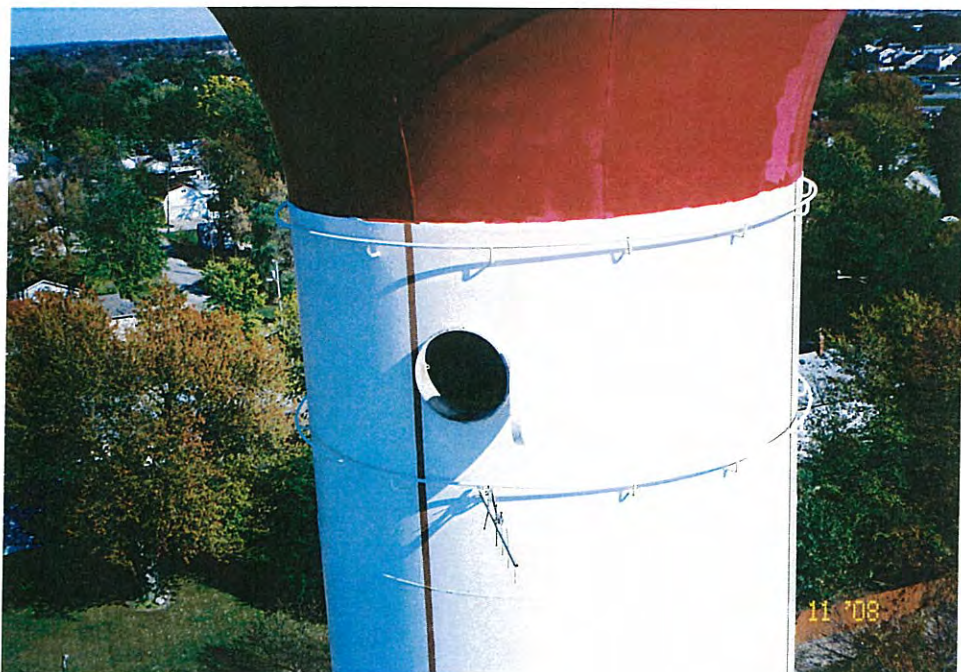
27. Painter's rings and painter's manhole.

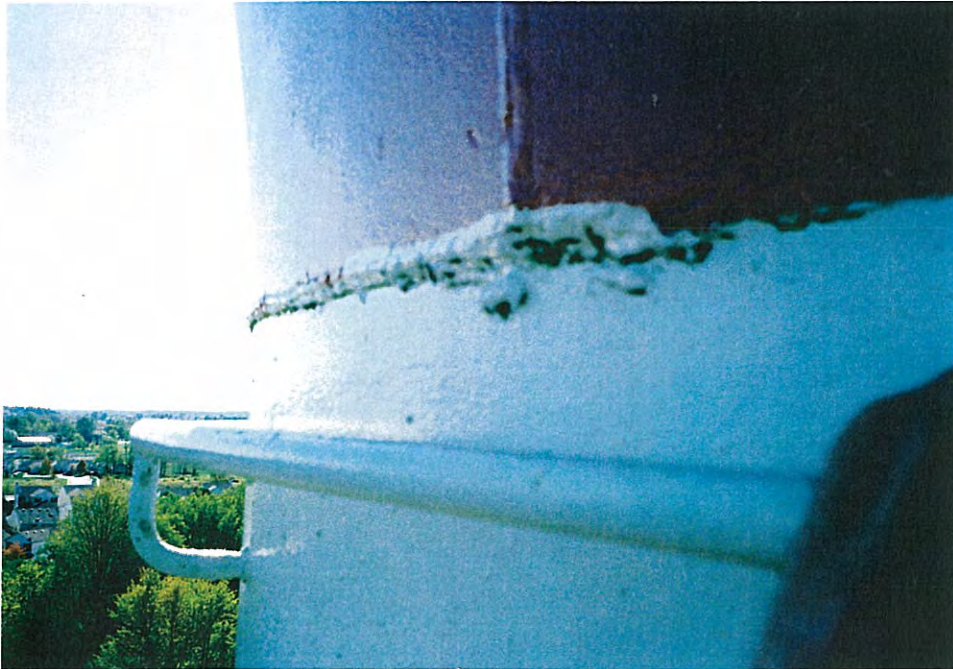
28. Painter's rings and painter's manhole.

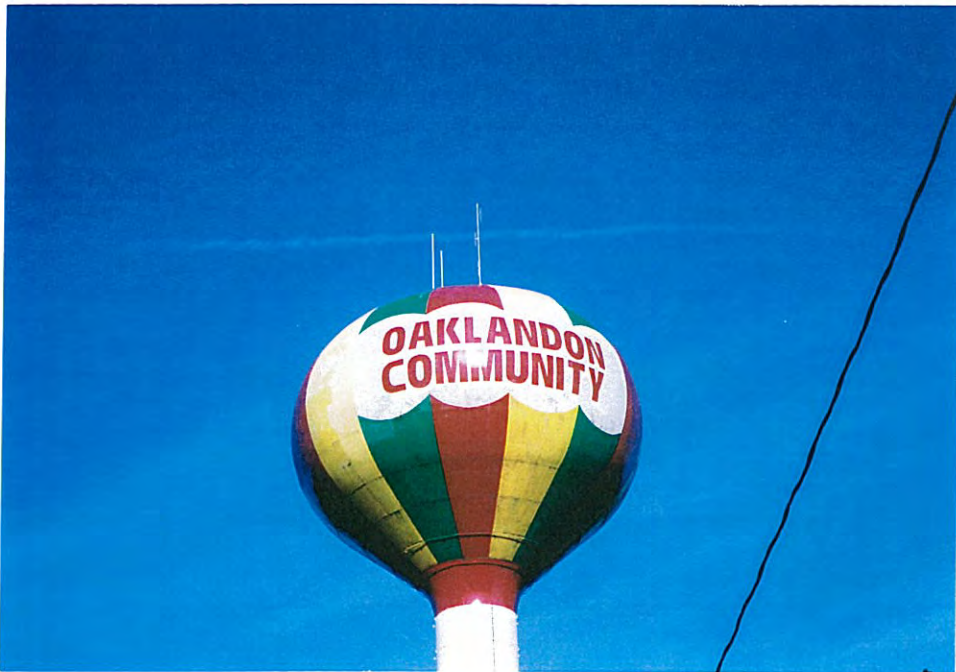
33. Container.

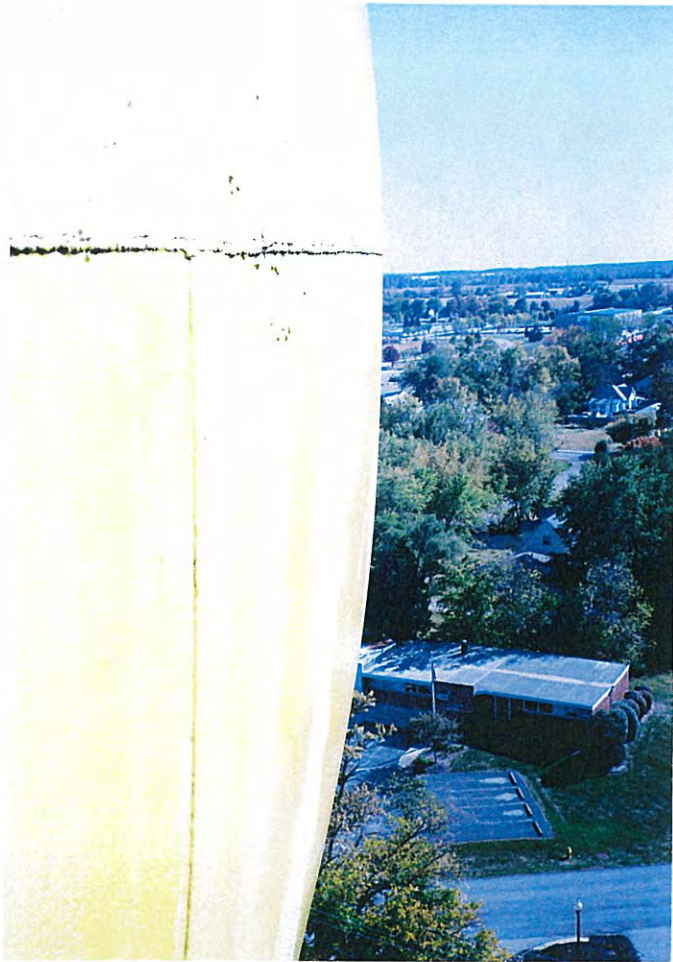
34. Container.

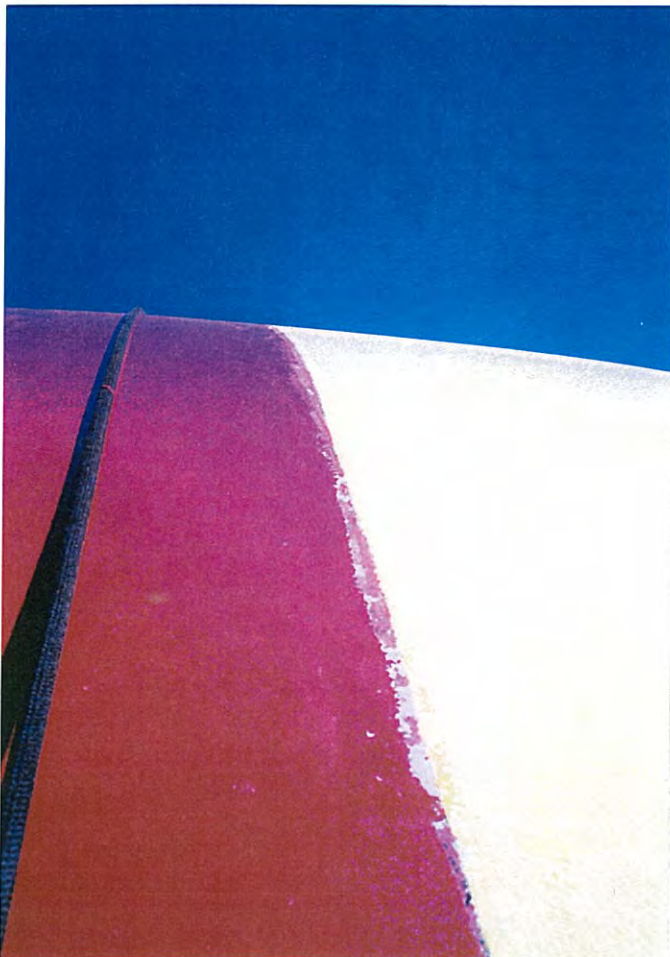
35. Faded graphic coating on shell.

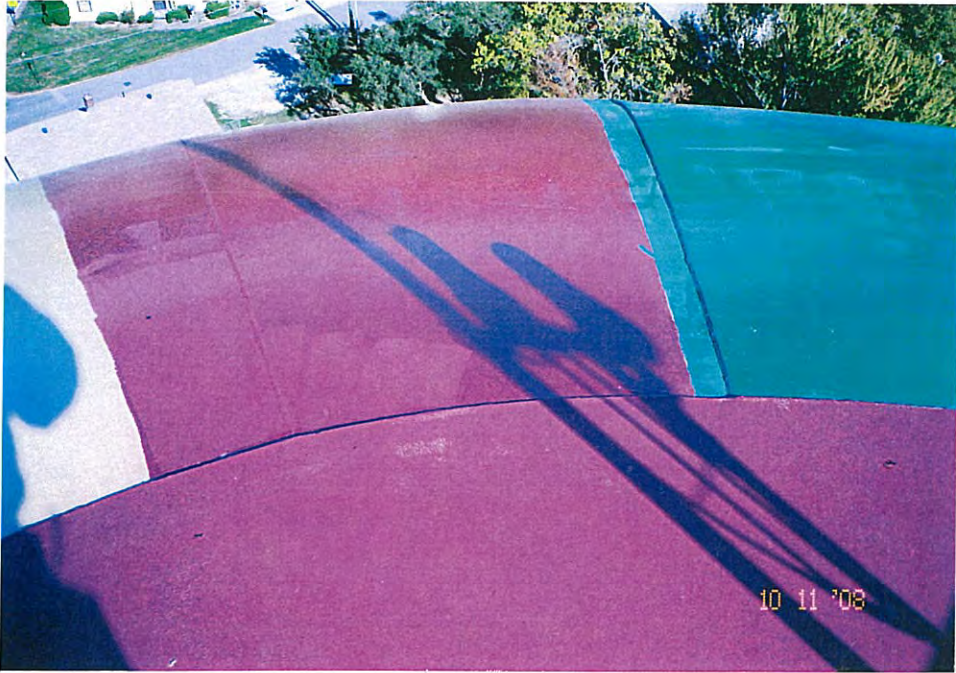
38. Faded graphic coating on roof.

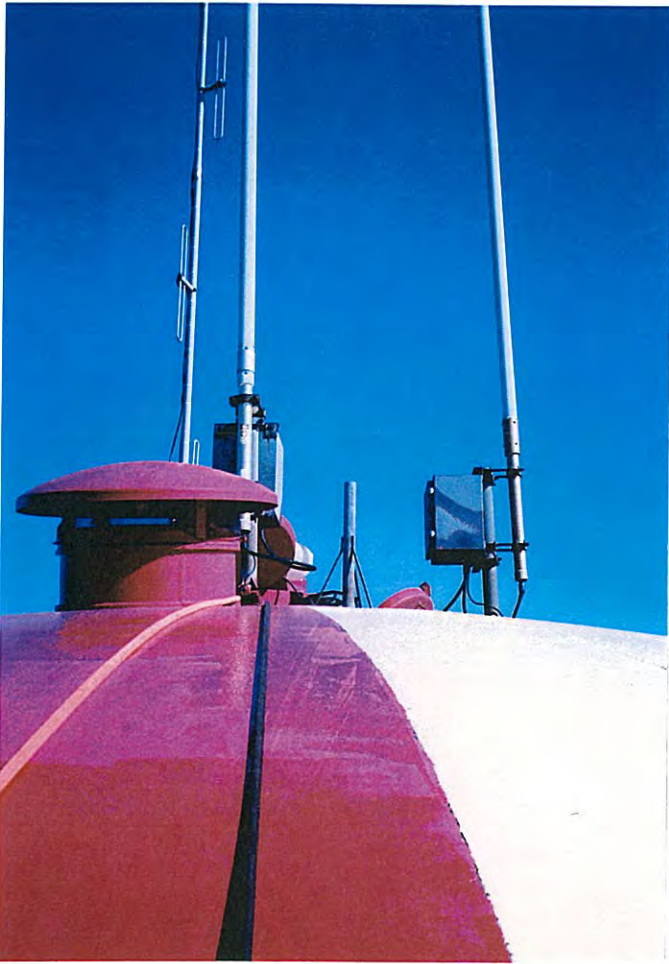
42. Roof vent, obstruction lights, antennas, electrical cabinets, and antenna equipment.

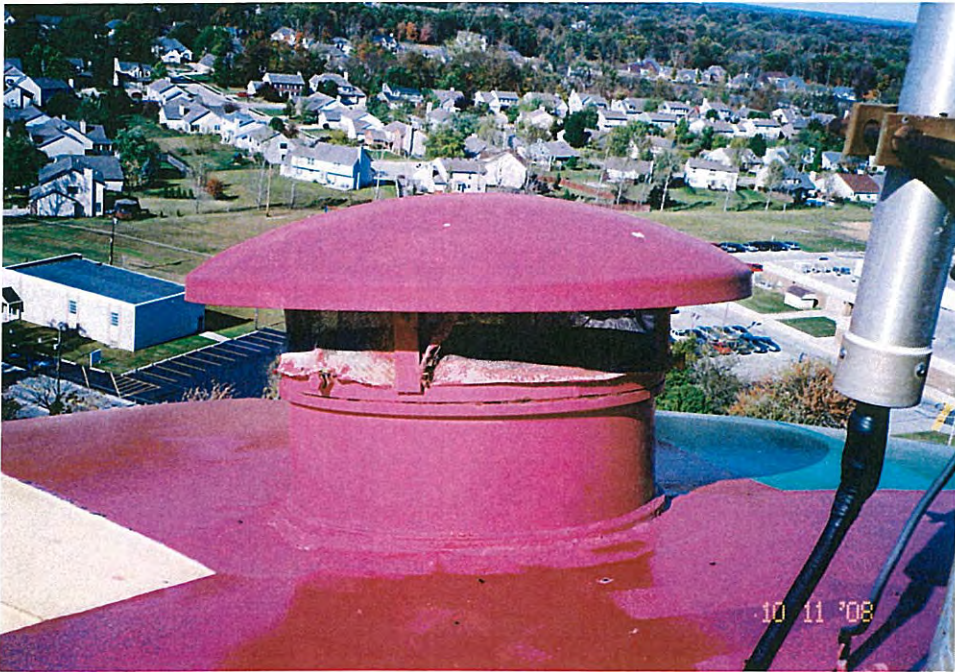
43. Roof vent, antennas, electrical cabinets, and antenna equipment.

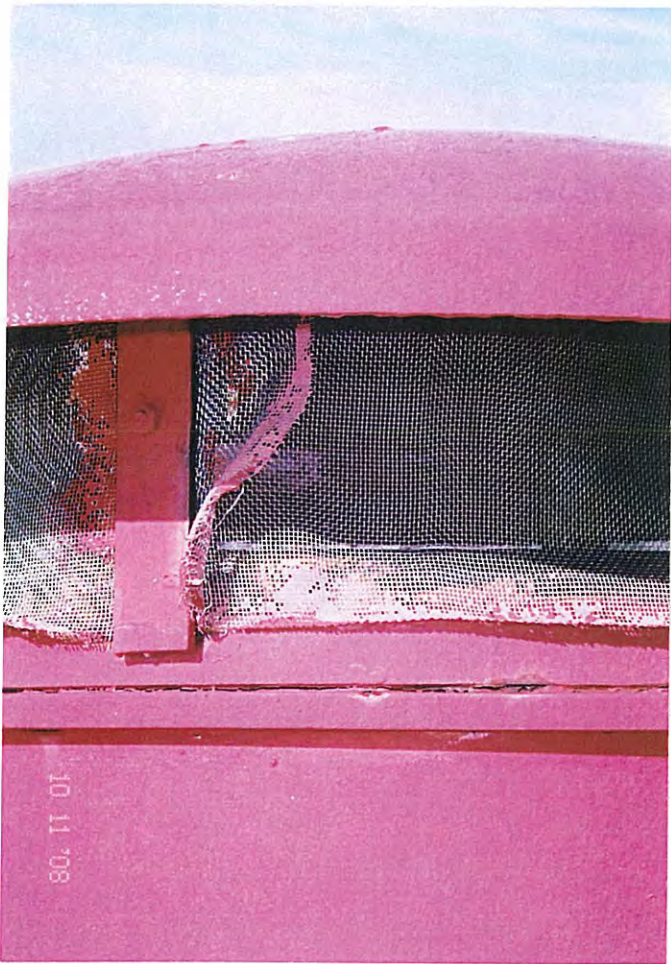
44. Roof vent.

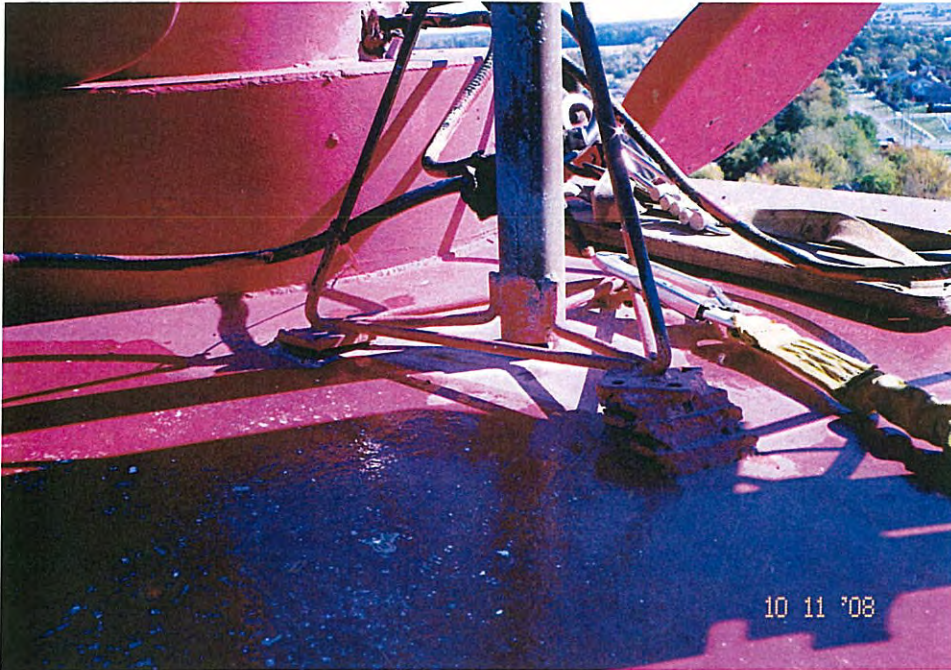
47. Antenna bracket on roof.

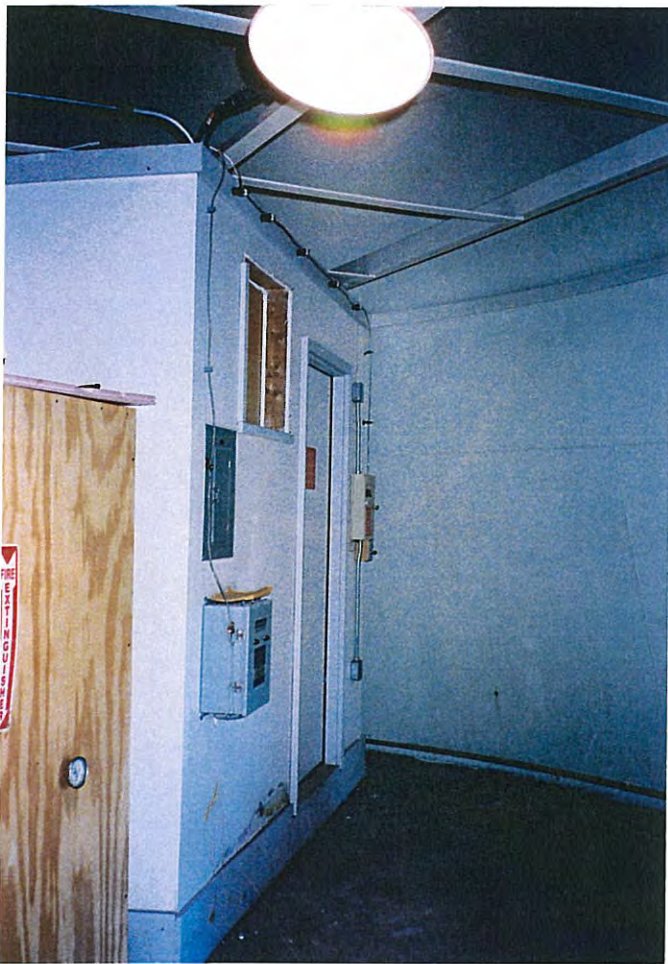
49. Enclosure in base cone interior.

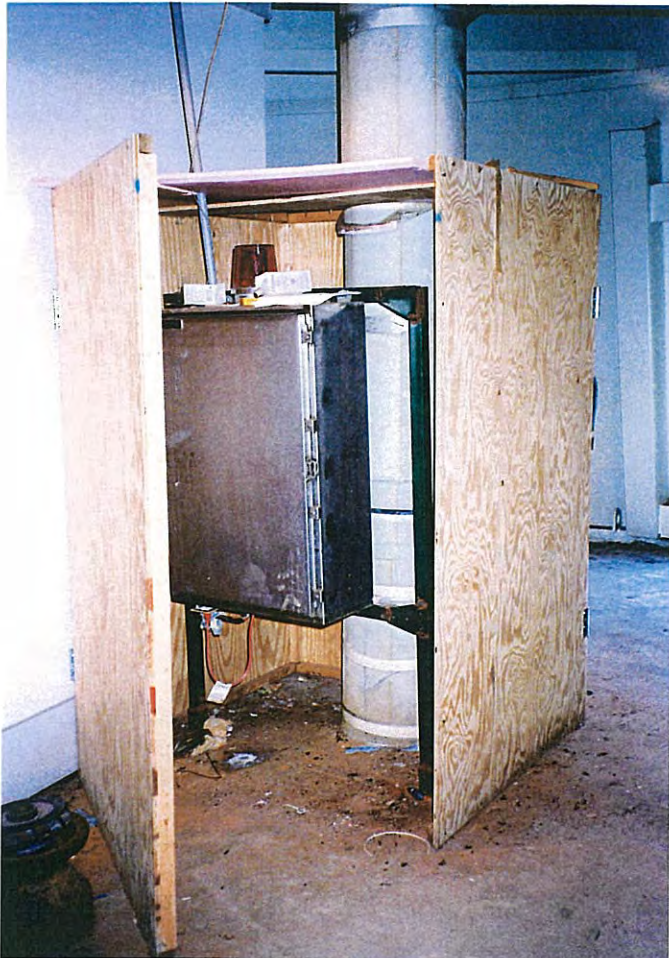
50. Enclosure in base cone interior.

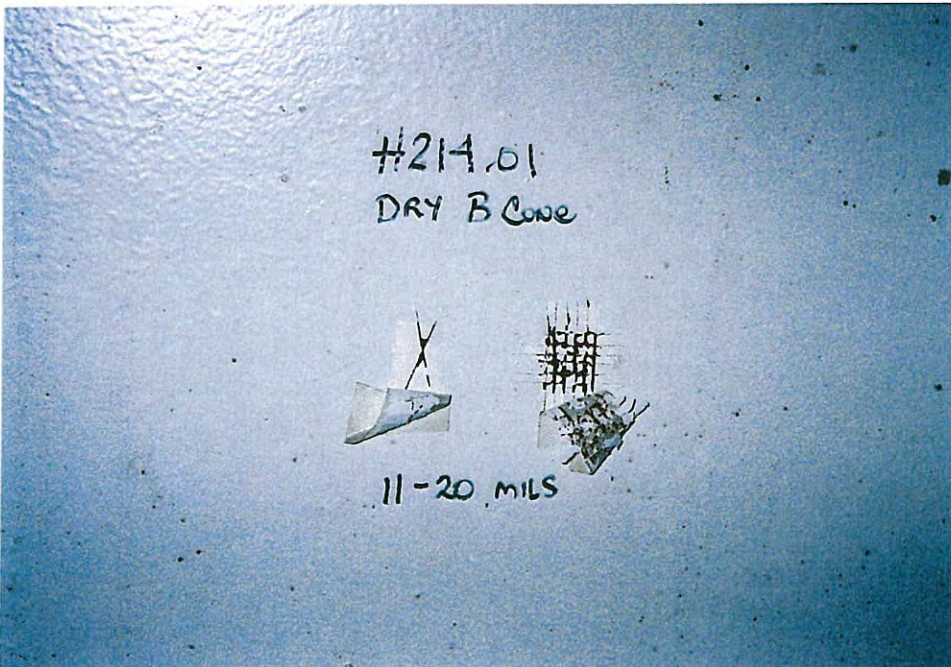
54. Coating thickness measurements and coating adhesion tests on in dry base cone.

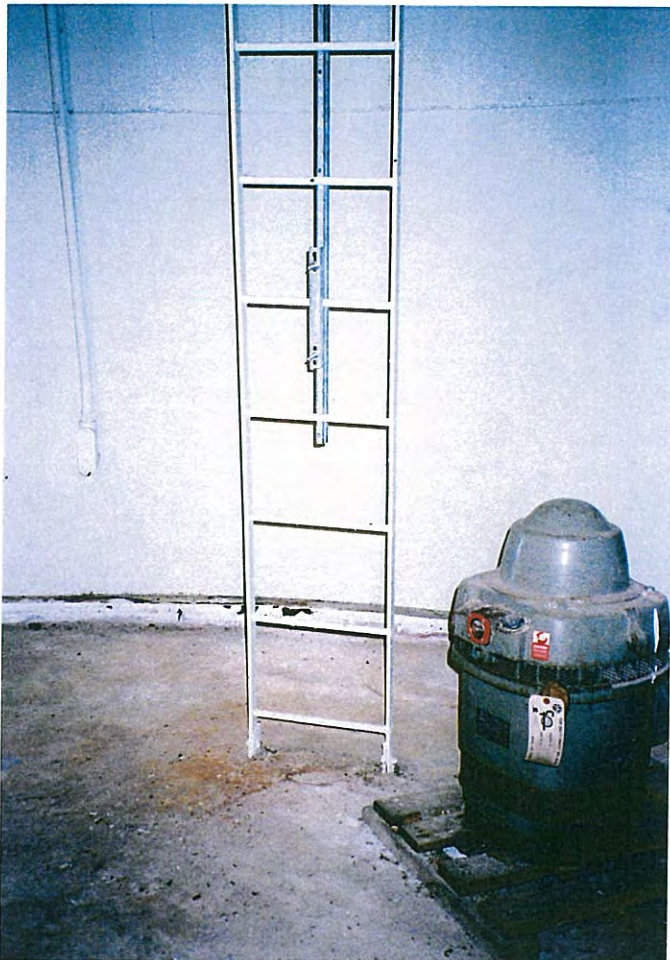
58. Base cone ladder, safe-climbing device, wooden pallet, and unused pump.

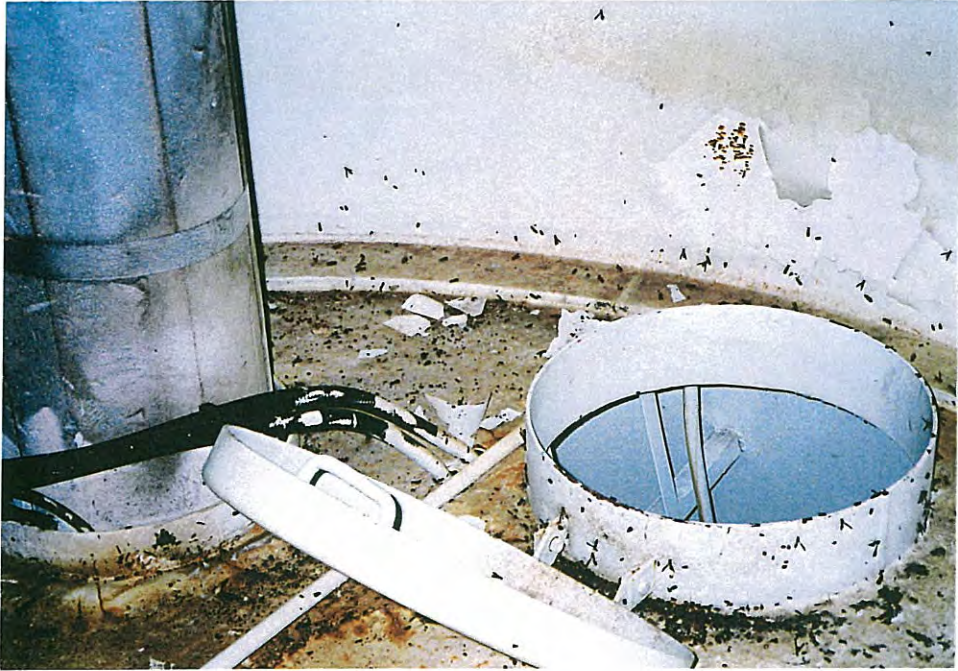
63. Condensate platform.

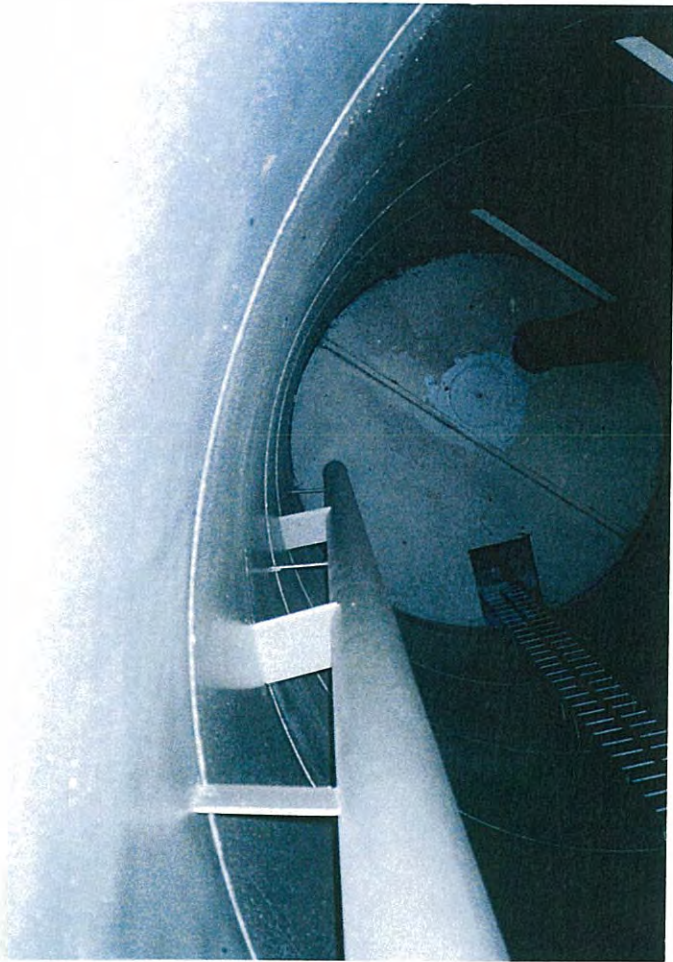
69. Overflow pipe and brackets in pedestal.

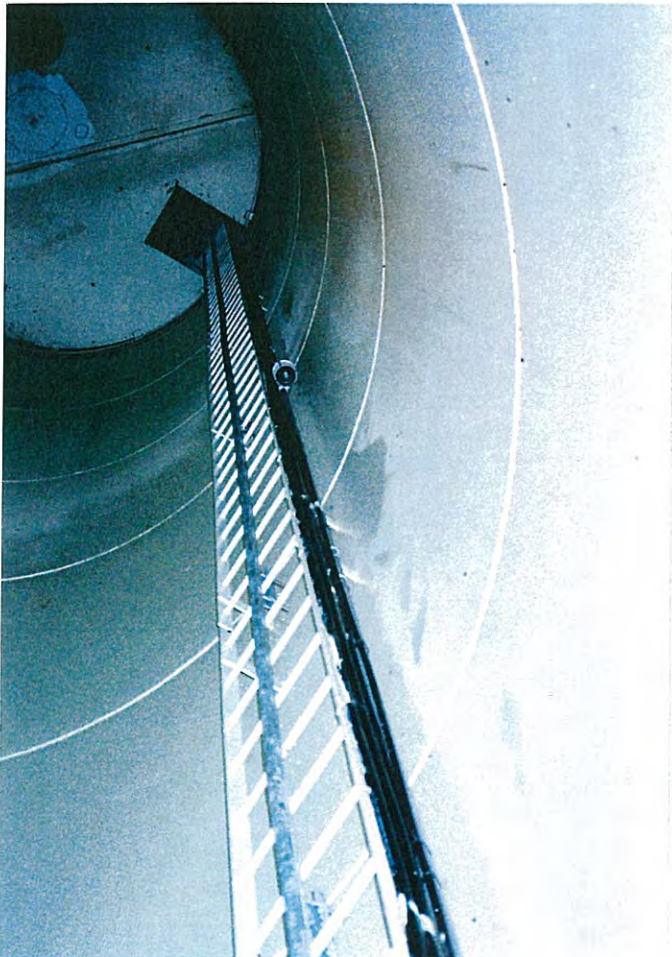
70. Pedestal ladder, safe-climbing device, cables, and inoperable light fixture.
