Subject: Lawrence Water PER Submittal

Preliminary Engineering Report
for **Water System Improvements**

LAWRENCE MUNICIPAL UTILITIES
LAWRENCE, INDIANA

November 2016
Revised January 9, 2017

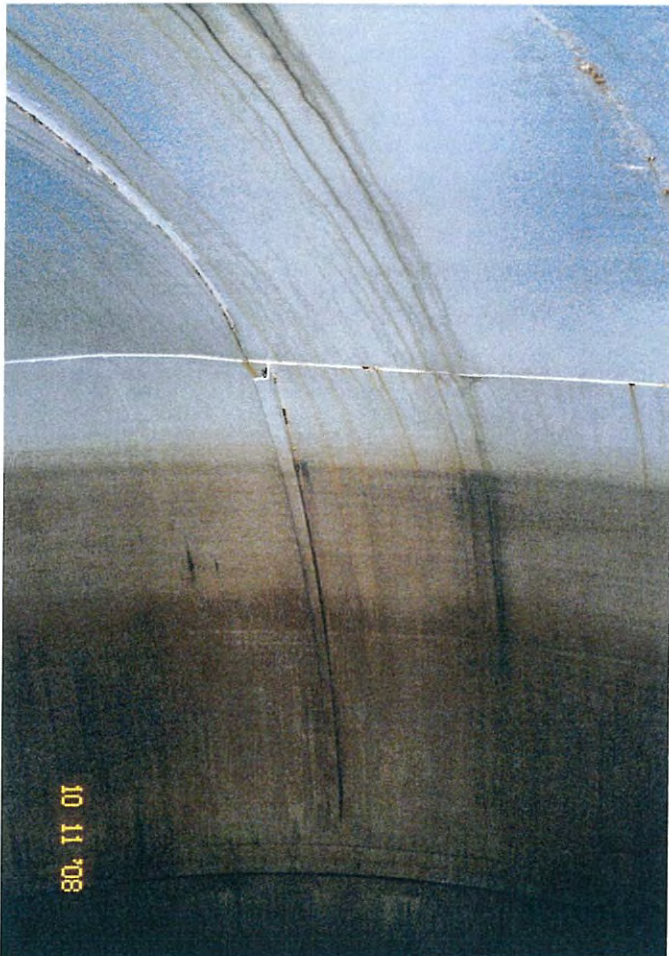
82. Roof knuckle interior.

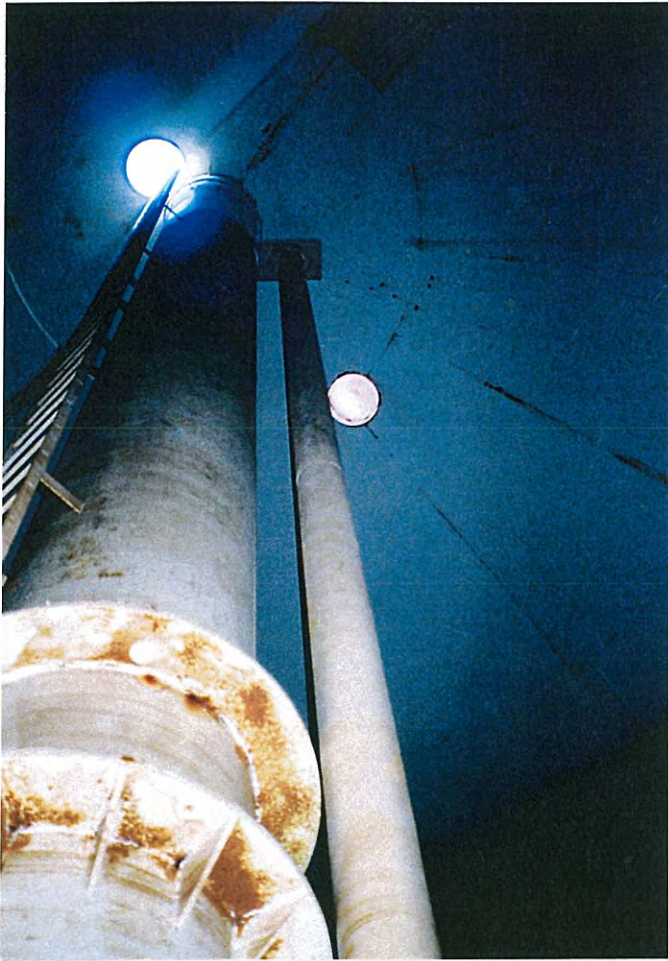
89. Overflow pipe and access tube.

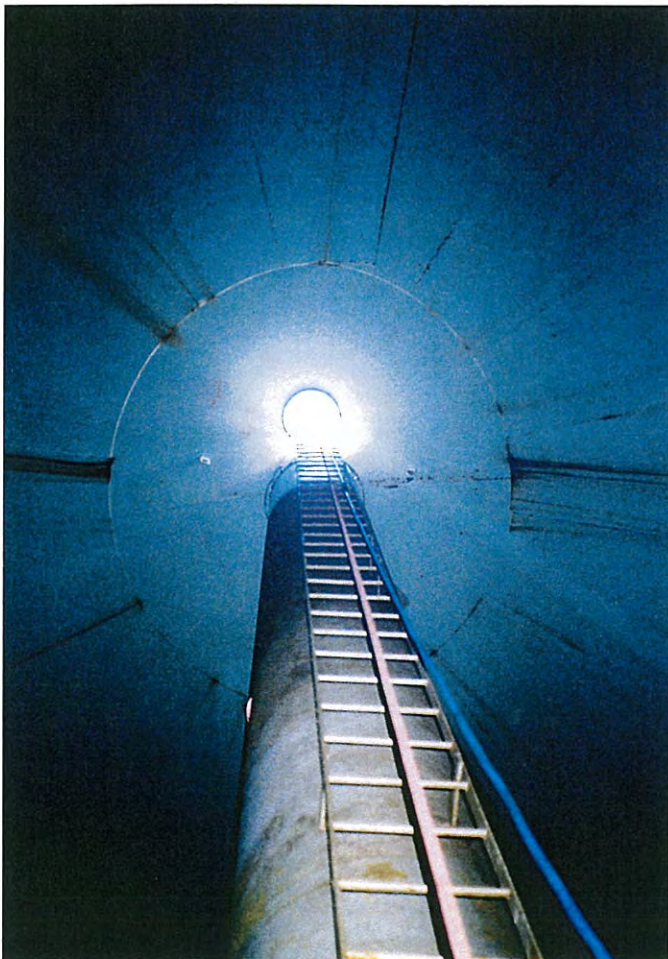
90. Interior wet ladder and access tube.

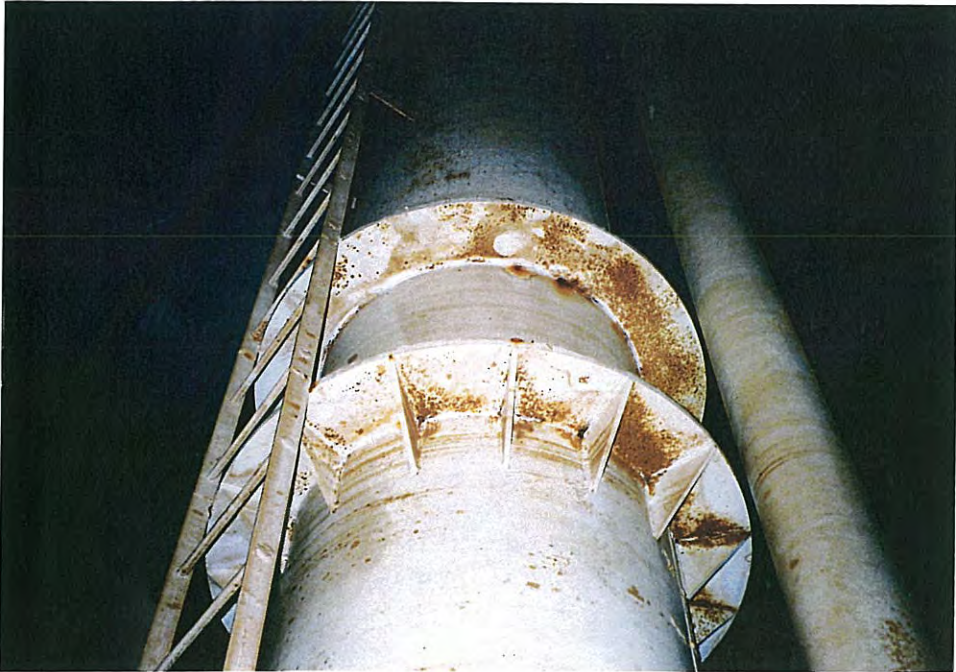
91. Wet ladder and access tube stiffeners.

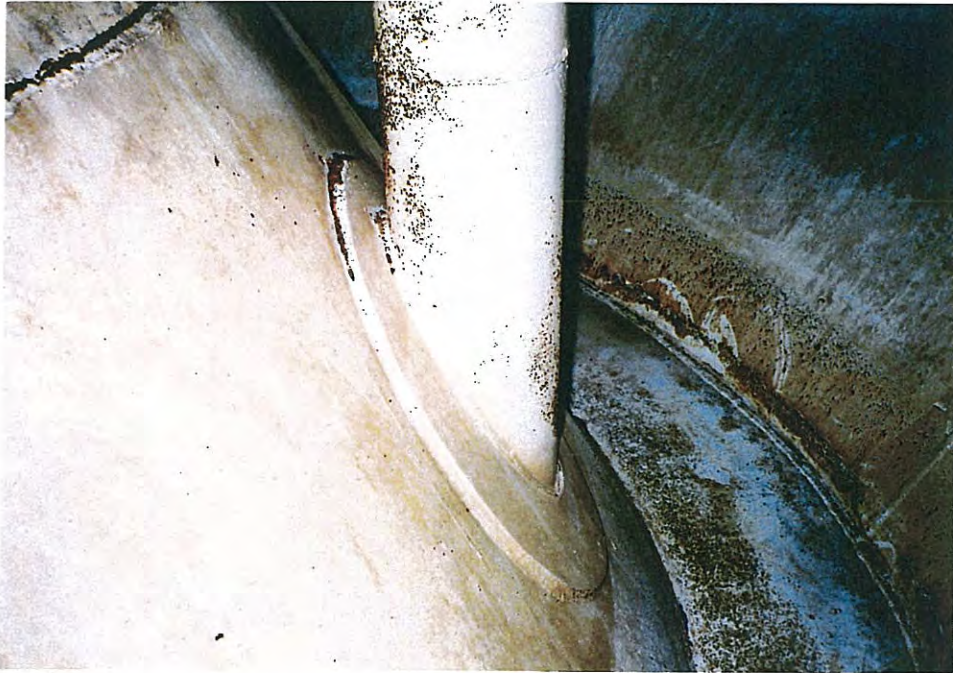
95. Overflow pipe penetration through bowl cone.

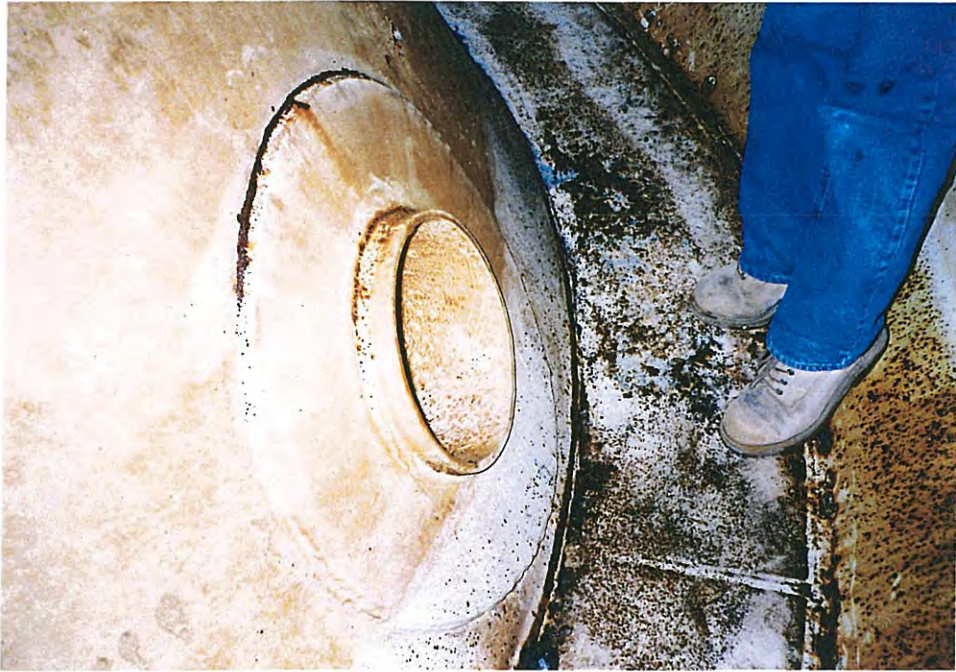
97. Inlet/outlet pipe.

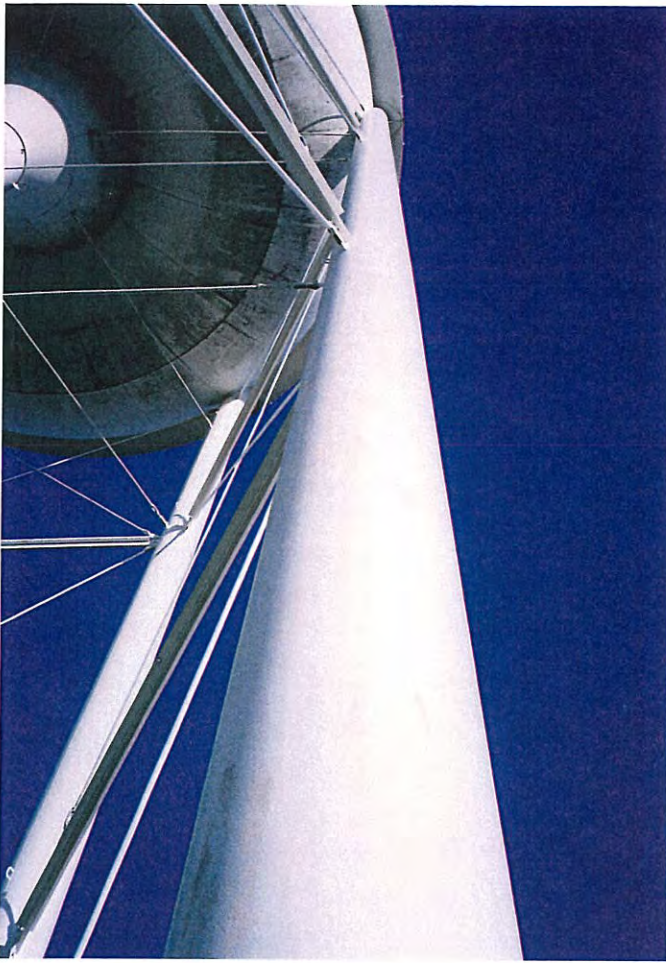
21. Column. Note areas of exposed underlying coating.

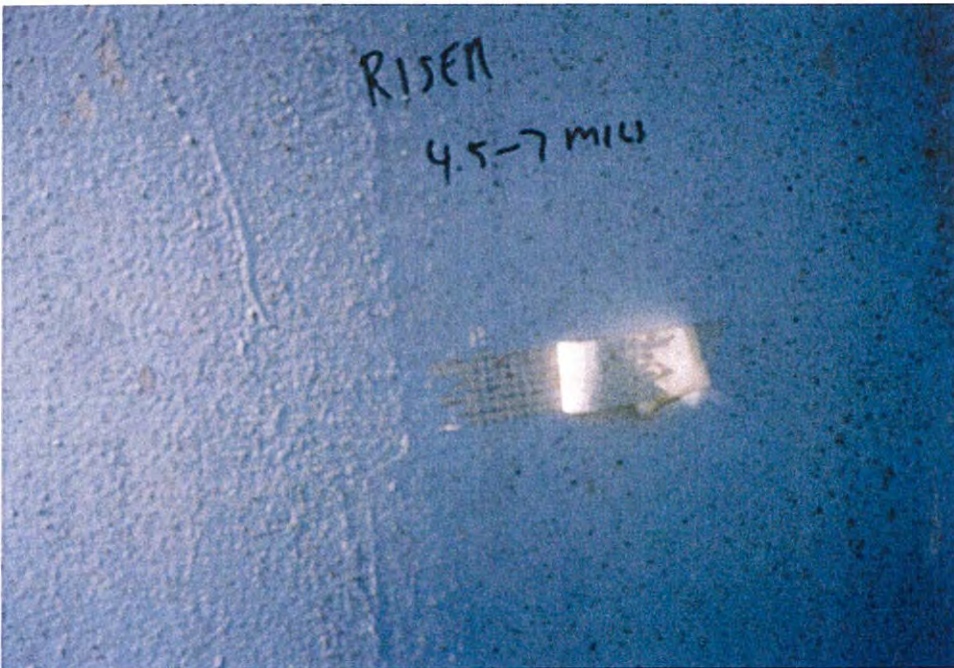
26. Coating thickness measurements and coating adhesion test on exterior riser.

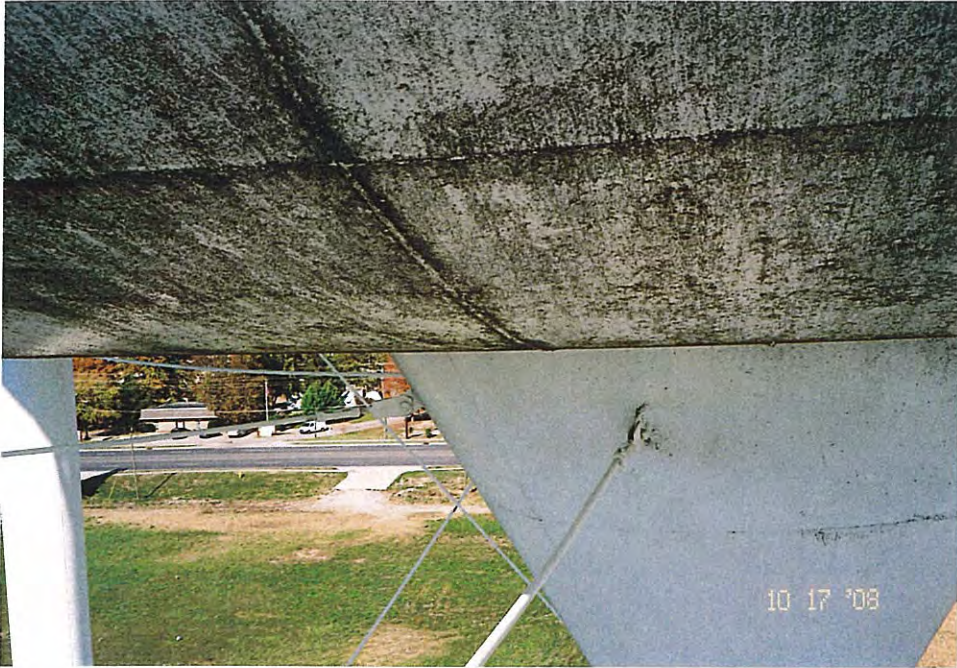
31. Mildew on exterior bowl.

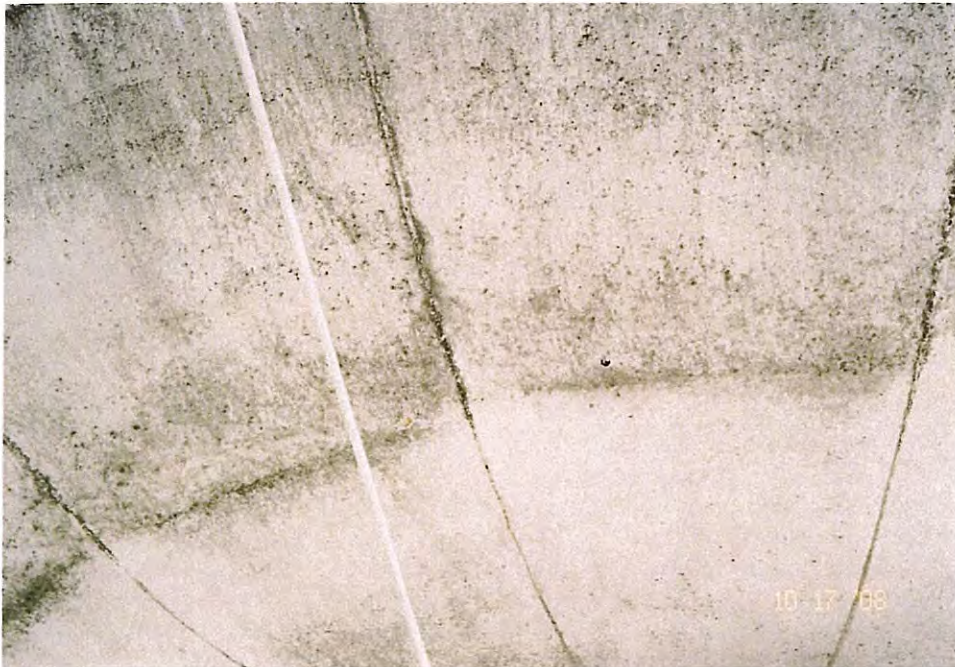
32. Mildew on exterior bowl.

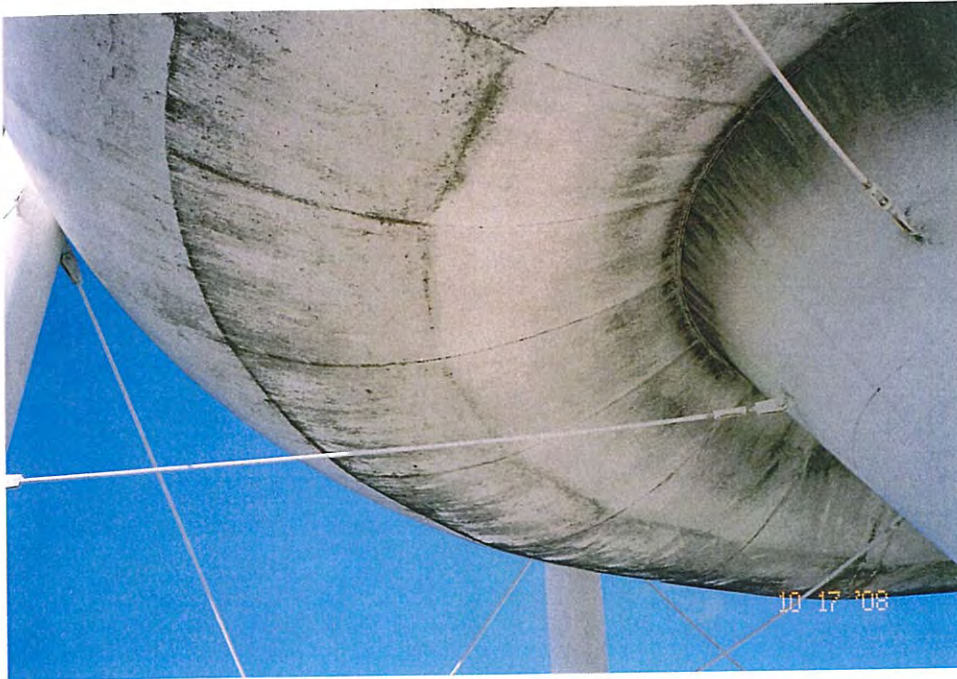
33. Mildew on exterior bowl.

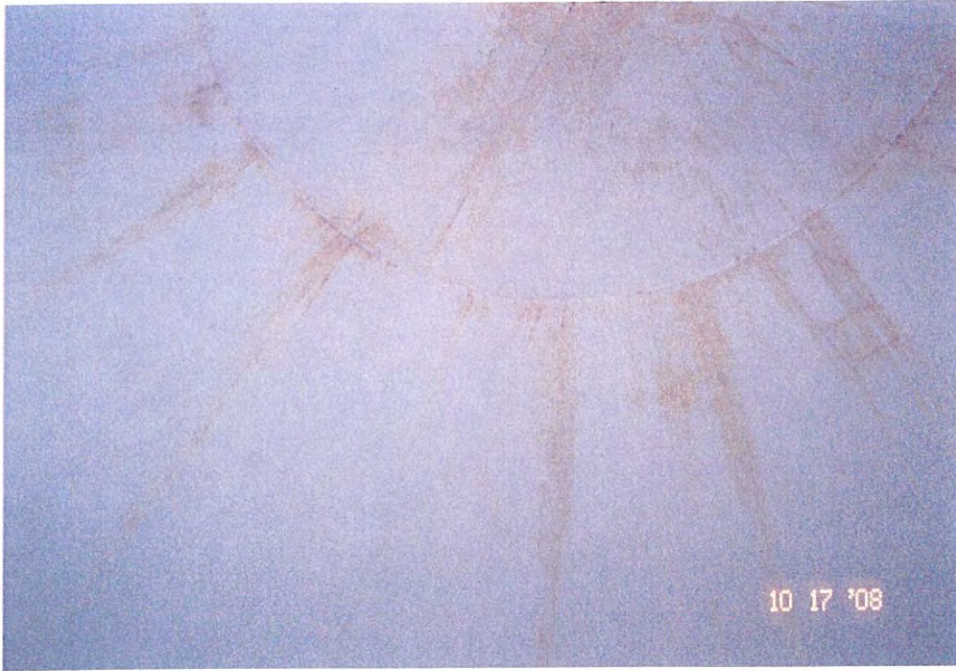
55. Interior roof.

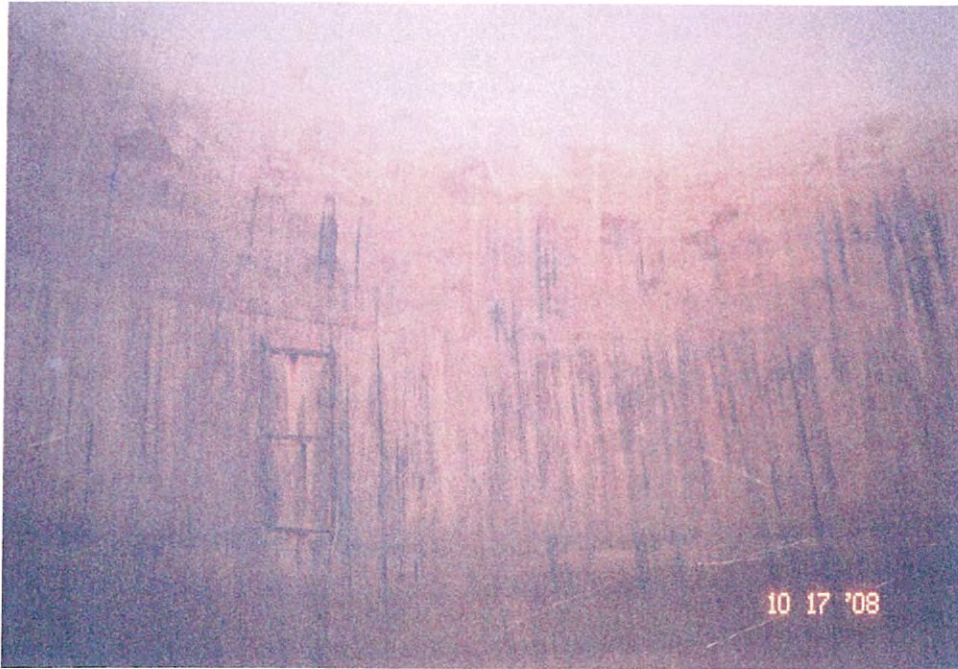
63. Interior shell.

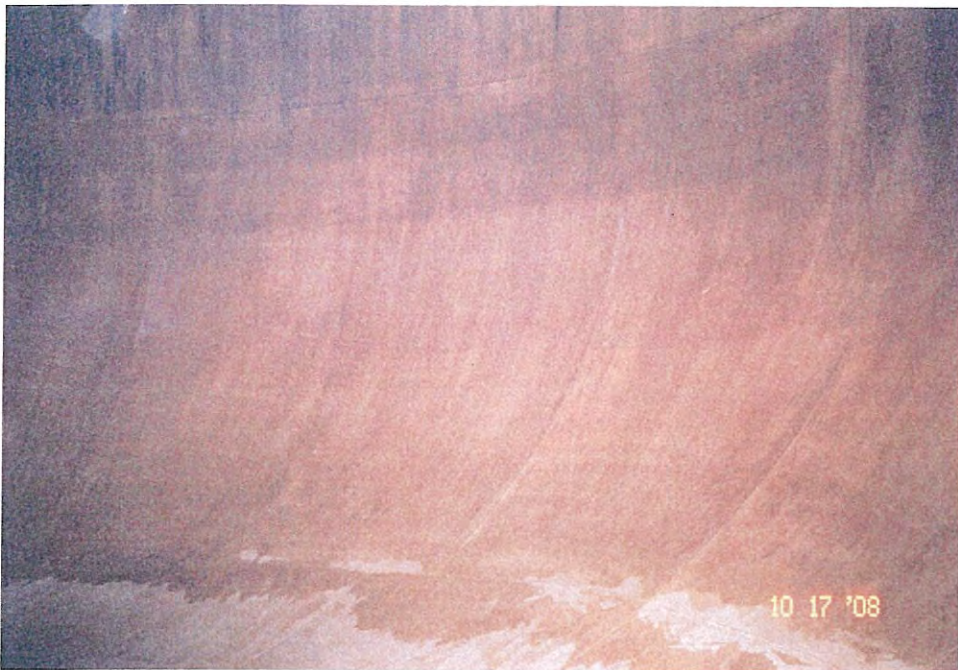
64. Interior bowl.

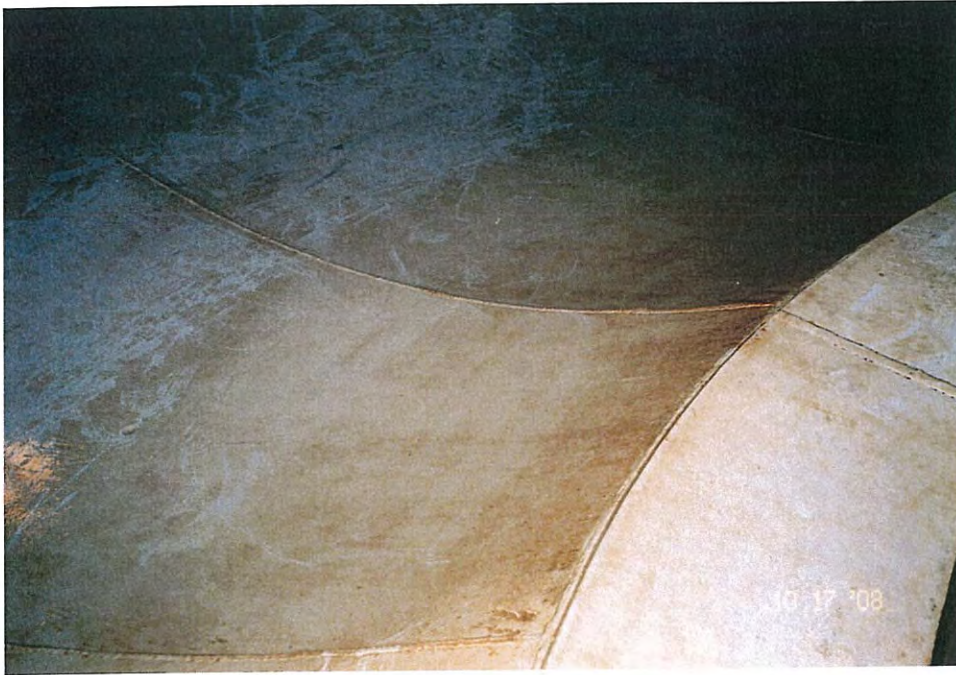
65. Interior bowl.

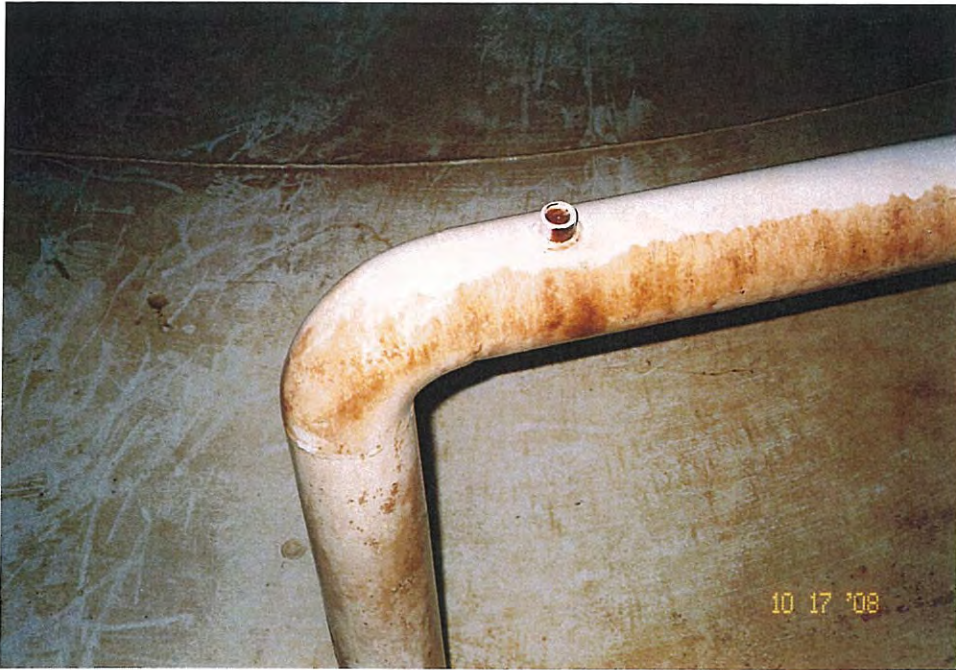
67. Siphon pipe in bowl.

10. **Siphon Pipe:** The missing air check valve for the siphon pipe should be replaced.
